E7402A-06

S E R V I C E N O T E

E7402A 9 kHz to 3.0 GHz EMC Analyzer

Replace Micron DRAM SIMMS from the A4, CPU assembly that can cause intermittent lock-up issues on instruments having option B72 only.

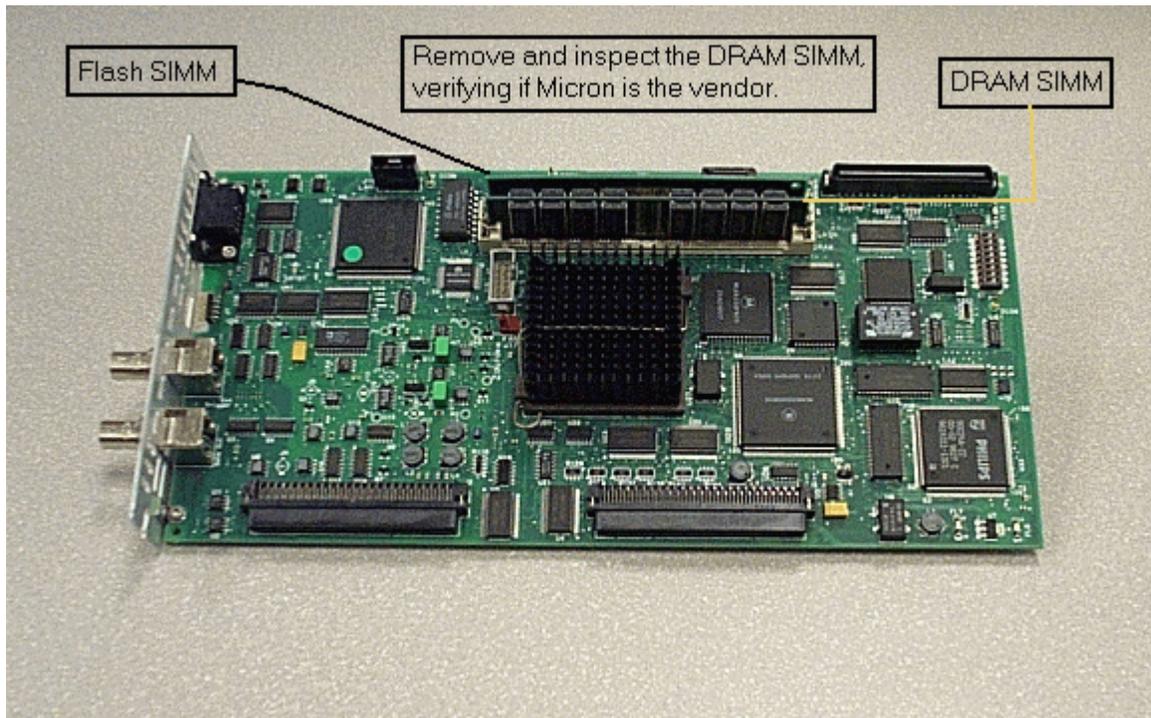
DRAM SIMMS using Micron parts can cause the instrument to lock-up and possibly white screen. This problem will only occur on instruments within the specified serial number range that have option B72, expanded memory. Micron has been removed from Agilent Technologies approved supplier list.

Remove the A4, CPU assembly from the instrument and pull out the DRAM SIMM pictured below. Additional information about removing the CPU assembly from the instrument can be found in the ESA or EMC Service Guide under chapter heading, "Replacing Assemblies". Inspect for Micron parts. If there is an "M" with a circle indicating the Micron parts, the SIMM should be replaced. All other component manufacturers are fine.
