E7515A-01B

Modification Recommended Service Note

E7515A UXM Wireless Test Set

Modify the Embedded PC to improve boot reliability.

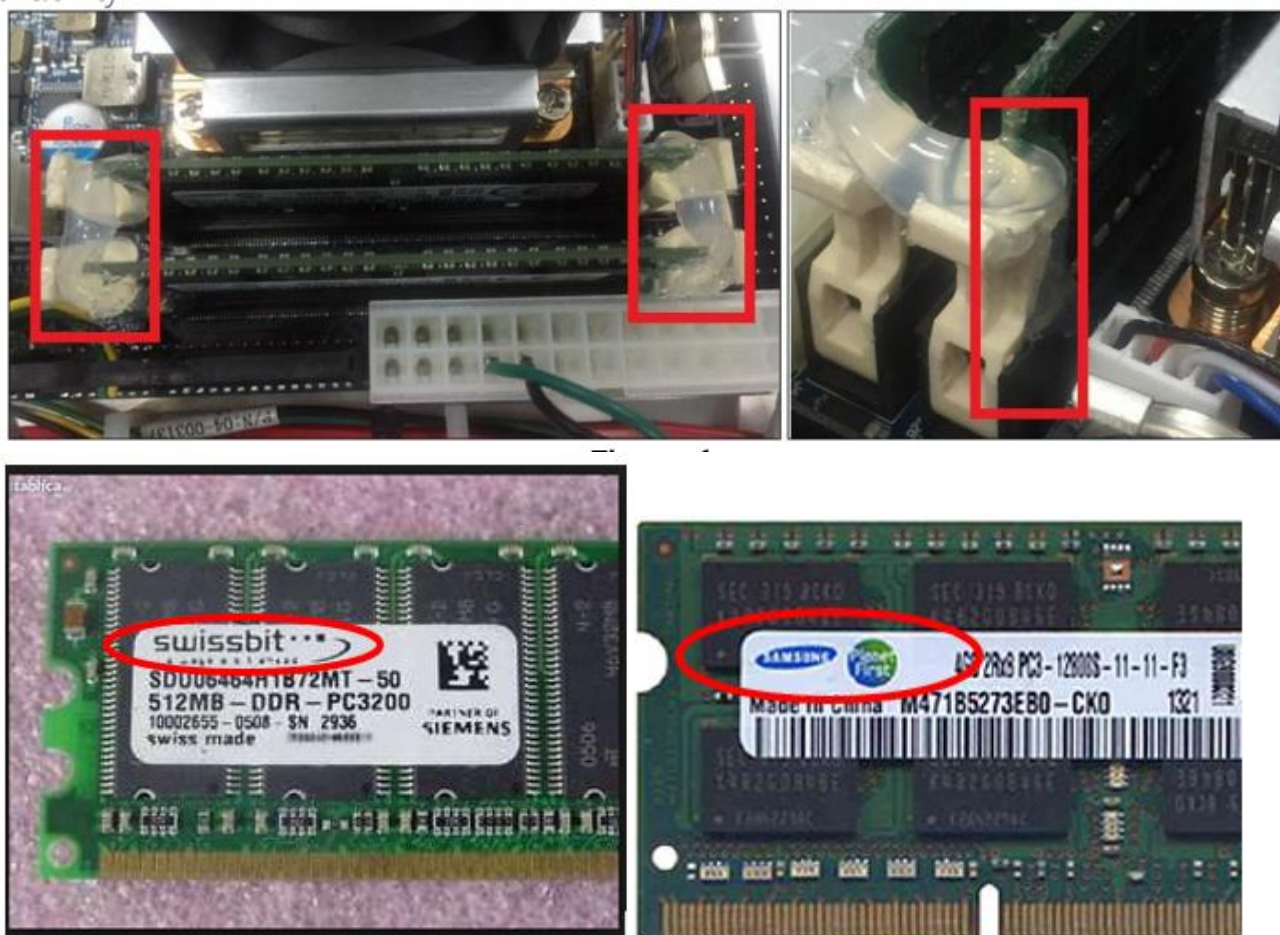
The E7515A will fail to boot if either of the RAM modules on the Embedded PC are not fully engaged in the memory slots or if the gold plating on the RAM modules has been damaged during transportation shock and vibration.

1. Remove the outer covers from the instrument
 2. Remove the Front Panel to fully inspect the RAM modules on the Embedded PC.
 3. Replace any **SwissBit** or **Samsung** DRAM with **Micron** RAM part number - 1819-1185.
- NOTE:** You may need to cut away Glue or RTV holding the existing Swissbit memory in place.

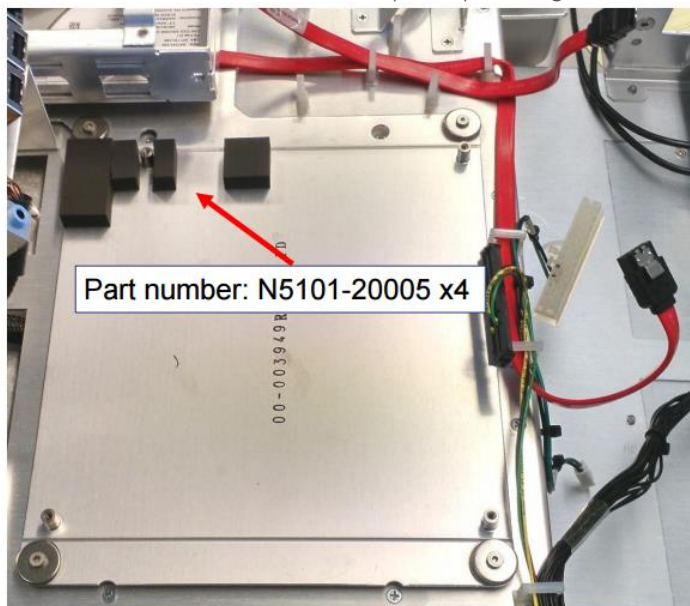
Extra padding was also added to the underside of the Embedded PC to further dampen the vibration and improve the boot reliability after transportation vibration.

- Inspect the underside of the Embedded PC and add 4x N5101-20005 if not already installed.
NOTE: You will need cut one square padding in half to straddle the standoff
