E7515A-01C

Modification Recommended Service Note

E7515A UXM Wireless Test Set

Modify the Embedded PC to improve boot reliability.

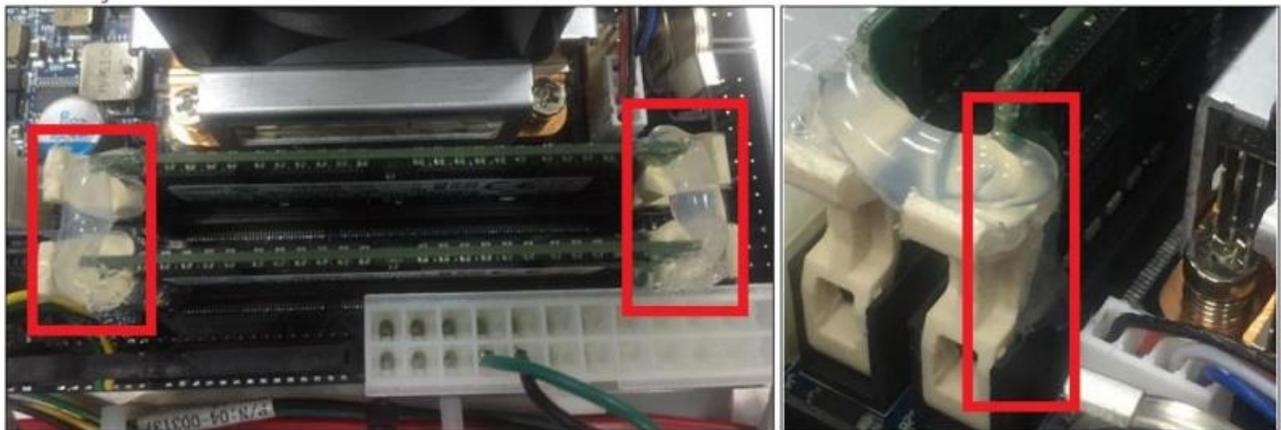
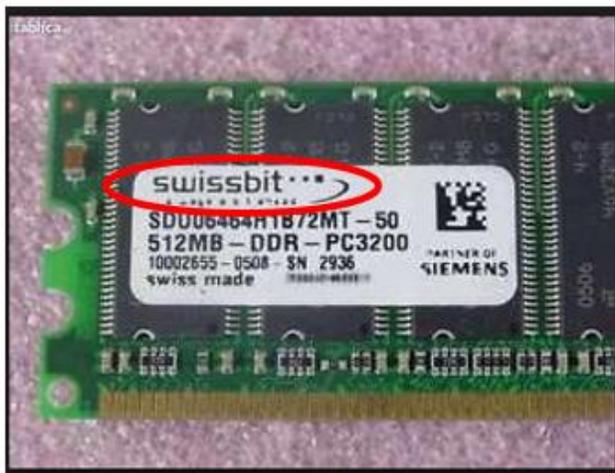
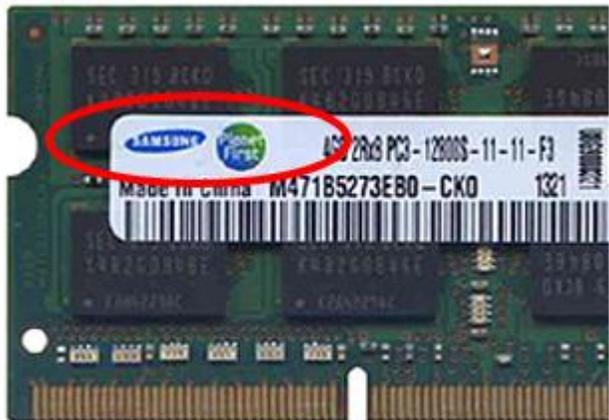
The E7515A will fail to boot if either of the RAM modules on the Embedded PC are not fully engaged in the memory slots or if the gold plating on the RAM modules has been damaged during transportation shock and vibration.

1. Remove the outer covers from the instrument
2. Remove the Front Panel to fully inspect the RAM modules on the Embedded PC.
3. Replace the failing **SwissBit** or **Samsung** DRAM with **Micron** RAM part number - 1819-1185.
NOTE: You may need to cut away Glue or RTV holding the existing memory in place.
