E7515A-04

# Modification Recommended Service Note

## E7515A - UXM Wireless Test Set

Serial Numbers: TH53460050 / TH54230257

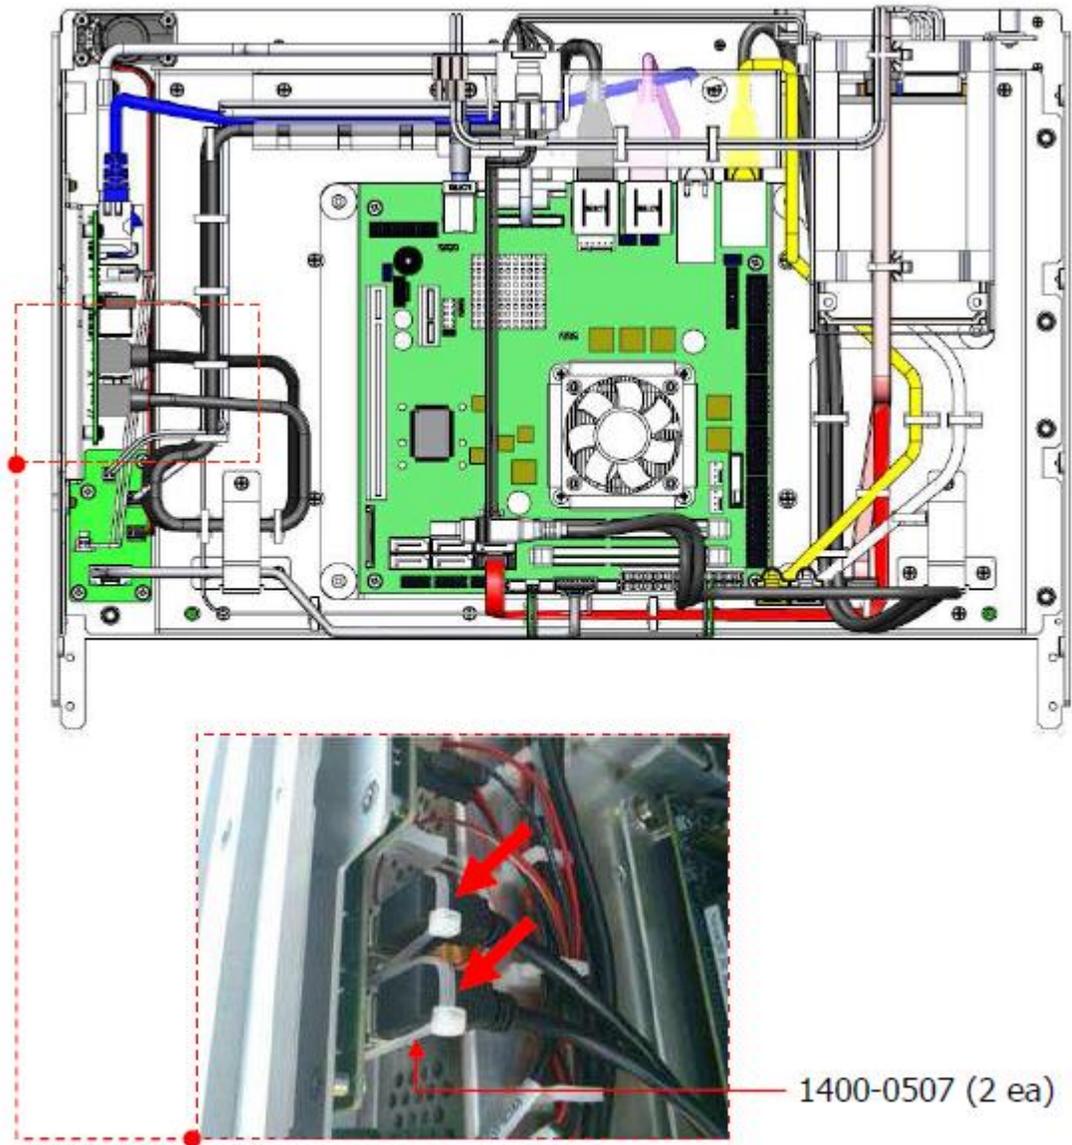
E7515A has some internal USB connections that do not have a built-in reliable locking mechanism. Failure analysis on early units revealed a USB loose connection. For example, the USB cable of the touchscreen controller was loose, and therefore the touchscreen did not work, until the USB connector was properly reseated.

*USB connections at the side of the front subassembly.*

Cable ties are attached to every E7515A USB internal connection in order to secure them. Cable ties are attached as shown in the following pictures.

**NOTE 1:** If the cable ties are removed as part of the repair job, install new cable ties to replace the removed ones before completing reassembly of the product.

**NOTE 2:** If an internal board with USB connectors is replaced (i.e PC motherboard), install new cable ties before completing reassembly of the product.

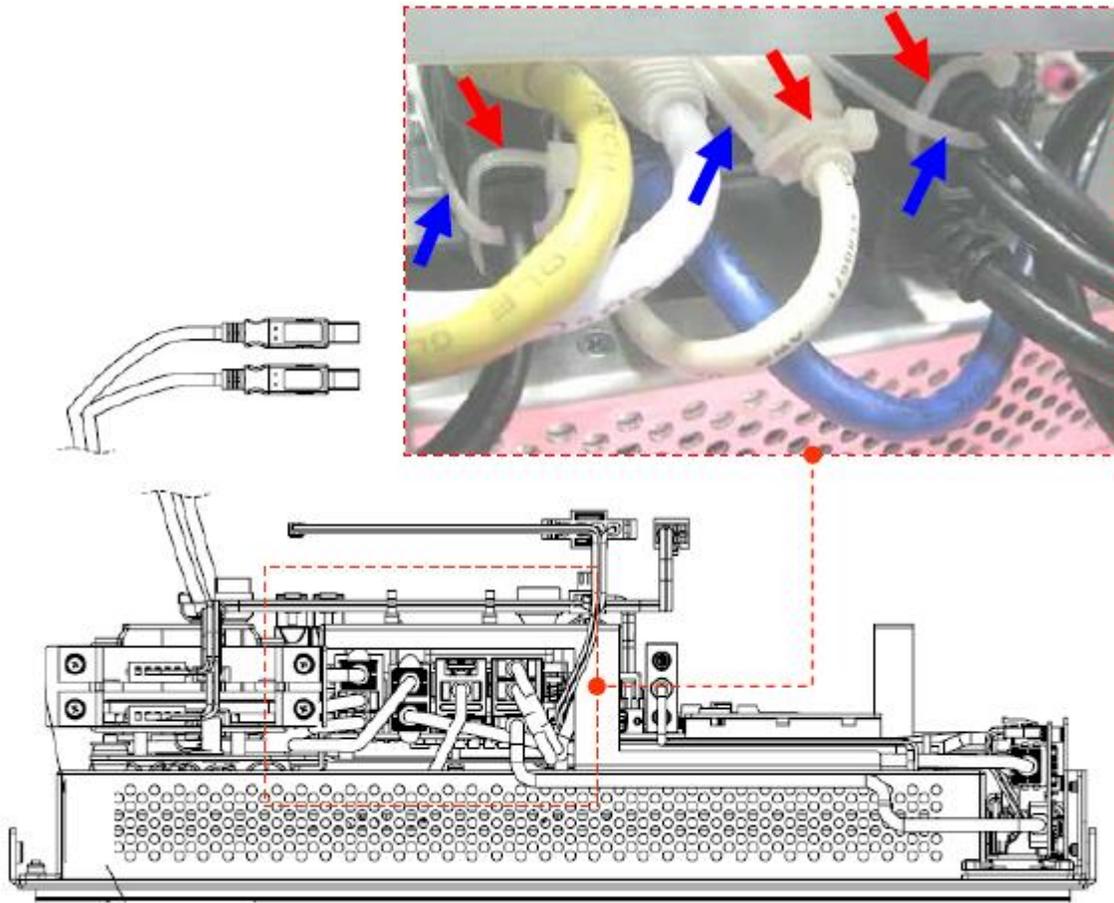
*USB connections at the PC motherboard (top view of motherboard connectors)*

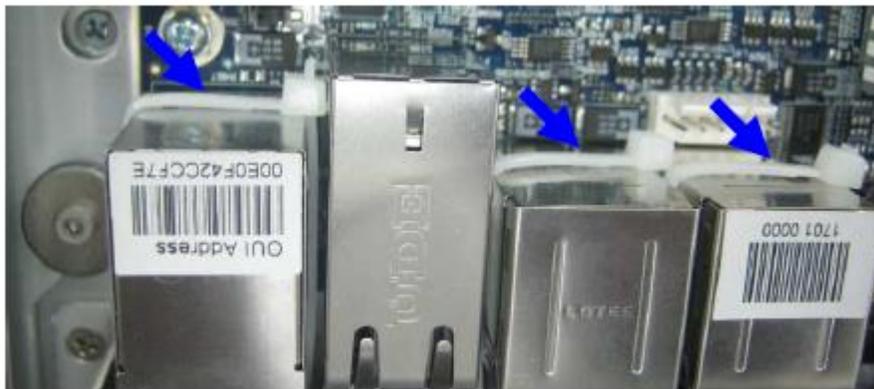
*USB connections at the PC motherboard (rear side view of motherboard connectors)*
