F7515A-06

# Modification Recommended Service Note

# E7515A UXM Wireless Test Set

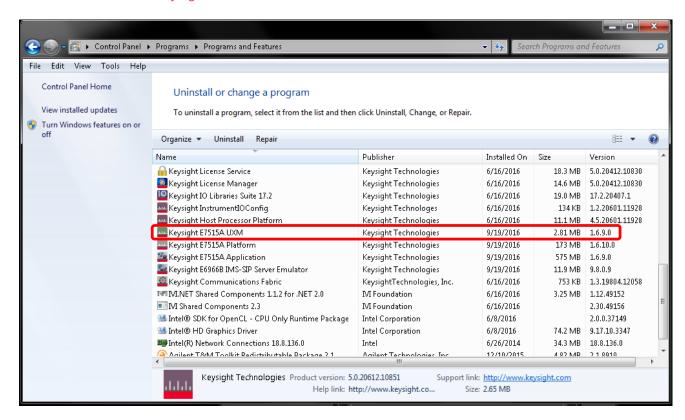
There are some identified quality issues tied to old versions of E7515A software, prior to UXM 1.4 (version 1.4.3.0) software release, which was released in Oct/08/2015. For example, in some instances, a software upgrade from a UXM version prior to 1.4 would corrupt some of the UXM hardware modules, leading to a faulty state when instrument boots up after the software upgrade.

1. Check the UXM software version in the windows control panel. If it is older than 1.4.3.0, it is strongly recommended to upgrade the instrument to the latest official UXM software version available at <a href="https://www.Keysight.com">www.Keysight.com</a>.

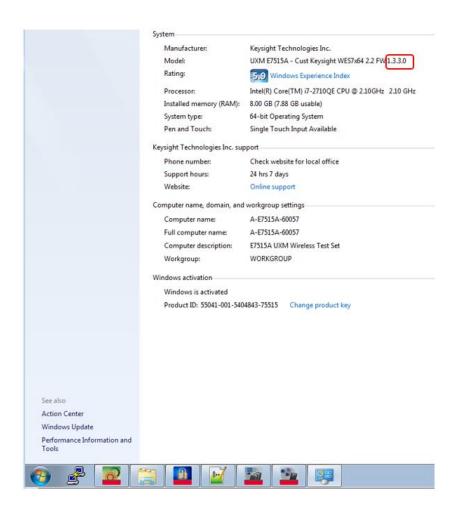
The Windows version can then be easily checked in the "Properties" windows:

If the revision number shown is below 1.4.x.x (i.e. like the above image), please contact your Keysight Technical Support engineer to check your instrument and potentially upgrade the Windows Recovery image.
