E7515B-01A

# Modification Recommended Service Note

## E7515B UXM 5G Wireless Test Platform

Serial Numbers: MY00000000 - MY59159999

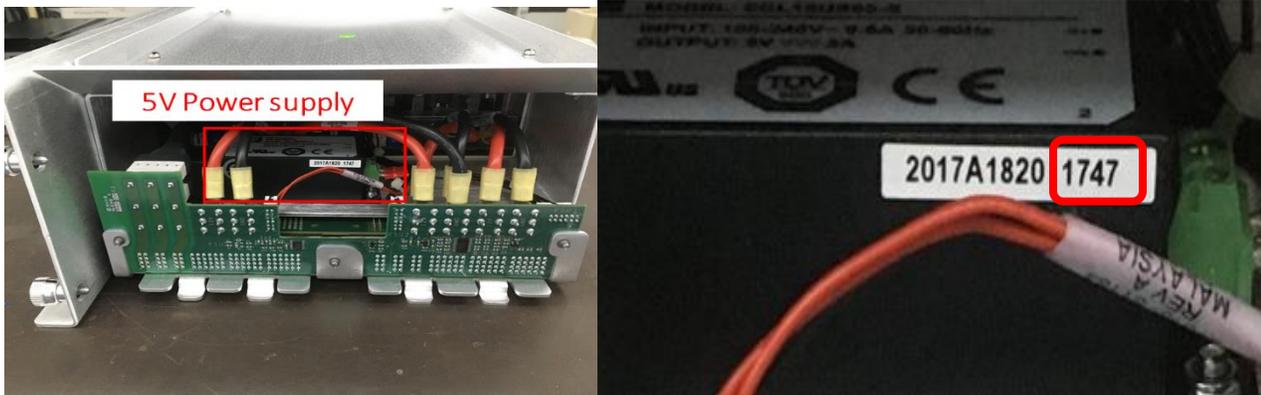
Due to a possible defective 5V rail on the UXM5G power supply, Keysight has agreed to implement a service note to replace all existing UXM5G version 1 power supply's that have the date code 1818 or below - see pictures below. This service note will apply to all E7515B instruments with serial numbers MY57150001 to MY59159999.

Date codes 1819 and above have an improved design that will improve the quality and reliability of the UXM5G Power Supply.

Close up view on date code ensure 1819 and above

The risk of failure is low but on your next service event Keysight will proceed to check the date code of the 5V regulator and if it is below 1819 will proceed to replace the PSU under this service note.
