E7917A-03

S E R V I C E N O T E

E7917A 2-Port OC-3c/12c ATM Routing Test Card

**Sometimes E7917A fails to power up.
Applies to any units not modified to A10 indicated by the label on the main
PCA as shown in Figure 1 and Figure 2.**

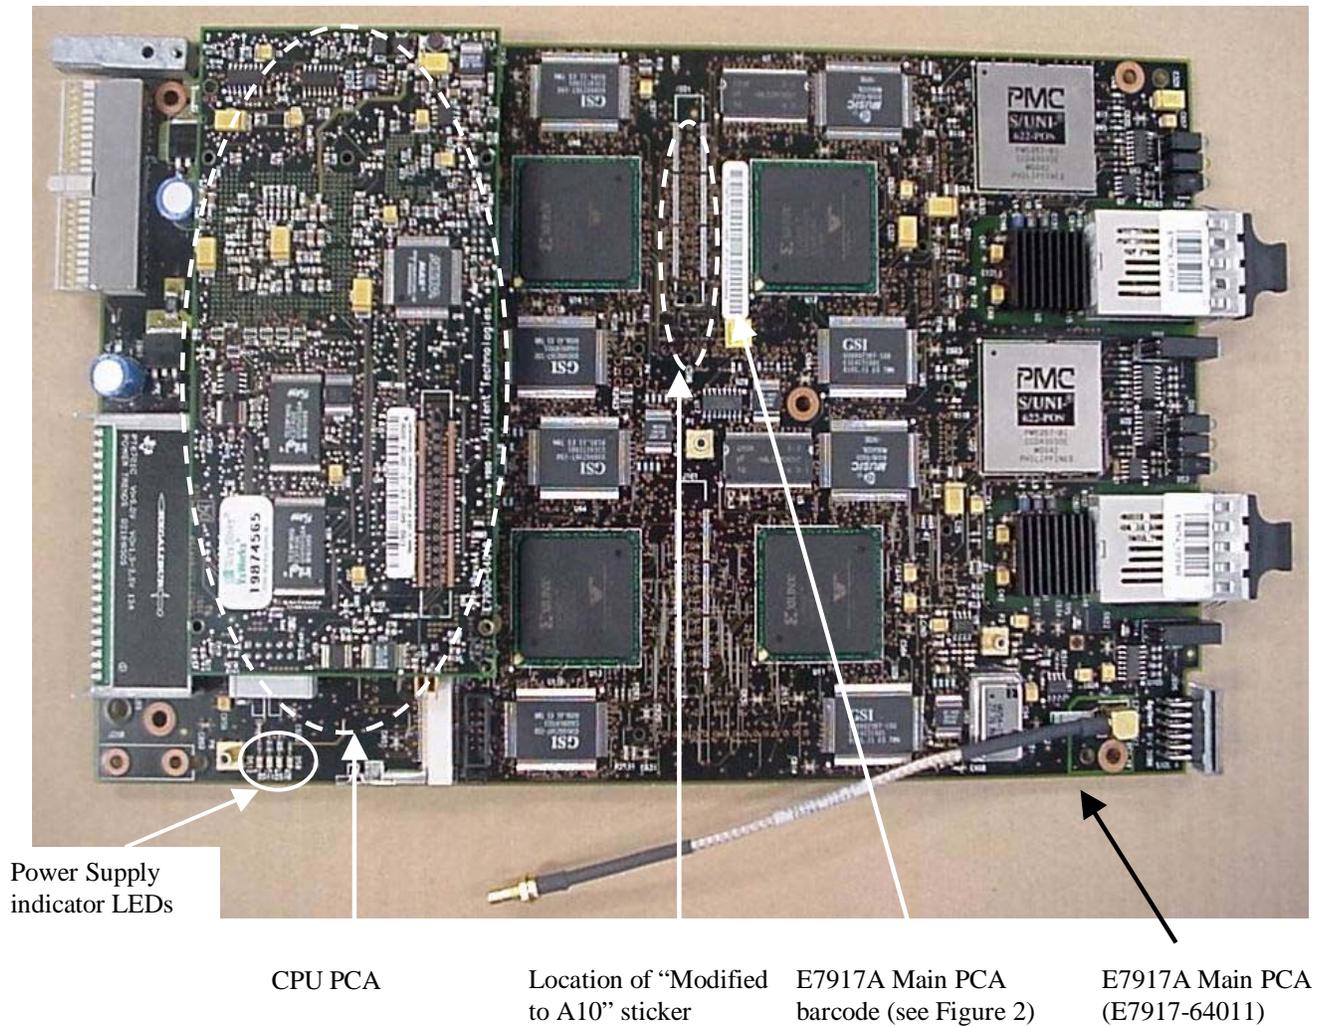
Figure 1 - Identification

The failure of the E7917A Test Card to power up is detected by the absence of any LED activity on the front panel of the Test Card. Alternatively, in an open RouterTester 900 4-Slot Chassis (E7900A) the power supply LED indicators (located at the rear left of the E7917A Test Card) fail to light when the Chassis is powered up, refer to Figure 1 on page 3.

1. Remove the E7917A Test Card from the E7900A Chassis.
2. Determine the current revision of the E7917A main PCA as follows (see Figure 1 below):
 - If a sticker is found on the E7917A main PCA indicating “Modified to A10” or “Modified A10”, no further work is required. Do not confuse with a potentially similar sticker on the CPU PCA.
 - If the E7917A main PCA barcode sticker indicates A10, no further work is required. Refer to Figure 2 below where the barcode sticker indicates PCA revision A09. In the absence of a “Modified to A10” sticker, the modification will be required.
 - The E7917A main PCA barcode sticker is generally located near U12, however on earlier versions of the PCA this sticker was randomly positioned on either side of the PCA by the Contract Manufacturer.
 - Do Not confuse the barcode sticker on the CPU PCA with that of the main E7917A PCA sticker.

16. Check that the E7917A TestCard power rail indication LEDs are all lit. Refer to Figure 1 on page 3 for their location on the main PCA. If any of these LEDs fail to light, re check the capacitor solder joints.
17. Check that the E7917A TestCard has correctly numbered up (refer to the Built In Self Test section of the E7900A service manual for further information).
18. Execute the Automated diagnostics section of the E7900A service manual with the E7917A TestCard in slot number one of the E7900A chassis to verify that operation of the E7917A TestCard.
19. End of process.

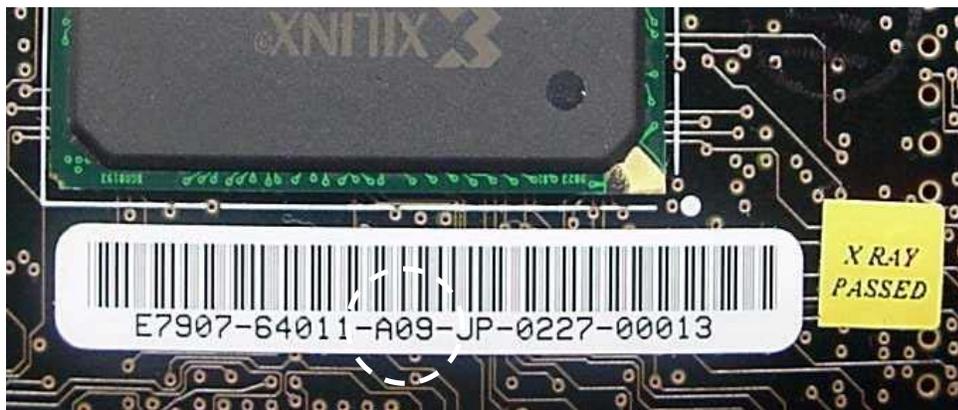
Figure 2 - E7917A PCA identification Barcode

PCA Modification / Revision number

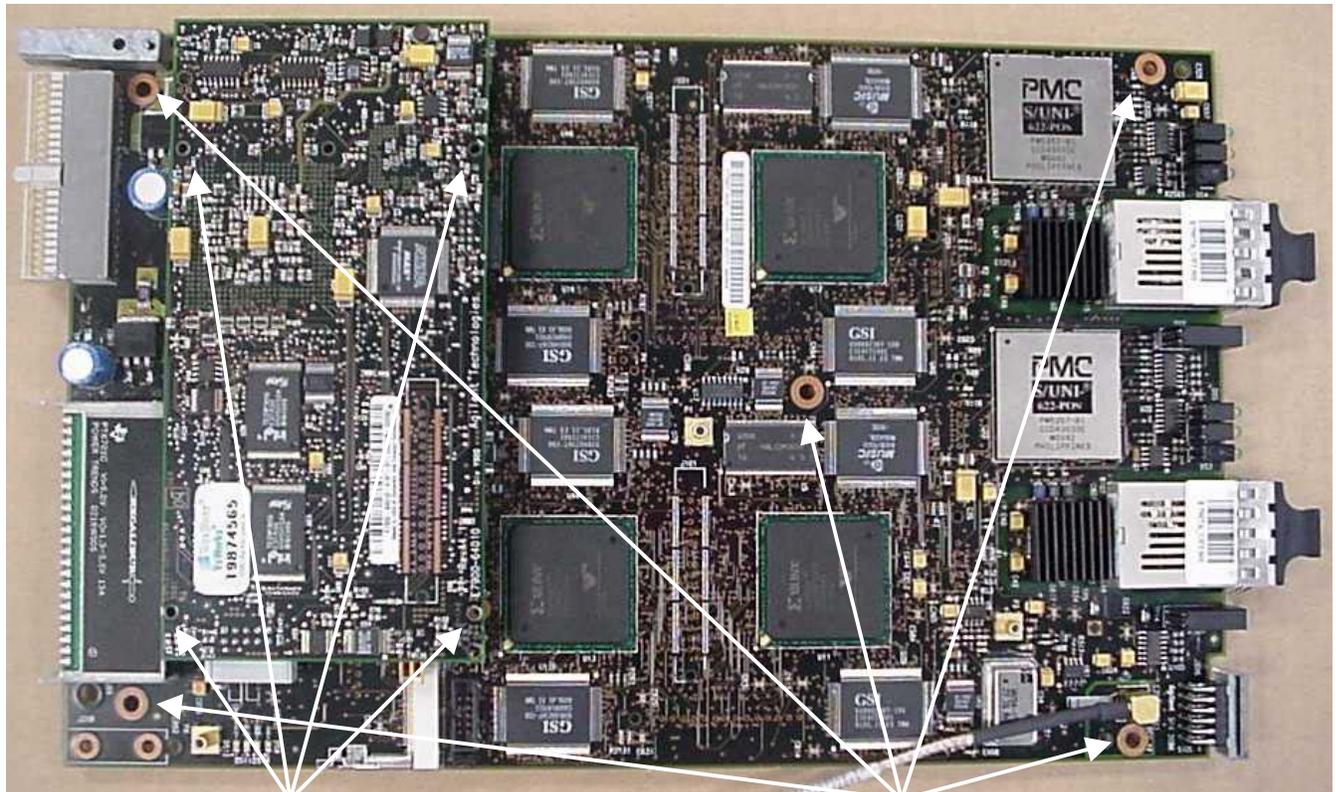
Figure 3 - Retaining Screw Positions

CPU PCA retaining screws

E7917A Test Card PCA retaining screws

Note: The sixth E7917A Test Card PCA retaining screw, location not shown above, is positioned in the center of the PCA directly under the leading edge (closer to the front panel) of the CPU PCA.

3. Remove the retaining nut of the SMB connector on the E7917A Test Card front panel and pull the cable clear.
4. Remove the four retaining screws of the CPU PCA and carefully remove the PCA from the main E7917A Test Card PCA, refer to Figure 3 below
5. Remove the six retaining screws of the main E7917A Test Card PCA, refer to Figure 3 below. Slightly raise the rear of the PCA so that the standoff's are clear of the underside of PCA to ensure that no surface mount components are knocked off the PCA and slowly pull the PCA optics modules clear of the front panel.

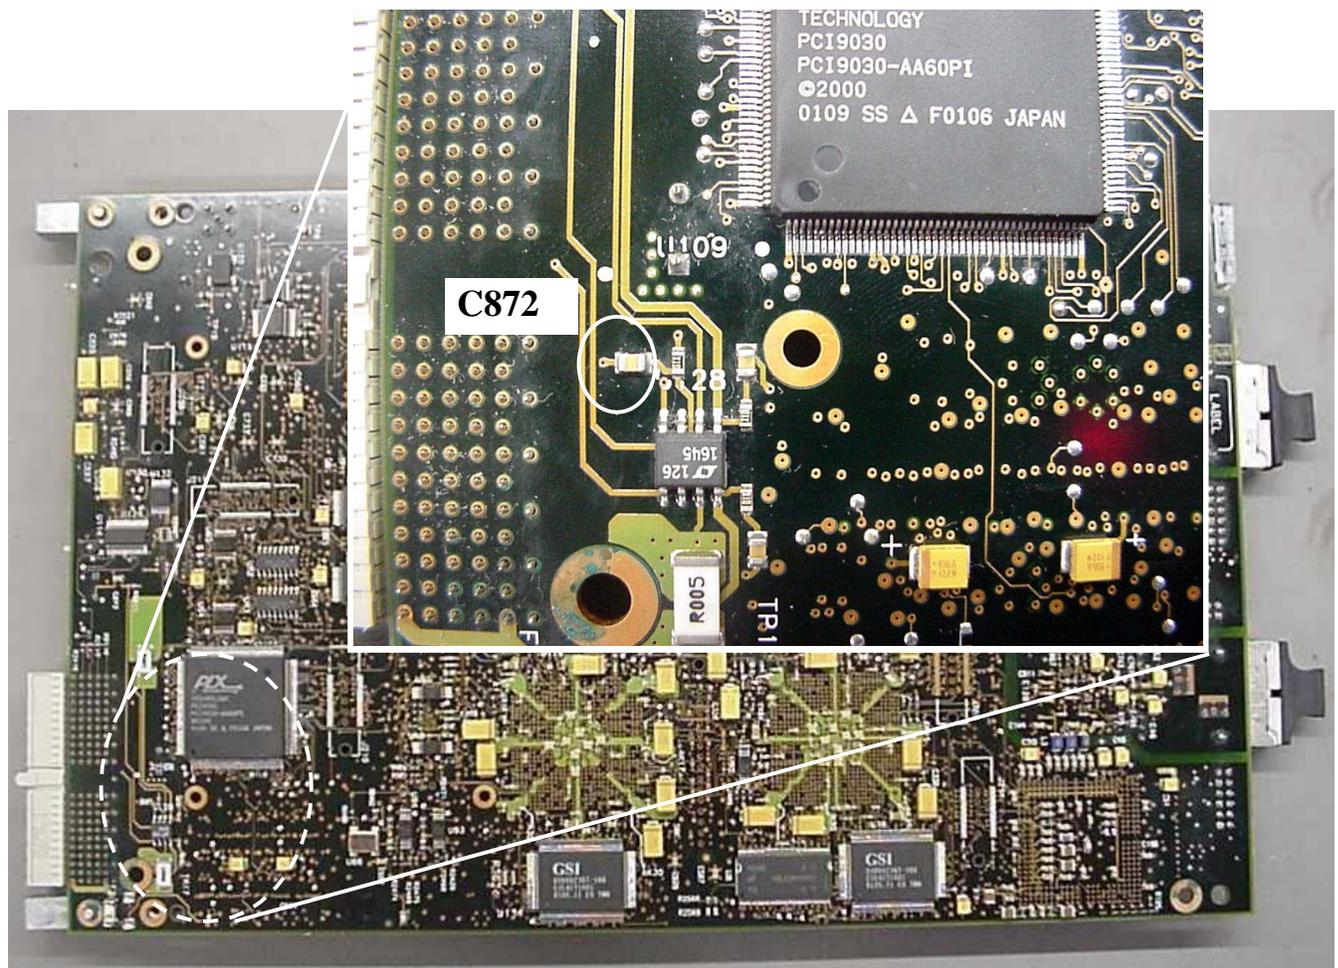
Figure 4 - Capacitor Identification for Replacement

6. The surface mount capacitor (C872) to be replaced can be located by referring to Figure 4 below.

7. Carefully remove C872 as identified in Figure 4 above. This part can be scrapped.
8. Carefully position and solder the new P/N 0160-7409, a 0.0068uF capacitor in place.
9. Carefully feed the two optical transceivers through the front panel, while holding the rear of the PCA clear of the metalwork standoff's to ensure no surface mount parts are dislodged.
10. Replace and retighten the six retaining screws.
11. Align the CPU PCA correctly with three connectors and firmly push down to make a solid fitting.
12. Replace and retighten the four retaining screws.
13. Feed the cable connector fitting through the front panel and retighten the retaining nut of the SMB connector.
14. Place a "Modified A10" sticker P/N E7917-00025 close to the E7917A Test Card PCA barcode, refer to Figure 1 on page 3 above for sticker location guide.
