E8257D-26

S E R V I C E N O T E

E8257D - Analog Signal Generator

Intermittent CPU boot-up and/or No display

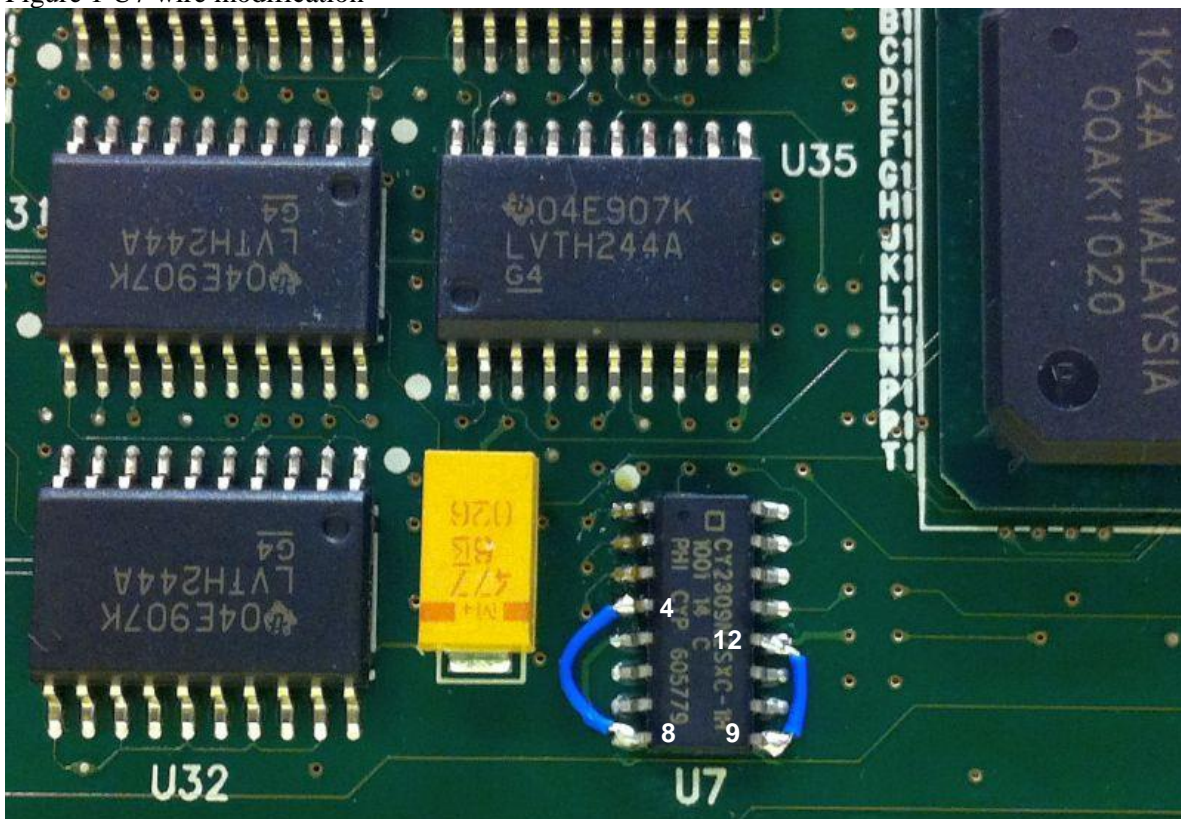
Figure 1 U7 wire modification

The clock buffer, U7 on the CPU board (E8251-60006 or E8251-60661), may cause intermittent boot up and/or no display when the instrument is powered up. It is recommended that this modification is performed on any instrument within the serial numbers above that exhibits an intermittent boot-up and/or a blank display.

Using the appropriate soldering technique and ESD station, perform a modification on the U7 circuit on the CPU board. Connect U7 pin 8 to 3.4V (wire pin 8 to pin 4) and connect U7 pin 9 to DCOM (wire pin 9 to pin 12).

1. Refer to E8257D Service Guide for the A18 CPU removal procedure.
2. Refer to Figure 1 for U7.
3. Use 30 AWG wire for wiring pin 8 to pin 4, and pin 9 to pin 12 per Figure 1.
4. Re-install CPU and cover.
5. Run self test.
6. No calibration is required.
