**E8257D-26A**

## E8257D Analog Signal Generator

### Intermittent CPU boot-up and/or No display

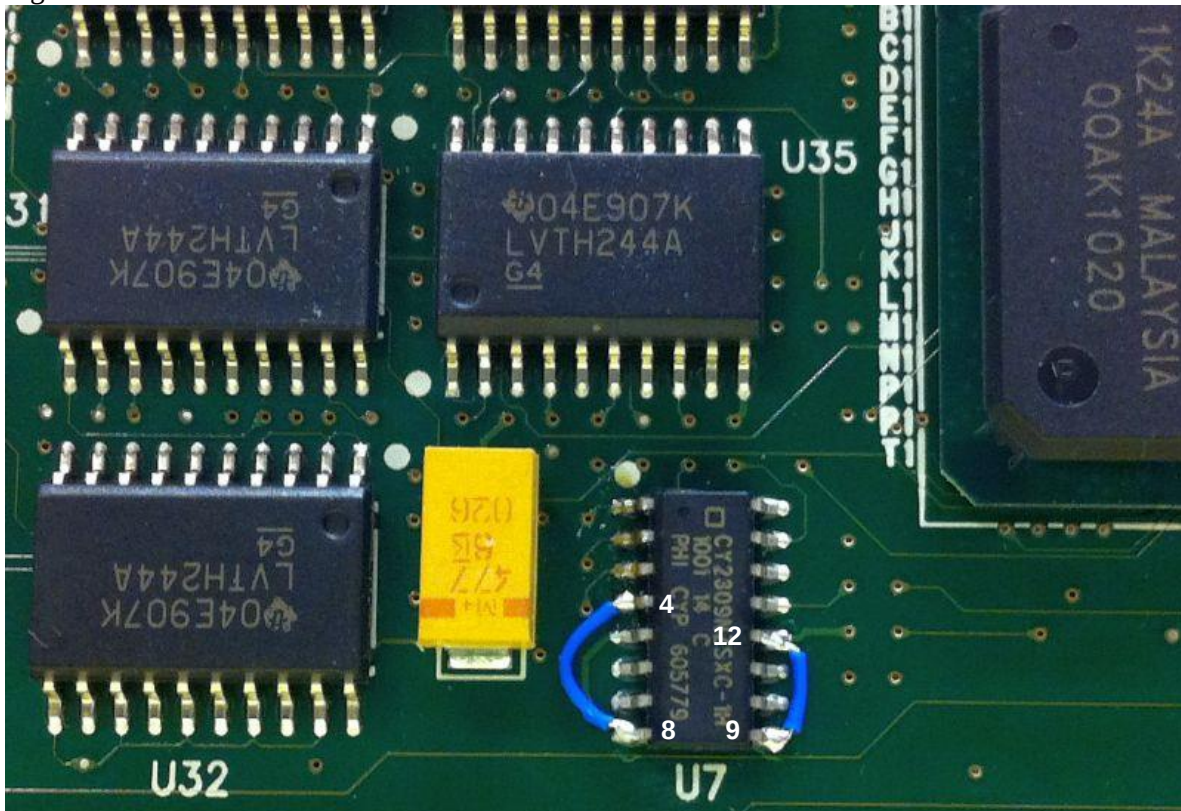
Figure 1 U7 wire modification

The clock buffer, U7 on the CPU board (E8251-60006 or E8251-60661), may cause intermittent boot up and/or no display when the instrument is powered up. It is recommended that this modification is performed on any instrument within the serial numbers above that exhibits an intermittent boot-up and/or a blank display.

Using the appropriate soldering technique and ESD station, perform a modification on the U7 circuit on the CPU board. Connect U7 pin 8 to 3.4V (wire pin 8 to pin 4) and connect U7 pin 9 to DCOM (wire pin 9 to pin 12).

1. Refer to E8257D Service Guide for the A18 CPU removal procedure.
2. Refer to Figure 1 for U7.
3. Use 30 AWG wire for wiring pin 8 to pin 4, and pin 9 to pin 12 per Figure 1.
4. Re-install CPU and cover.
5. Run self test.
6. No calibration is required.
