**E8257D-26B**

# **S E R V I C E N O T E**

## E8257D Analog Signal Generator

### **Intermittent CPU boot-up and/or No display**

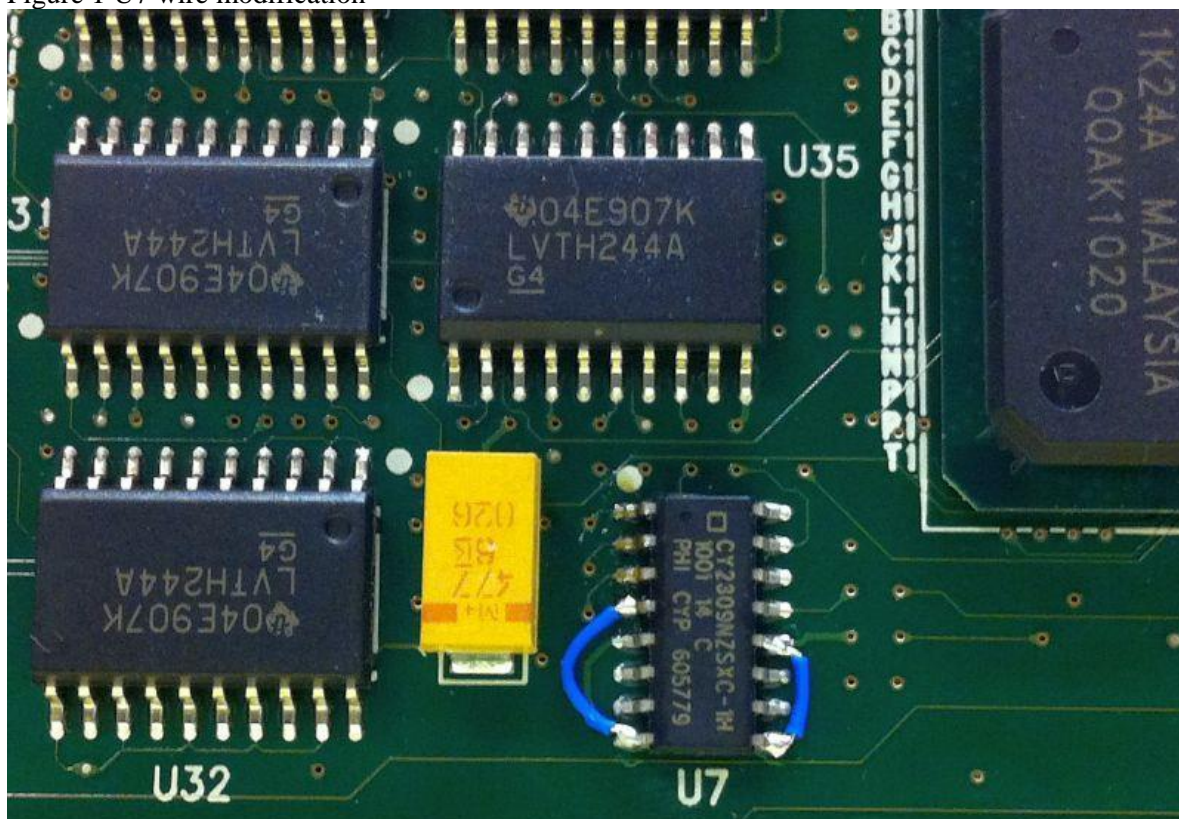
Figure 1 U7 wire modification

The clock buffer, U7 on the CPU board (E8251-60006 or E8251-60661 Revision 004 and below), may cause intermittent boot up and/or no display when the instrument is powered up. It is recommended that this modification is performed on any instrument within the serial numbers above that exhibits an intermittent boot-up and/or a blank display.

Using the appropriate soldering technique and ESD station, perform a modification on the U7 circuit on the CPU board. Connect U7 pin 8 to 3.4V (wire pin 8 to pin 4) and connect U7 pin 9 to DCOM (wire pin 9 to pin 12).

1. Refer to E8257D Service Guide for the A18 CPU removal procedure.
2. Refer to Figure 1 for U7.
3. Use 30 AWG wire for wiring pin 8 to pin 4, and pin 9 to pin 12 per Figure 1.
4. Re-install CPU and cover.
5. Run self test.
6. No calibration is required.
