E8257N-04

# Information Only Service Note

## E8257N Sweep Generator

Communication Failure when using GPIB to download firmware with Firmware Upgrade Assistant (FUA).

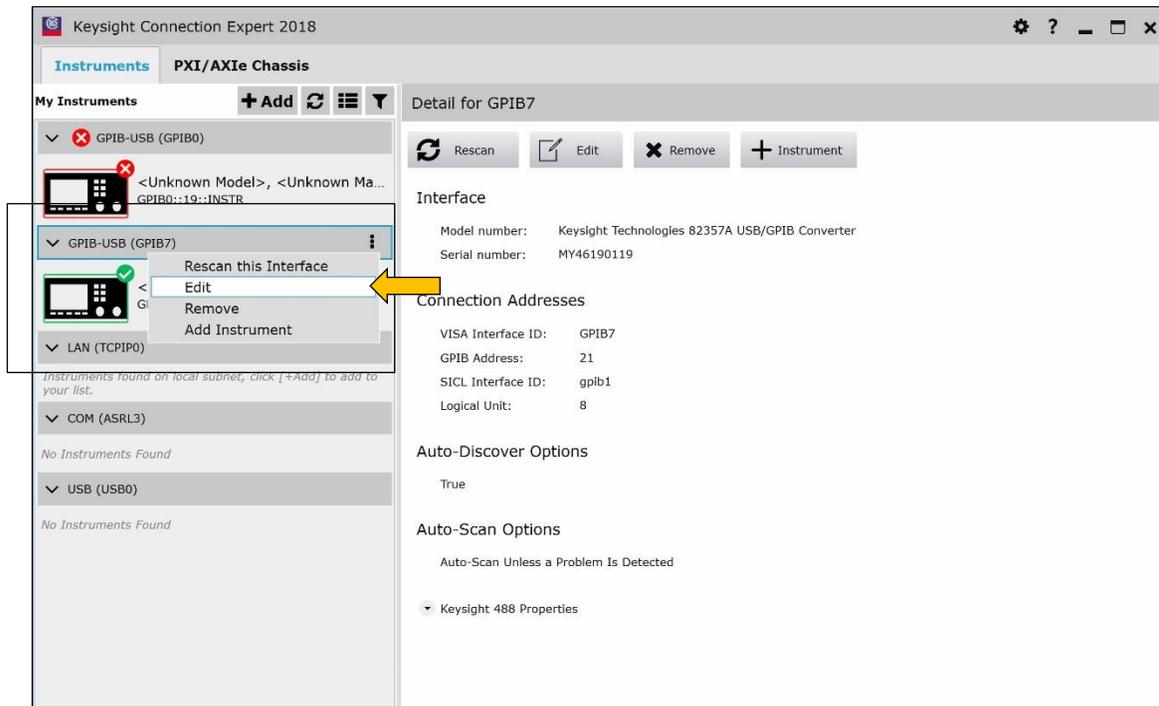
Figure 1

You may encounter GPIB communication failure when using the Firmware Upgrade Assistant (FUA) to upgrade your instrument. This is due to the IO Libraries that disabled the GPIB card.

1. On your PC, start the Keysight Connection Expert software. Click Start > All Programs > Keysight IO Libraries Suite > Agilent Connection Expert. If you do not have Keysight IO Libraries Suite installed on your PC, you can download it from the following website: <http://www.keysight.com/find/iolib>.
2. In the Instruments tab, select your instrument to make the connection.
3. Right-click on “GPIB-USB (GPIB#)” # represents the Visa Interface ID #. Then, click “Edit”. (Refer to Figure 1)

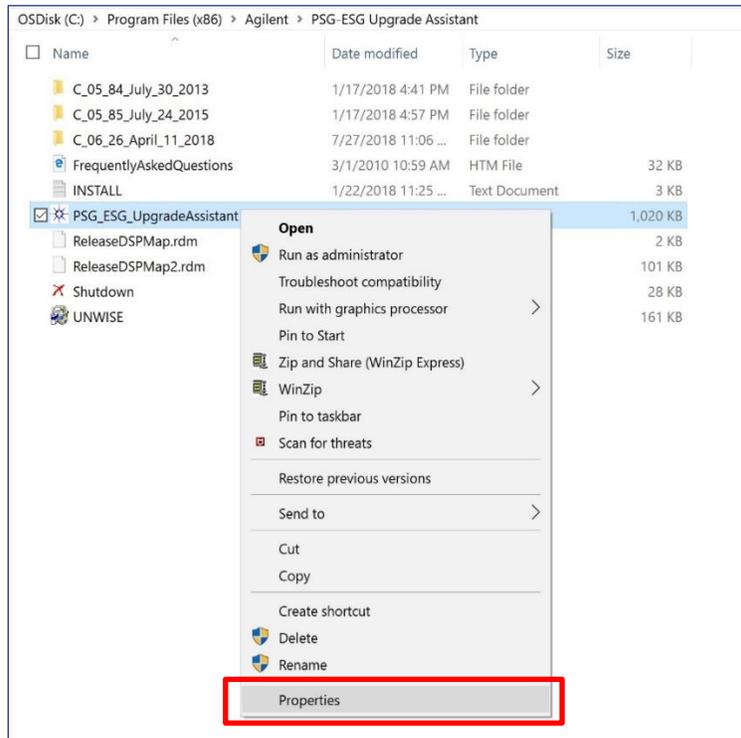
Figure 3

Below are also some extra settings if you are using Windows10 and unable to run the FUA.

1. Find the PSG-ESG Upgrade Assistant application file in the C drive. By default, it is installed on C:\Program Files(X86)\Agilent\PSG-ESG Upgrade Assistant folder. Right click on it.
2. Then click on “Properties”. (Refer to Figure 3)
