E8267D-13

S E R V I C E N O T E

E8267D PSG Vector Signal Generator

Spurs and poor image rejection in wide band IQ mode (option H16 & 016).

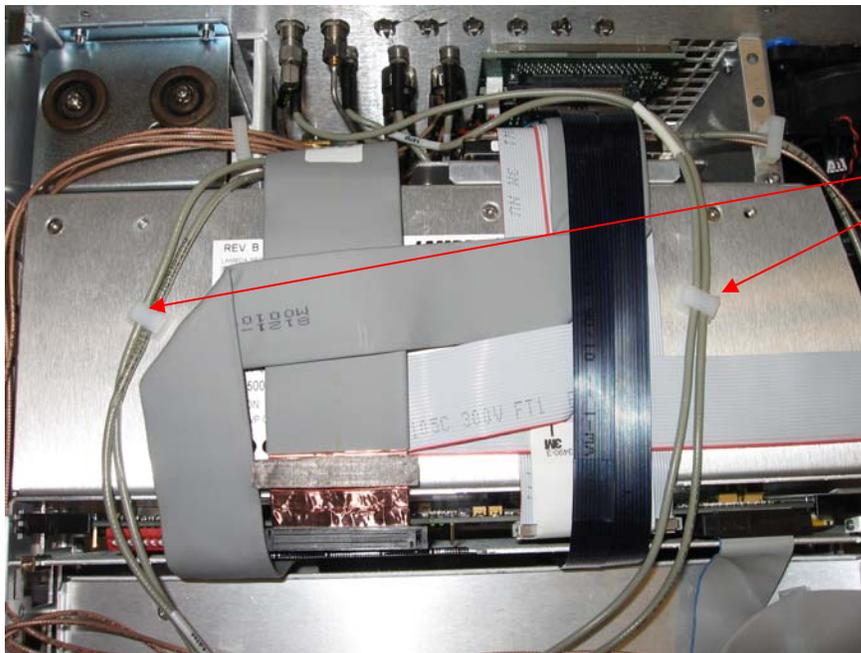
Routing and clips

E8267D instruments with option H16 or 016 may have spurs and poor image rejection when wide band IQ mode is being used. The spurs and poor image rejection may be caused by mismatched cables in the wide band IQ path.

1. Remove the external and internal covers. See service guide for process to remove and reinstall covers.
2. Remove from the rear panel the wide band input cables I, I bar, Q, Q bar (W123-125) from the rear panel and from A13 IQ MUX. Note the routing so the new cables can be routed the same way.
3. Install the 4 SMA bulkhead adapters 1250-1666 into the rear panel in place of the cables.
4. Connect the 4 new 8121-1667 cables to the rear panel adapters, route the cables the same as the old cables were routed and connect the other ends to the A13 IQ MUX according to the following:
