**E8267D-24**

# **S E R V I C E                      N O T E**

## **E8267D Digital Signal Generator**

**Intermittent CPU boot-up and/or No display**

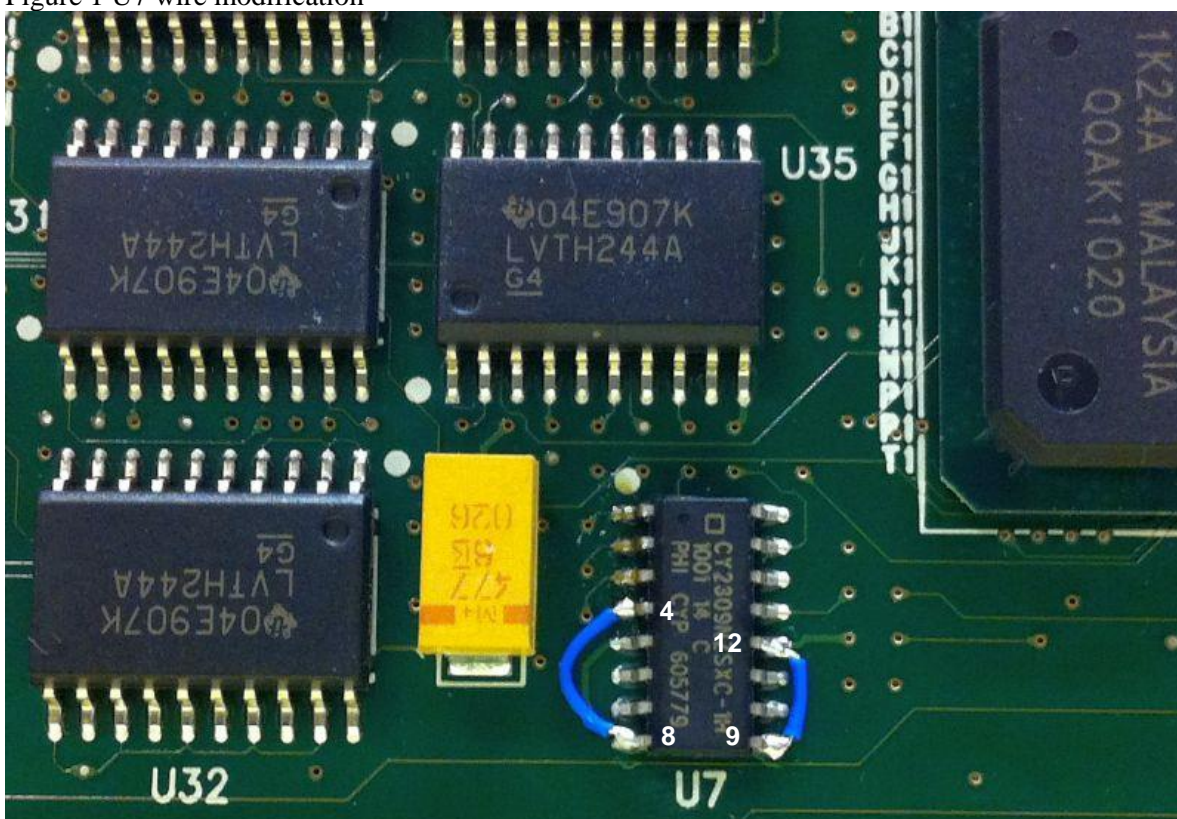
Figure 1 U7 wire modification

The clock buffer, U7 on the CPU board (E8251-60006 or E8251-60661), may cause intermittent boot up and/or no display when the instrument is powered up. It is recommended that this modification is performed on any instrument within the serial numbers above that exhibits an intermittent boot-up and/or a blank display.

Using the appropriate soldering technique and ESD station, perform a modification on the U7 circuit on the CPU board. Connect U7 pin 8 to 3.4V (wire pin 8 to pin 4) and connect U7 pin 9 to DCOM (wire pin 9 to pin 12).

1. Refer to E8257D Service Guide for the A18 CPU removal procedure.
2. Refer to Figure 1 for U7.
3. Use 30 AWG wire for wiring pin 8 to pin 4, and pin 9 to pin 12 per Figure 1.
4. Re-install CPU and cover.
5. Run self test.
6. No calibration is required.
