**E8267D-24A**

**S E R V I C E N O T E**

**E8267D Digital Signal Generator**

**Intermittent CPU boot-up and/or No display**

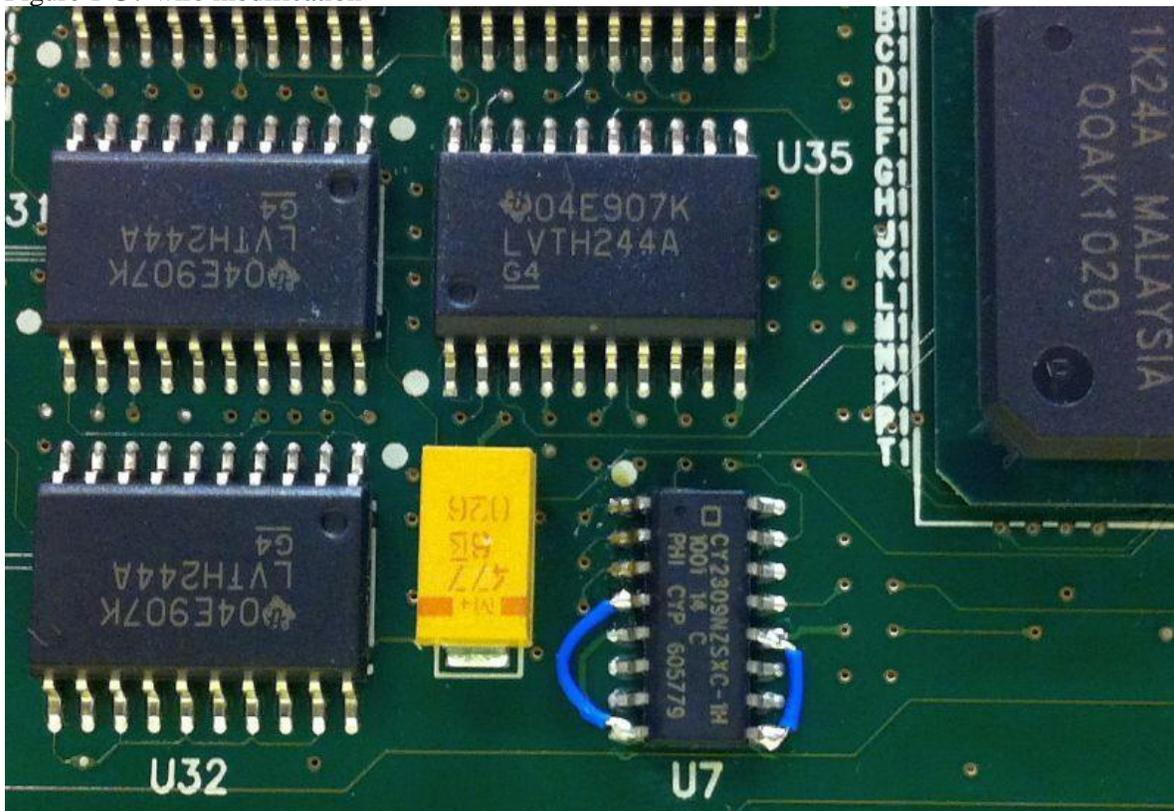
Figure 1 U7 wire modification

The clock buffer, U7 on the CPU board (E8251-60006 or E8251-60661 Revision 004 and below), may cause intermittent boot up and/or no display when the instrument is powered up. It is recommended that this modification is performed on any instrument within the serial numbers above that exhibits an intermittent boot-up and/or a blank display.

Using the appropriate soldering technique and ESD station, perform a modification on the U7 circuit on the CPU board. Connect U7 pin 8 to 3.4V (wire pin 8 to pin 4) and connect U7 pin 9 to DCOM (wire pin 9 to pin 12).

1. Refer to E8257D Service Guide for the A18 CPU removal procedure.
2. Refer to Figure 1 for U7.
3. Use 30 AWG wire for wiring pin 8 to pin 4, and pin 9 to pin 12 per Figure 1.
4. Re-install CPU and cover.
5. Run self test.
6. No calibration is required.
