**E8357A-02D****S E R V I C E****N O T E**Supersedes:  
E8357A-02C**E8357A PNA Series RF Network Analyzers****Serial Numbers: 00000000 thru 46999999**

**Many of the Front Panel Interface (FPI) boards which were installed per Service Note E8357A-02B need to be modified or replaced because the RPG shaft can disconnect, and the front panel keyboard and RPG can respond intermittently upon boot up.**

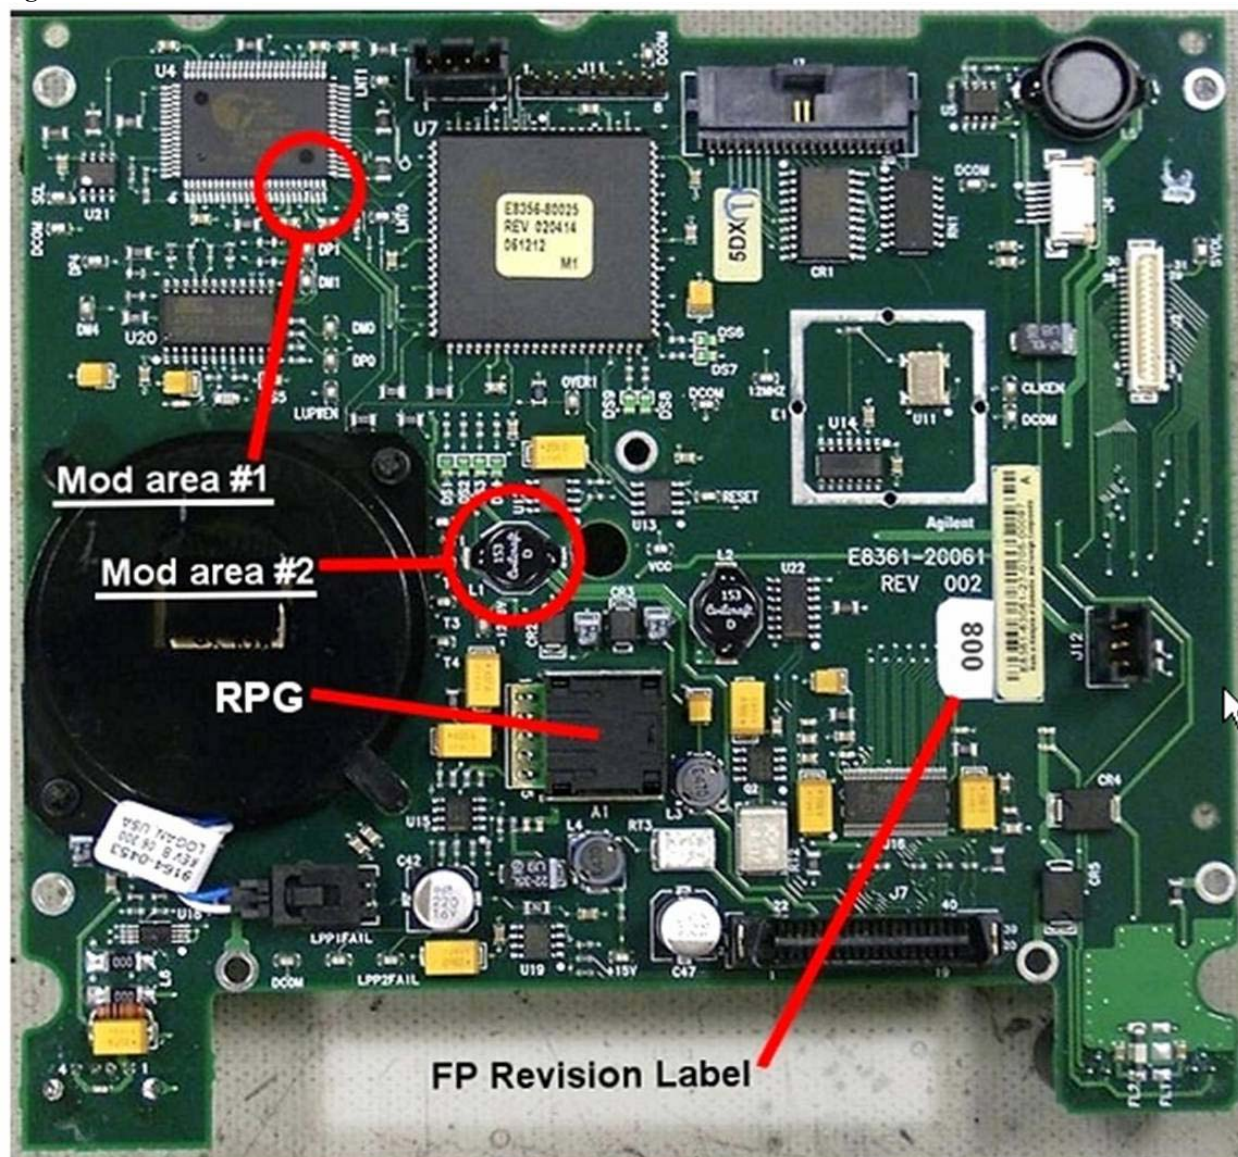
FPI boards E8356-60209 and the older E8356-60029 were both identified as causing a serious “won’t boot” condition and a USB signal integrity issue. These issues were noticed in production as well as service centers. The booting issue was due to a tantalum capacitor (C58, 4.7uF, and 50V) reversed biased at 10 percent of its rated voltage. Both issues were fixed with a board layout change of the E8361-63061, revisions 001 to 007 FPI boards. Older E8361-63061 revision 008 FPI boards were identified as having an intermittent front panel keyboard and RPG lockup problems. This problem has been traced to an incorrect voltage applied to a pin on the U4 IC.

Refer to Figure 1 for the two modification areas to be addressed. Note that while this picture happens to show the FPI board completely removed from the front frame assembly, this is not necessary to perform the required modifications.

- Modification #1 consists of shorting two pins of U4 together with a small amount of solder.
- Modification #2 consist of removing L1.

Unsolder and completely remove the black surface mount inductor L1 from the front panel assembly board. This is no longer needed and can be discarded.
