Supersedes:  
E8358A-02C

## E8358A PNA Series RF Network Analyzers

Serial Numbers: 00000000 thru 46999999

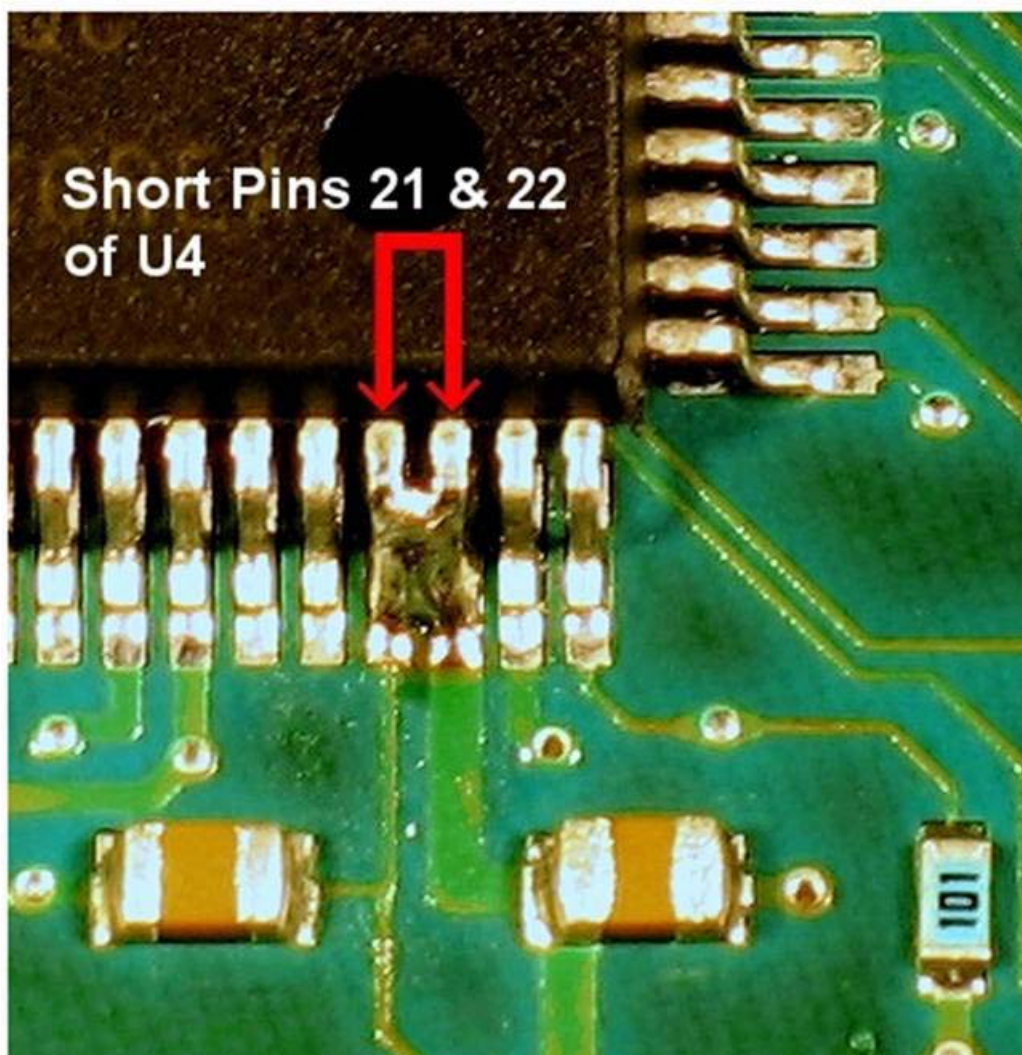
FPI boards E8356-60209 and the older E8356-60029 were both identified as causing a serious “won’t boot” condition and a USB signal integrity issue. These issues were noticed in production as well as service centers. The booting issue was due to a tantalum capacitor (C58, 4.7uF, and 50V) reversed biased at 10 percent of its rated voltage. Both issues were fixed with a board layout change of the E8361-63061, revisions 001 to 007 FPI boards. Older E8361-63061 revision 008 FPI boards were identified as having an intermittent front panel keyboard and RPG lockup problems. This problem has been traced to an incorrect voltage applied to a pin on the U4 IC.

Carefully solder pins 21 and 22 together on U4. Refer to Figure 2 for the exact location. Use care so that no other pins are shorted. Use of a very fine tip soldering iron is recommended and a large work-task magnifying glass is very helpful.
