E8361C-05

S E R V I C E N O T E

E8361C PNA Microwave Network Analyzers

A new touchscreen display inverter shield is available to improve PNA noise floor performance.

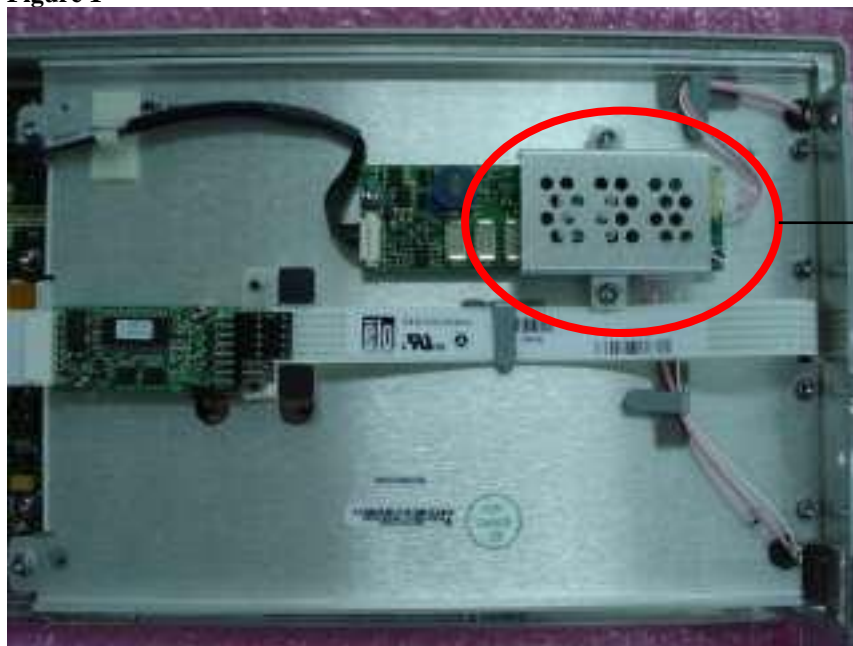
If a PNA C-model exhibits poor noise performance, examine the inverter shield to see if it is the N5230-00013. Figure 1 shows that the N5230-00013 shield has vent holes. If present, replace the old shield (N5230-00013) with the new shield (N5230-00017) as per the following instructions.

Figure 1: Old
inverter
shield
N5230-00013
