**E8362A-01C****S E R V I C E****N O T E**Supersedes:  
E8362A-01B**E8362A PNA Series RF Network Analyzers**

Serial Numbers: 00000000 thru 46999999

**Older Front Panel Interface (FPI) boards can cause the following problems:**

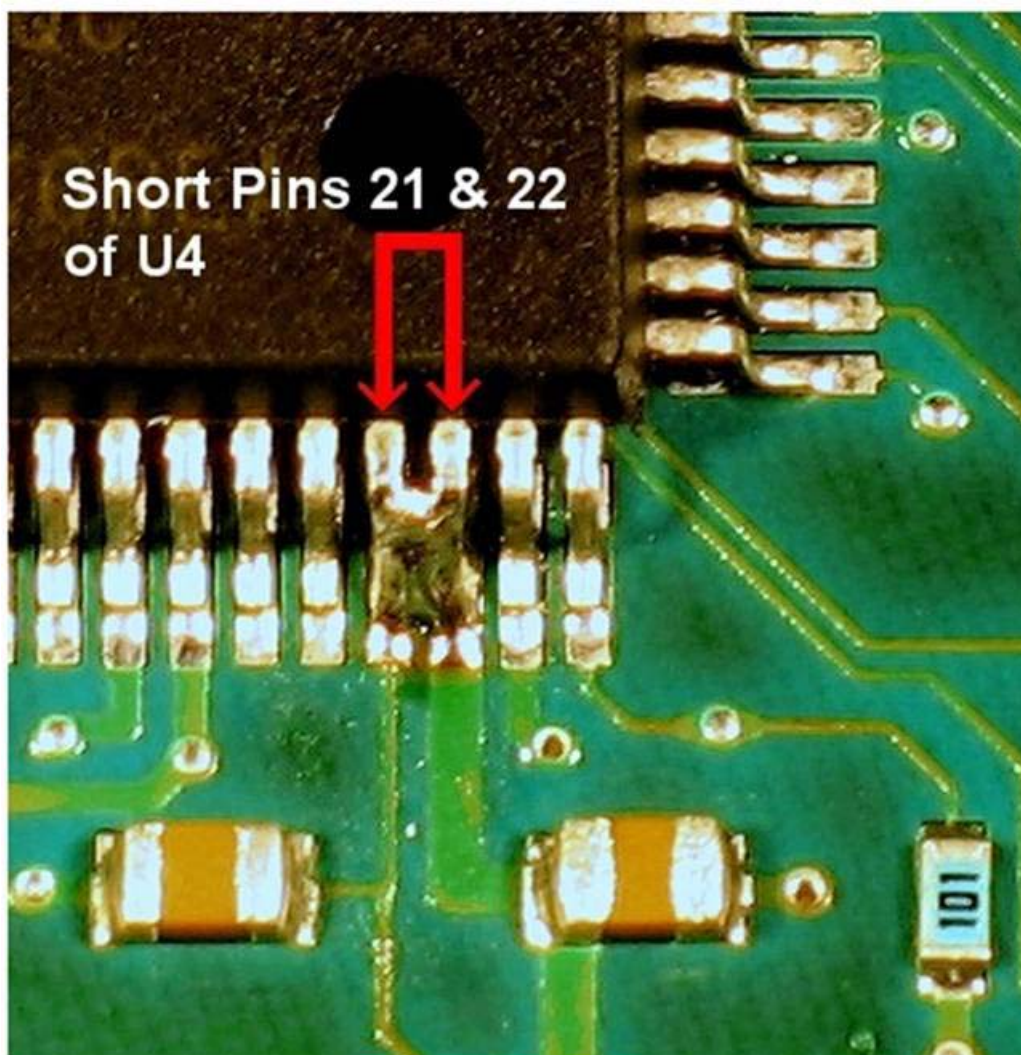
Both intermittent problems have been traced to an incorrect voltage applied to a pin on the U4 IC.

Carefully solder pins 21 and 22 together on U4. Refer to Figure 2 for the exact location. Use care so that no other pins are shorted. Use of a very fine tip soldering iron is recommended and a large work-task magnifying glass is very helpful.
