**E8362CH85-01**

# **S E R V I C E                      N O T E**

## **E8362CH85 PNA Microwave Network Analyzers**

**A new touchscreen display inverter shield is available to improve PNA noise floor performance.**

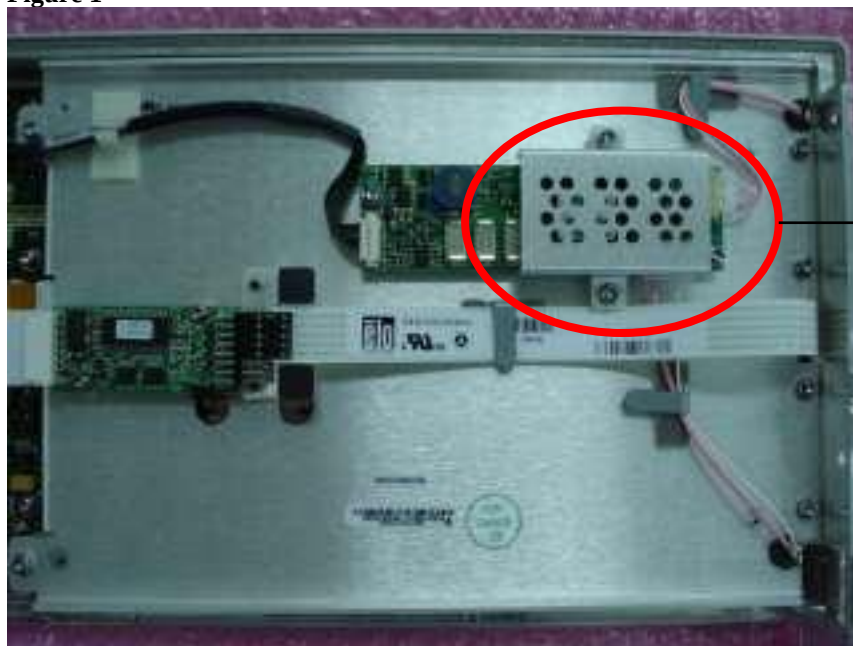
**Figure 1**

Some PNA C-models may exhibit poor noise floor performance caused by inverter shield N5230-00013.

If a PNA C-model exhibits poor noise performance, examine the inverter shield to see if it is the N5230-00013. Figure 1 shows that the N5230-00013 shield has vent holes. If present, replace the old shield (N5230-00013) with the new shield (N5230-00017) as per the following instructions.

Figure 1: Old  
inverter  
shield  
N5230-00013
