**E8363C-02**

# **S E R V I C E                      N O T E**

## **E8363C PNA Microwave Network Analyzers**

**A new touchscreen display inverter shield is available to improve PNA noise floor performance.**

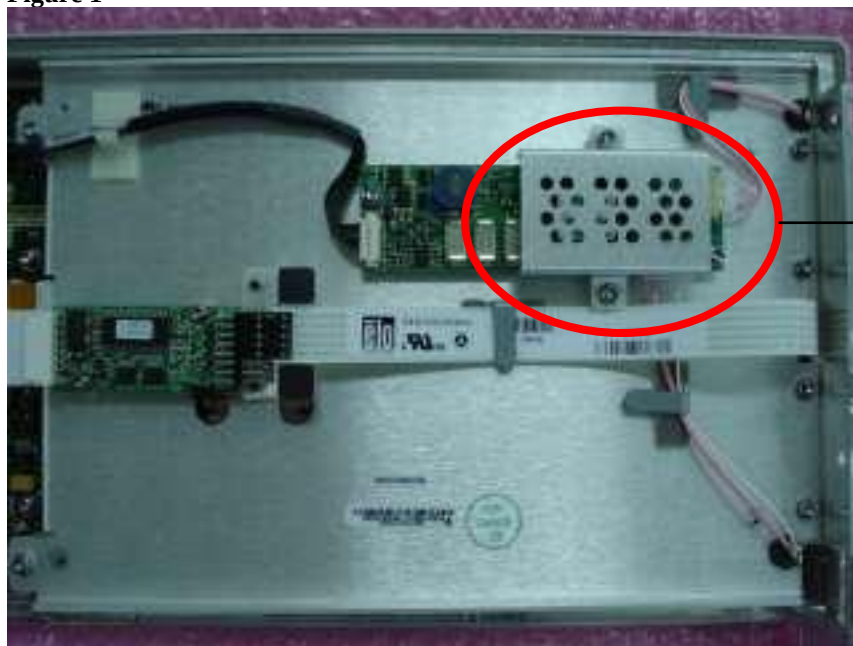
**Figure 1**

Some PNA C-models may exhibit poor noise floor performance caused by inverter shield N5230-00013.

7. Follow the instructions in the subsection "Removal Procedure."
8. Once the front panel has been removed from the PNA, place it on a flat surface. Figure 1 shows that the N5230-00013 inverter shield has vent holes.

Figure 1: Old  
inverter  
shield  
N5230-00013

If a PNA C-model exhibits poor noise performance, examine the inverter shield to see if it is the N5230-00013. Figure 1 shows that the N5230-00013 shield has vent holes. If present, replace the old shield (N5230-00013) with the new shield (N5230-00017) as per the following instructions.
