E8364BH85-01

S E R V I C E N O T E

E8364BH85 PNA Series RF Network Analyzers

Older Front Panel Interface (FPI) boards can cause the following problems:

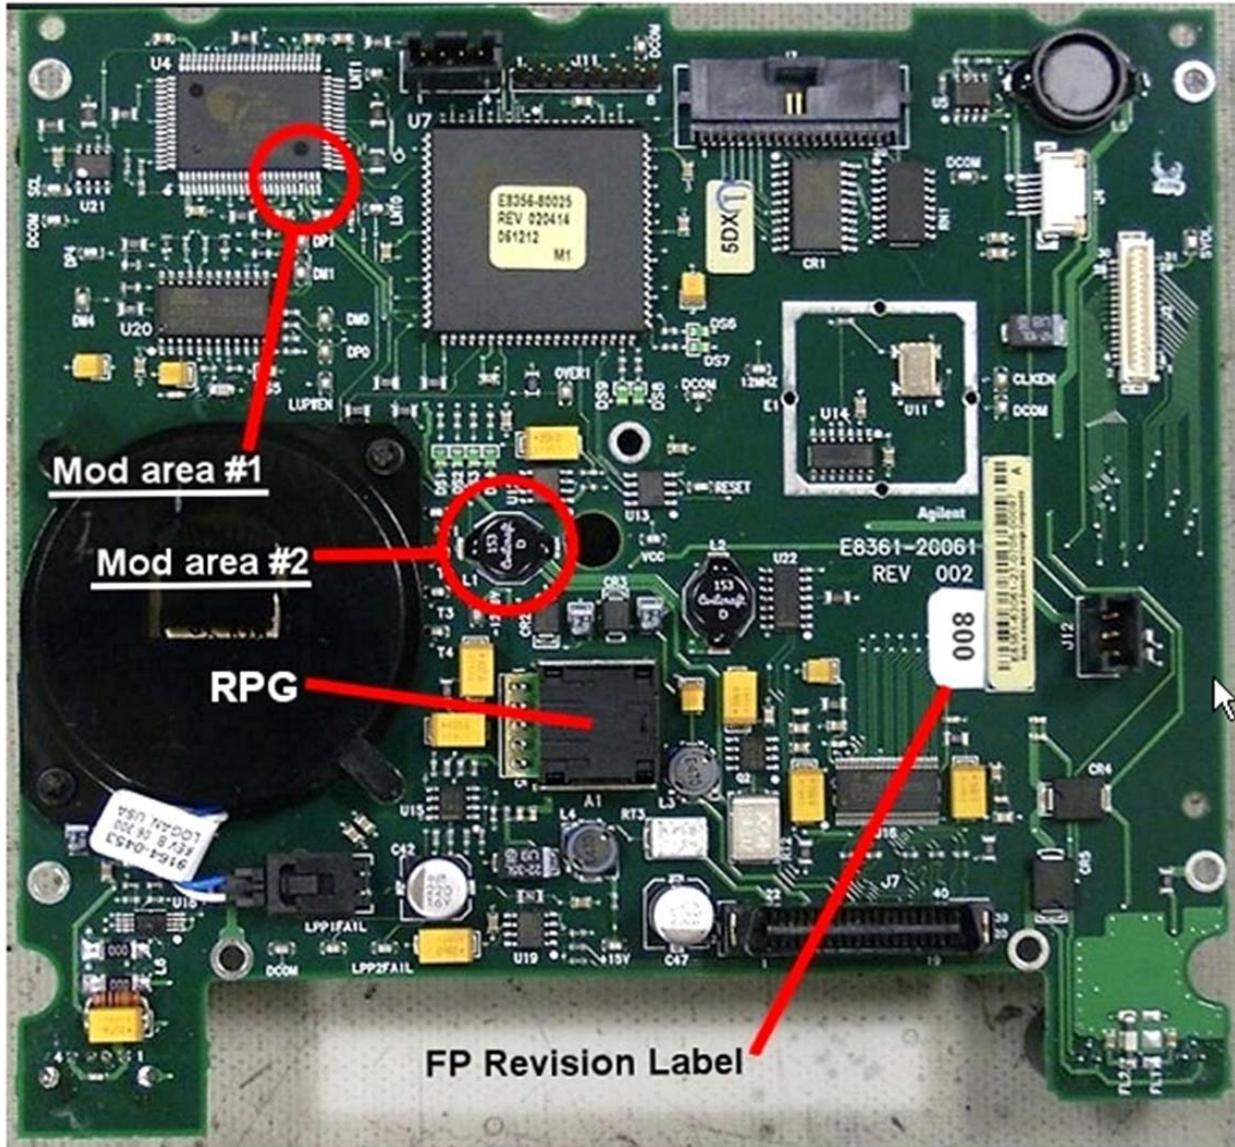
Both intermittent problems have been traced to an incorrect voltage applied to a pin on the U4 IC.

Refer to Figure 1 for the two modification areas to be addressed. Note that while this picture happens to show the FPI board completely removed from the front frame assembly, this is not necessary to perform the required modifications.

- Modification #1 consists of shorting two pins of U4 together with a small amount of solder.
- Modification #2 consist of removing L1.
