E8364BH85-06

S E R V I C E N O T E

E8364BH85 PNA Series RF Network Analyzers

Replace Inverter board (0950-3379) due to faulty component.

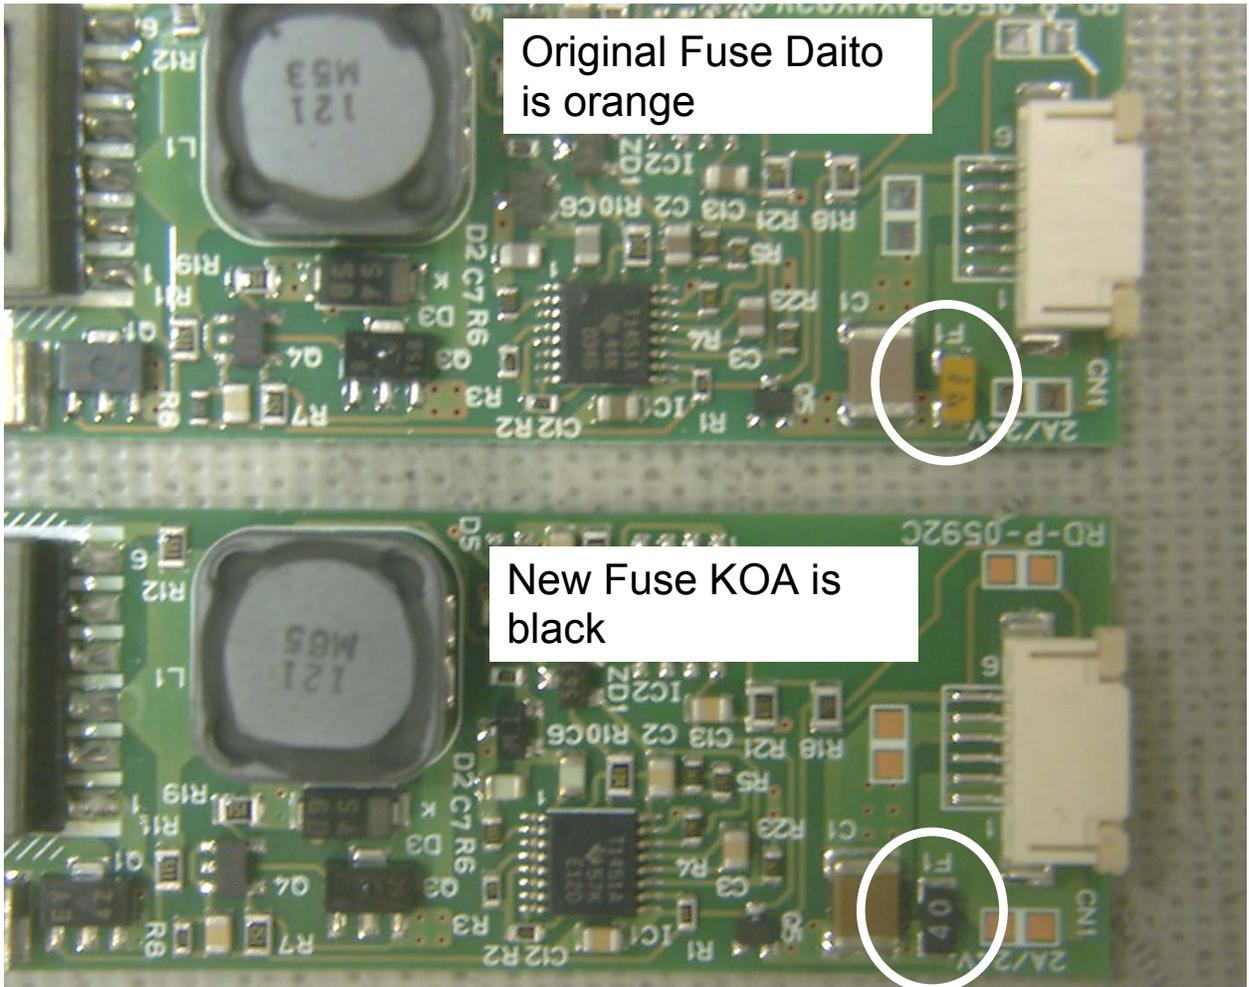
The original fuse (see photo) in the DC/AC Inverter board (p/n 0950-3379) is prone to failure in normal use.

Replace the Inverter board with a board containing the new fuse (see photo).
