**E8364CH85-02**

# **S E R V I C E                      N O T E**

## **E8364CH85 PNA Microwave Network Analyzers**

**A new touchscreen display inverter shield is available to improve PNA noise floor performance.**

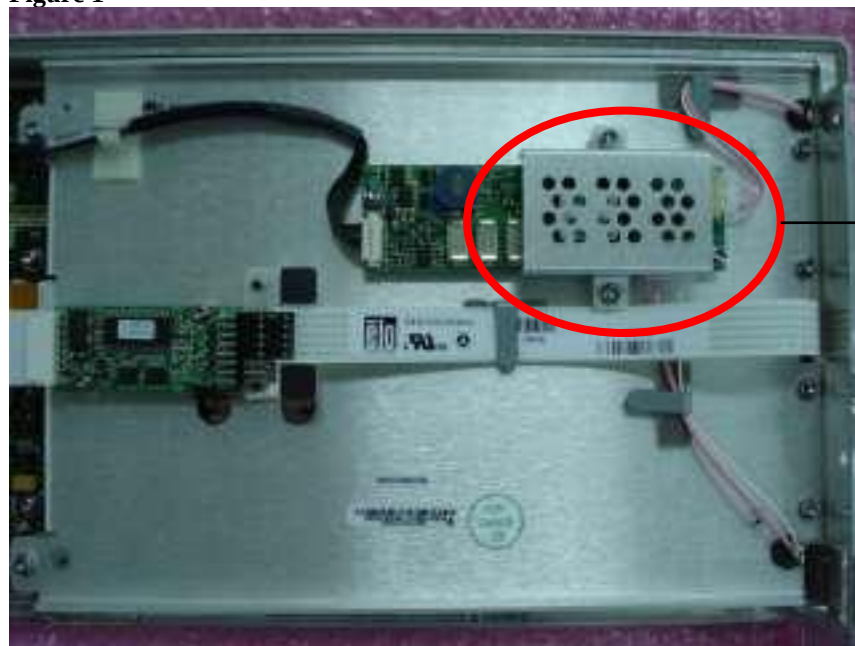
**Figure 1**

Some PNA C-models may exhibit poor noise floor performance caused by inverter shield N5230-00013.

If a PNA C-model exhibits poor noise performance, examine the inverter shield to see if it is the N5230-00013. Figure 1 shows that the N5230-00013 shield has vent holes. If present, replace the old shield (N5230-00013) with the new shield (N5230-00017) as per the following instructions.

Figure 1: Old  
inverter  
shield  
N5230-00013
