S E R V I C E N O T E

Supersedes:
E8802A-01A

E8802A PNA Series RF Network Analyzers

Serial Numbers: 00000000 thru 46999999

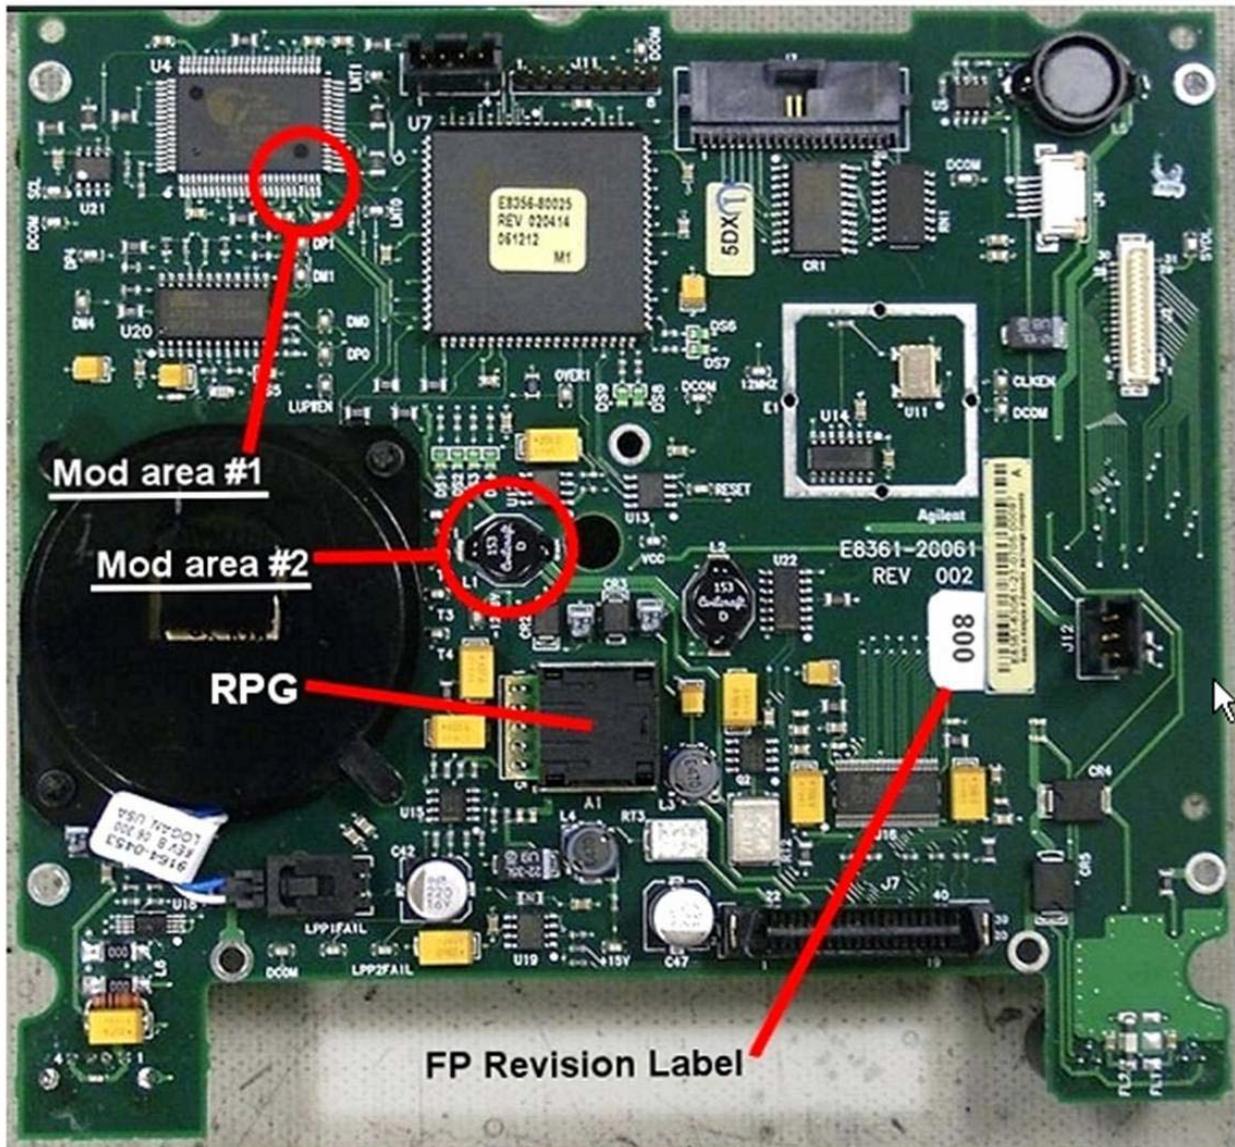
FPI boards E8356-60209 and the older E8356-60029 were both identified as causing a serious “won’t boot” condition and a USB signal integrity issue. These issues were noticed in production as well as service centers. The booting issue was due to a tantalum capacitor (C58, 4.7uF, and 50V) reversed biased at 10 percent of its rated voltage. Both issues were fixed with a board layout change of the E8361-63061, revisions 001 to 007 FPI boards. Older E8361-63061 revision 008 FPI boards were identified as having an intermittent front panel keyboard and RPG lockup problems. This problem has been traced to an incorrect voltage applied to a pin on the U4 IC.

Refer to Figure 1 for the two modification areas to be addressed. Note that while this picture happens to show the FPI board completely removed from the front frame assembly, this is not necessary to perform the required modifications.

- Modification #1 consists of shorting two pins of U4 together with a small amount of solder.
- Modification #2 consist of removing L1.

Unsolder and completely remove the black surface mount inductor L1 from the front panel assembly board. This is no longer needed and can be discarded.
