**J2213A-03**

**S E R V I C E N O T E**

**HP J2213A Protocol Analyzer**

**Monochrome LED Board Modification (NOT Color)**

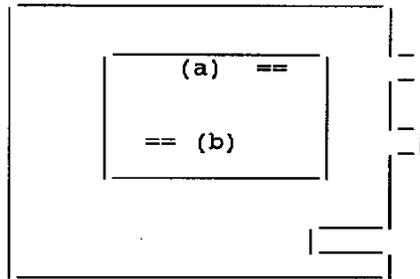
Jumper locations  
(a) or (b) is on  
the small board.

3. Carefully snap out LED display board assembly
4. Locate jumper and remove at one of either location as shown in the diagram

5. Reinstall wires/fasteners and board assembly
6. Test brightness operation
