SN J3953B-01

S E R V I C E N O T E

J3953B VQT

Updated replacement of analog card for improved PESQ scores

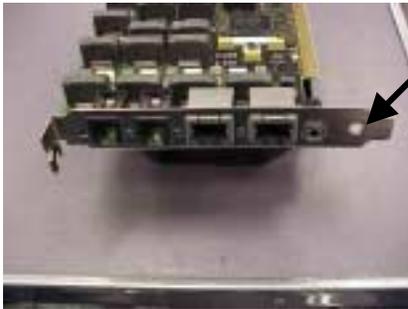
Adapting the Infineon ALIS FXO chipset for use in the E&M ports of the analog board results in extra circuit noise. This limits the maximum PESQ scores. Replacing this board with the modified assembly reduces the circuit noise and improves the possible PESQ scores when using the E&M ports. If a customer returns a J3953B with complaints of PESQ scores not accurate, implement this service note.

Replace the analog FXO E&M card with the latest version. This, along with downloading the VQT application Software Version 4.1.1 or later will correct the noise interference improve the PESQ scores. When the “defective” analog card is removed the metal grounding tab **MUST** be swapped to the new assembly. In the J3953B you will also need to add the VQT grounding assembly 5065-8300, if it has not already been added.

Move metal ground tab
to new assembly.
