SN J6800A-07A

S E R V I C E N O T E

J6800A Network Analyzer

We have determined a root-cause of the Network Analyzer failures involving unstable operation of the acquisition system after being repaired previously.

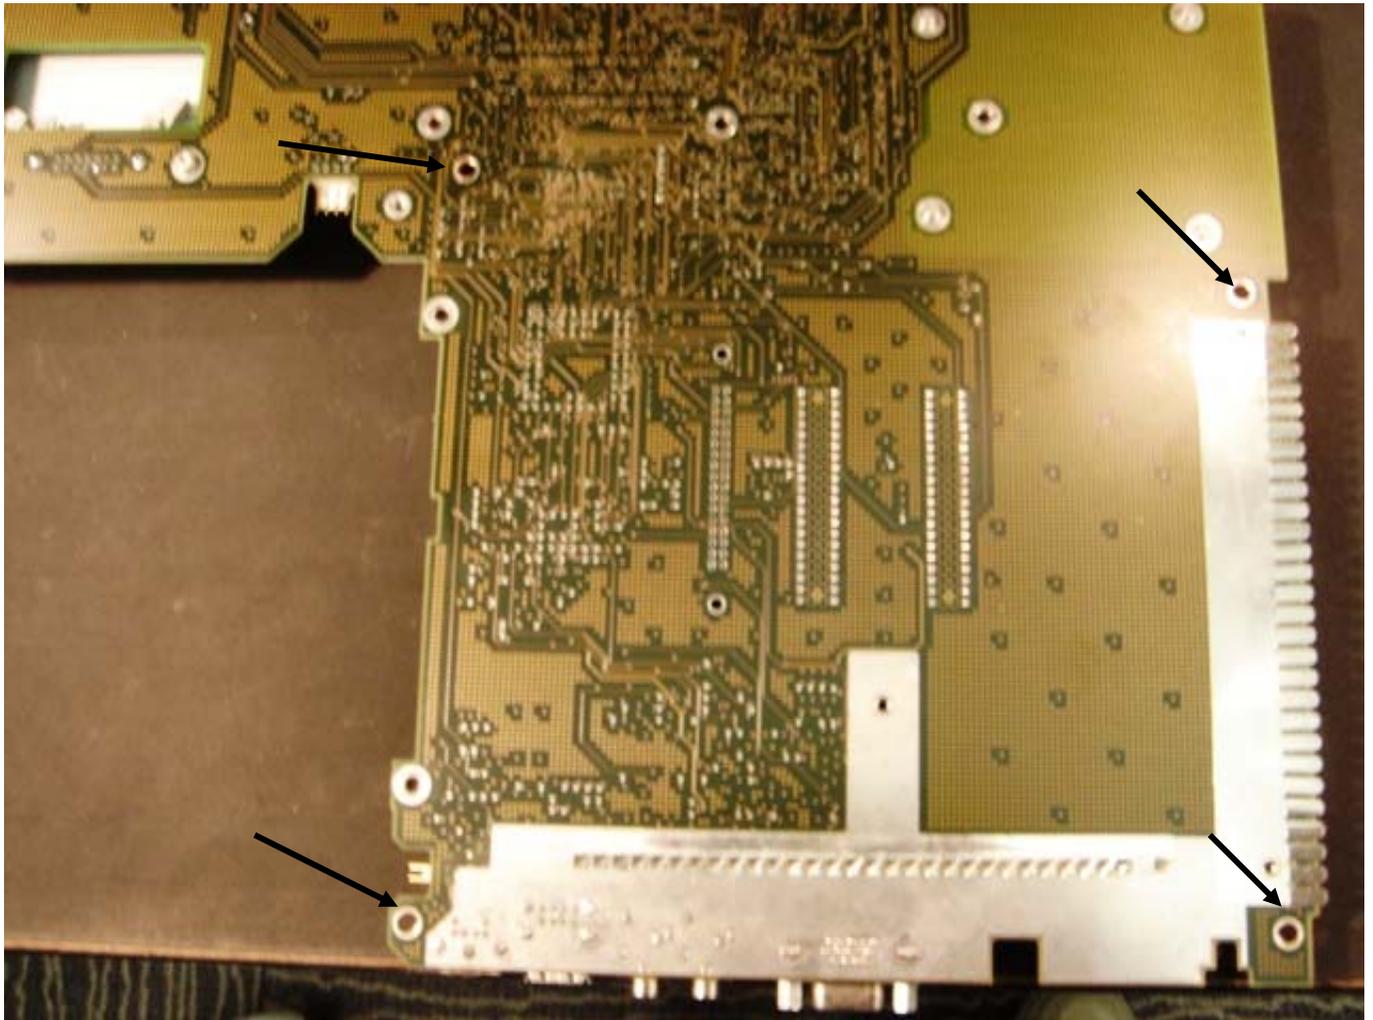
The CPU carrier card has 4 mounting holes that are used to hold the acquisition cards to the chassis. (See photo #1) After some extended period of time, the threads on these screws cuts through the plating of the hole and wears away the PCB material, exposing the copper inner-layers.(See photo #2) These exposed copper layers can short 3.3v or 5.0v to ground. This causes excessive current draw, stressing the power supply and often scorching the Host I/O power connector itself. (See photo #3)

Photo #1 showing placement of mounting holes (4)

Use washers (3050-2187) with long mounting screws when re-assembling.

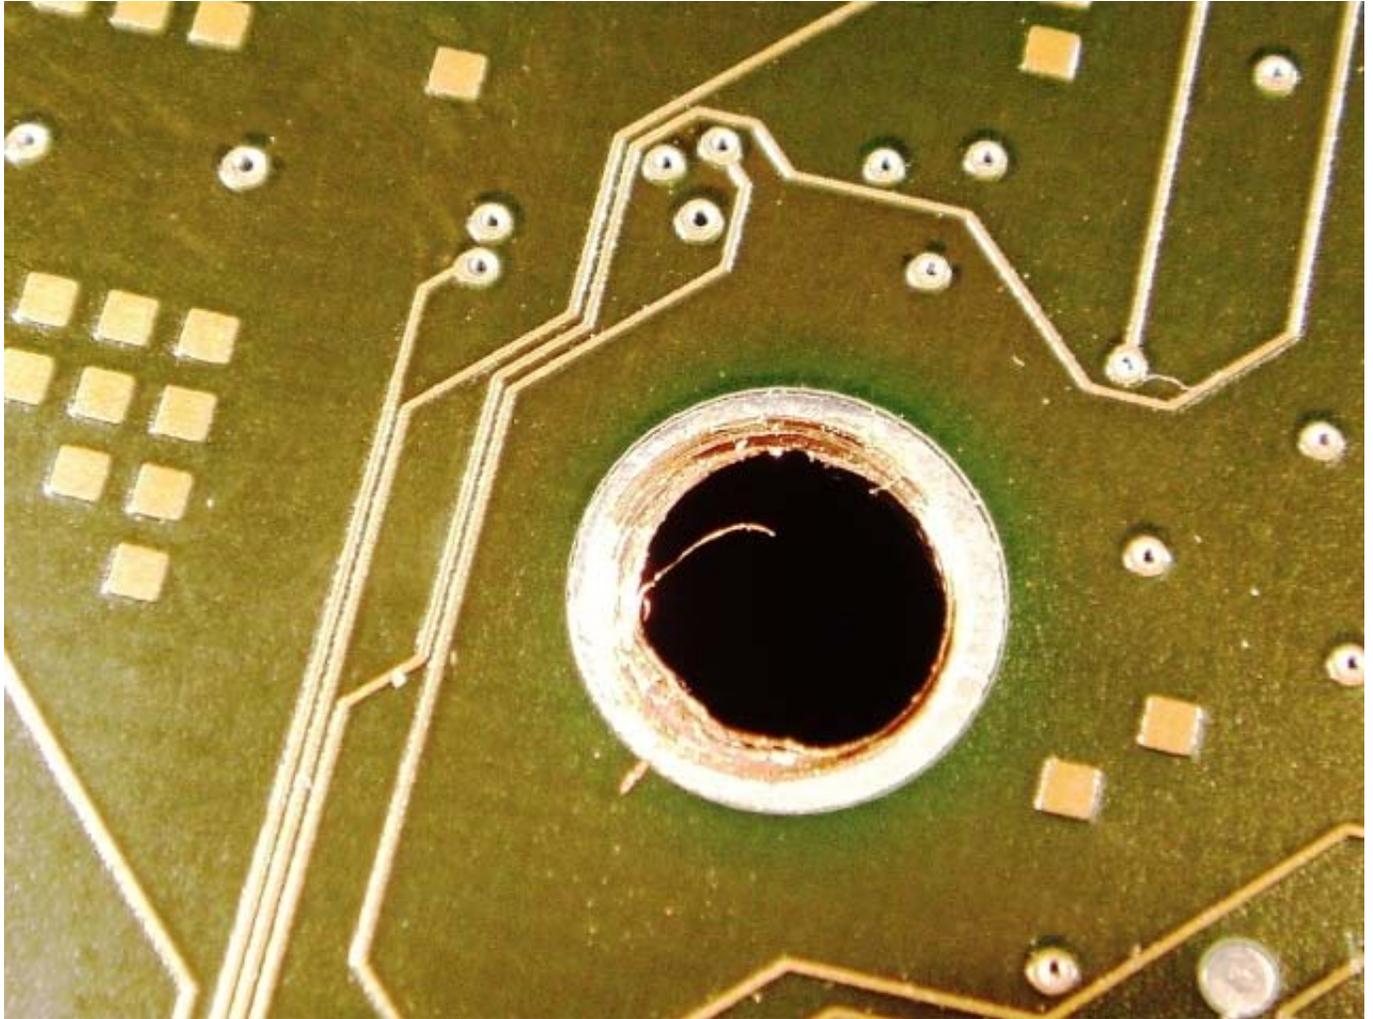
Photo #2 Close up of mounting hole showing copper pulled down into hole.

Replace all damaged parts, re-assemble unit using the washers(3050-2187) and test per J6800A service manual.

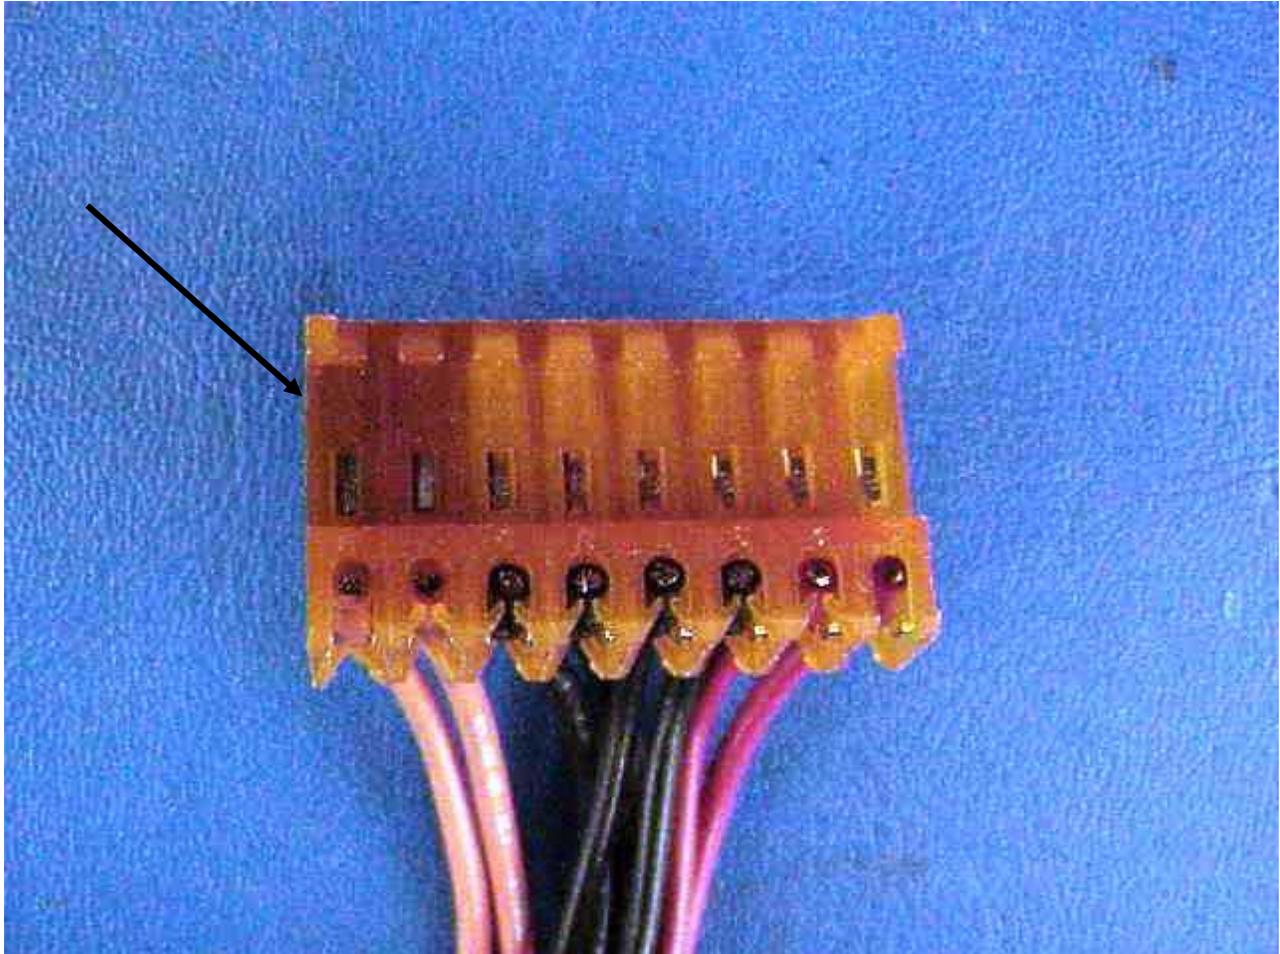
Discolored(burnt) Host I/O cable
