SN J6801A-02

S E R V I C E N O T E

J6801A

May 6, 2002

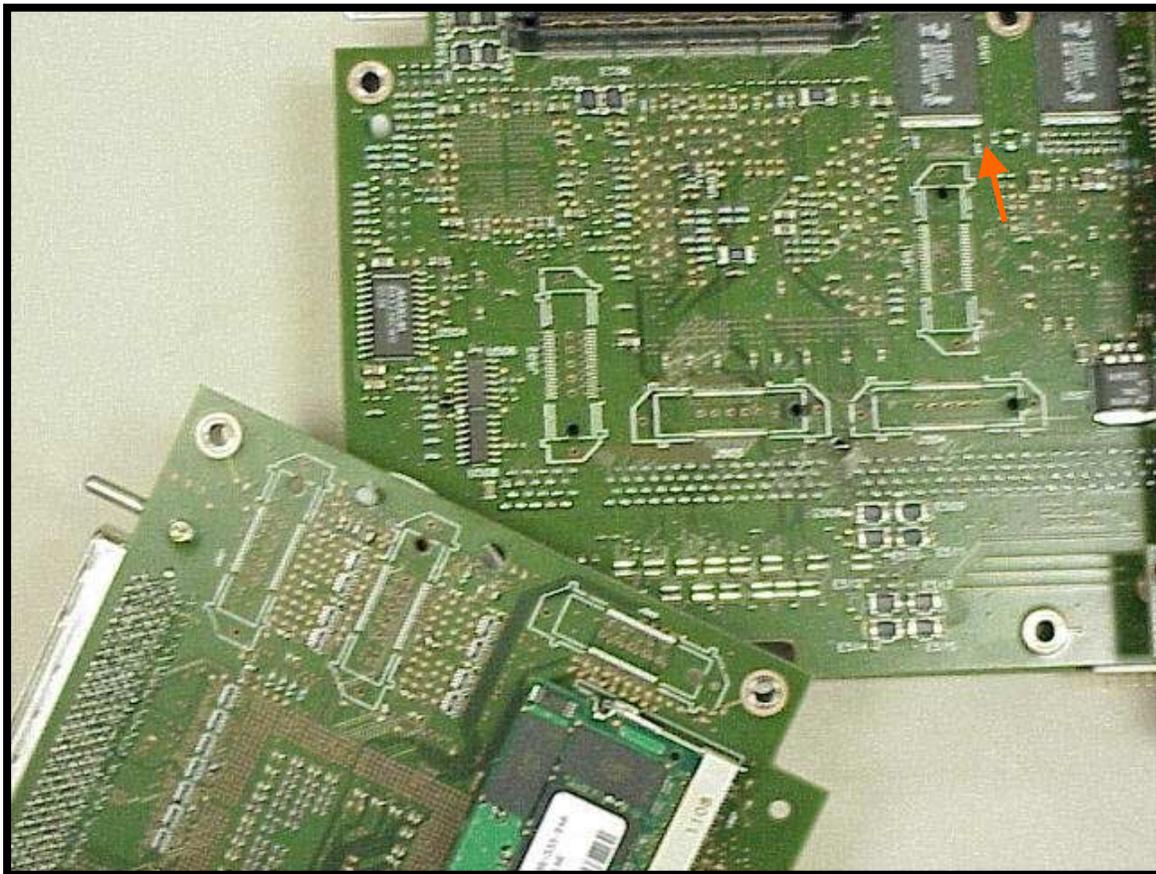
All J6801A's were assembled with PCB's lacking 2 parts critical to proper operation.

When the next release of Software for the J6801A, currently scheduled for August, is downloaded into units, the download will fail to properly install itself. Also, proper operation cannot be assured as the 88 MHz. Clock that is loaded on the boards is not the correct frequency.

Add resistor R526 (0699-3874) to the location on the PCB signified by the red arrow. It should be placed on the pads adjacent to the two holes in the PCB.

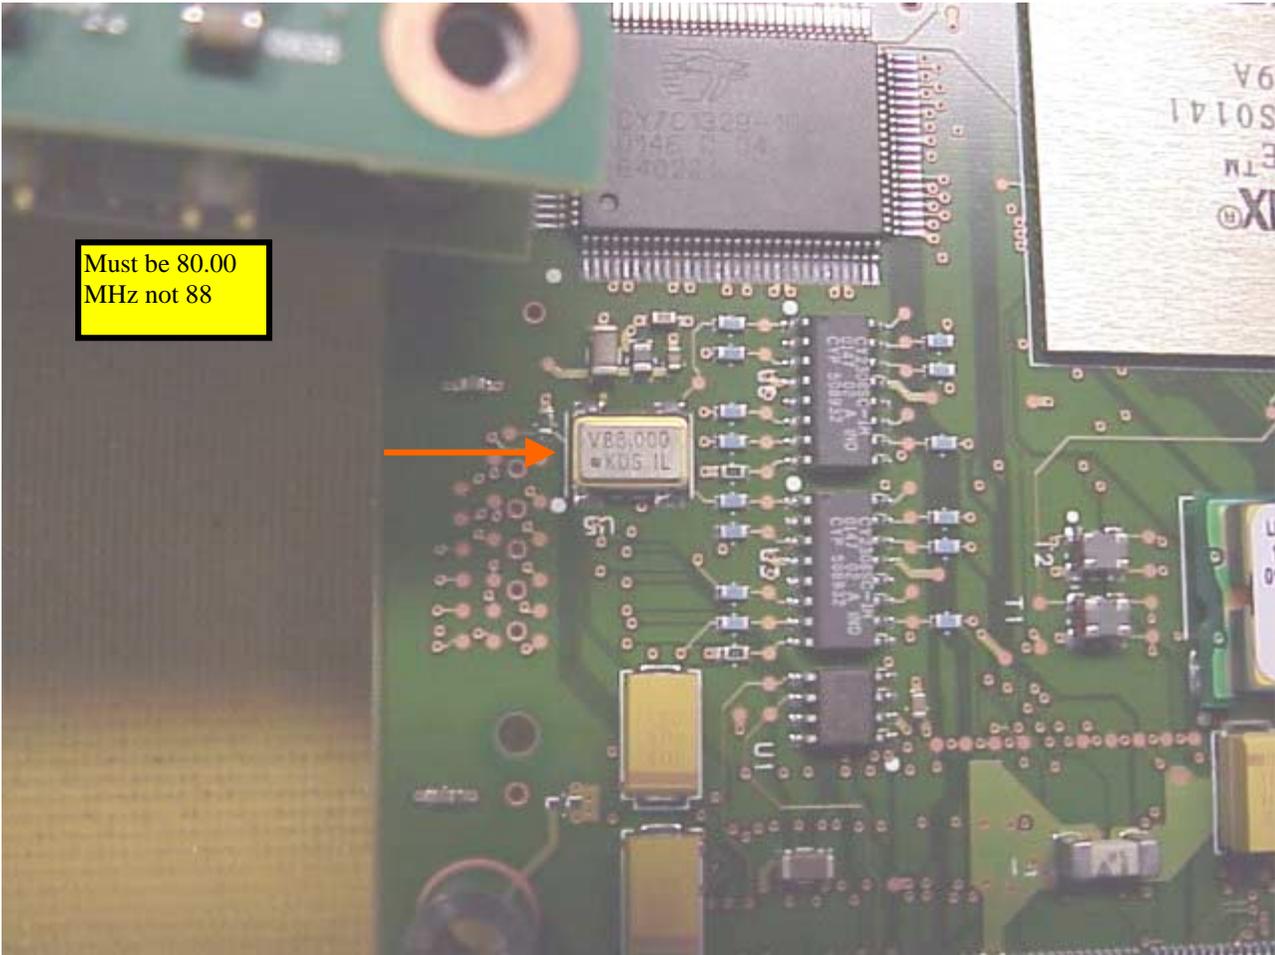
Must be 80.00
MHz not 88

Next, turn the board stack over and remove the oscillator located at U5. Replace it with Part Number 1813-1243. See picture on next page. Re-assemble the unit, test and return to customer.
