SN J6801A-04

S E R V I C E N O T E

J6801A DNA

March 15, 2005

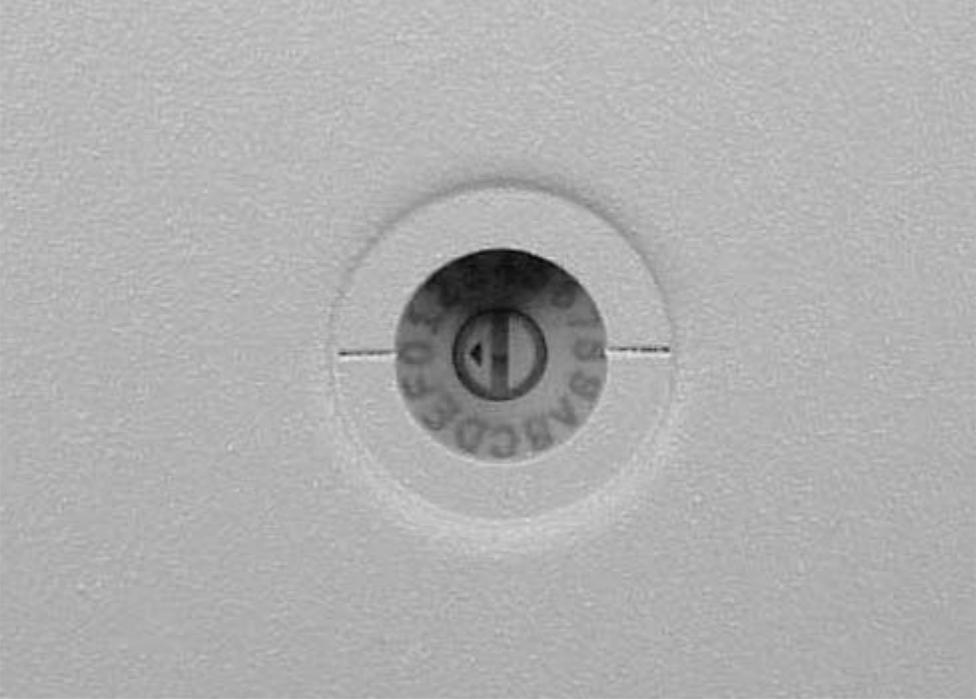
We have determined a root-cause of the DNA failures in daisy chaining. It is due to the Ethernet switch chip on the Ethersync PCA being set to use "flow control" which the should never be used. What we see is that one of "N" DNAs in a chain send a "pause" frame to all switch ports periodically that causes the server to disconnect the DNAs, thus causing a "Connection lost to Server" error message.

The 1st picture shows the bottom of the J6801A. The second picture shows the bottom of the J6801A with the access plug removed and the original setting of the ether sync switch. The 3rd picture shows the "new" setting for the switch. After changing the switch setting the user should replace the access plug.
