**J6801B-01****S E R V I C E                      N O T E**Supersedes:  
None**J6801B Distributed Network Analyzer**

Serial Numbers: SG46230615/ SG46241004

**Network Time Protocol synchronization does not function as clock-master correctly on affected units.****To Be Performed By: Agilent-Qualified Personnel****Parts Required:**

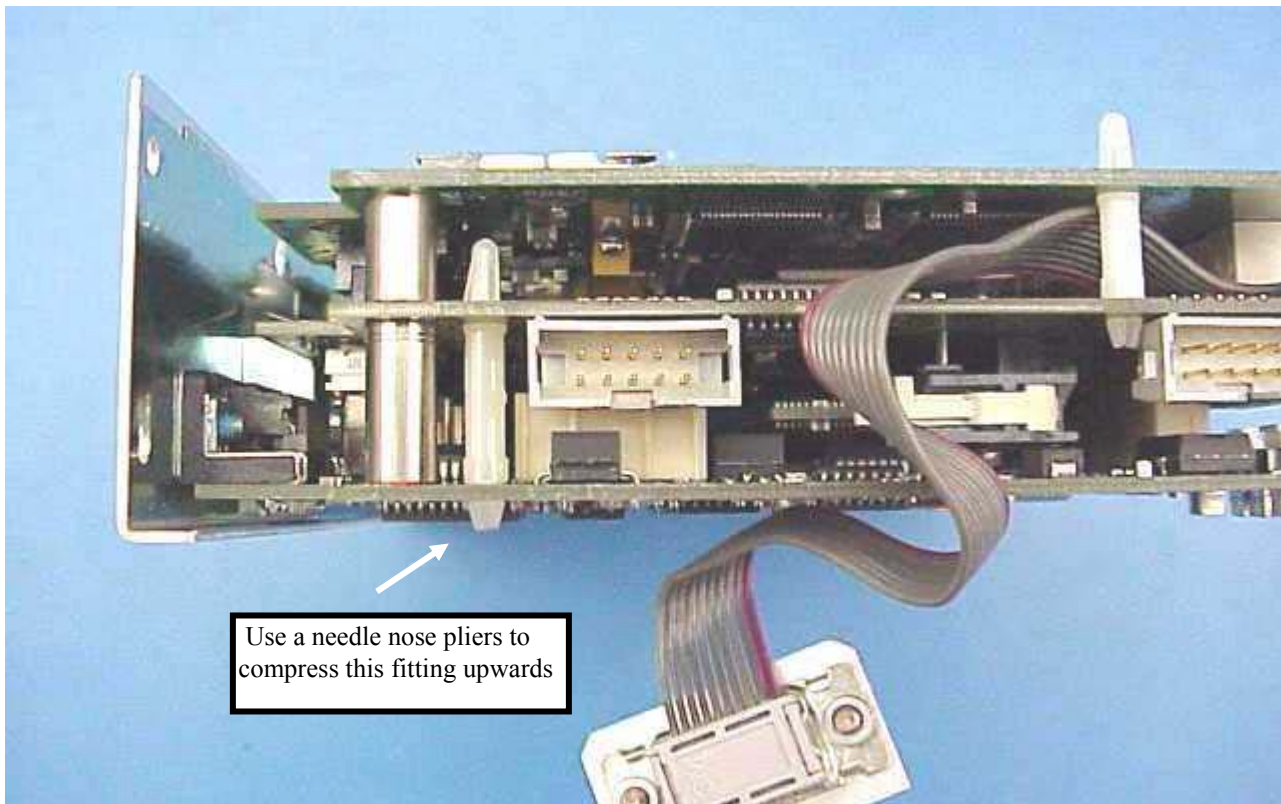
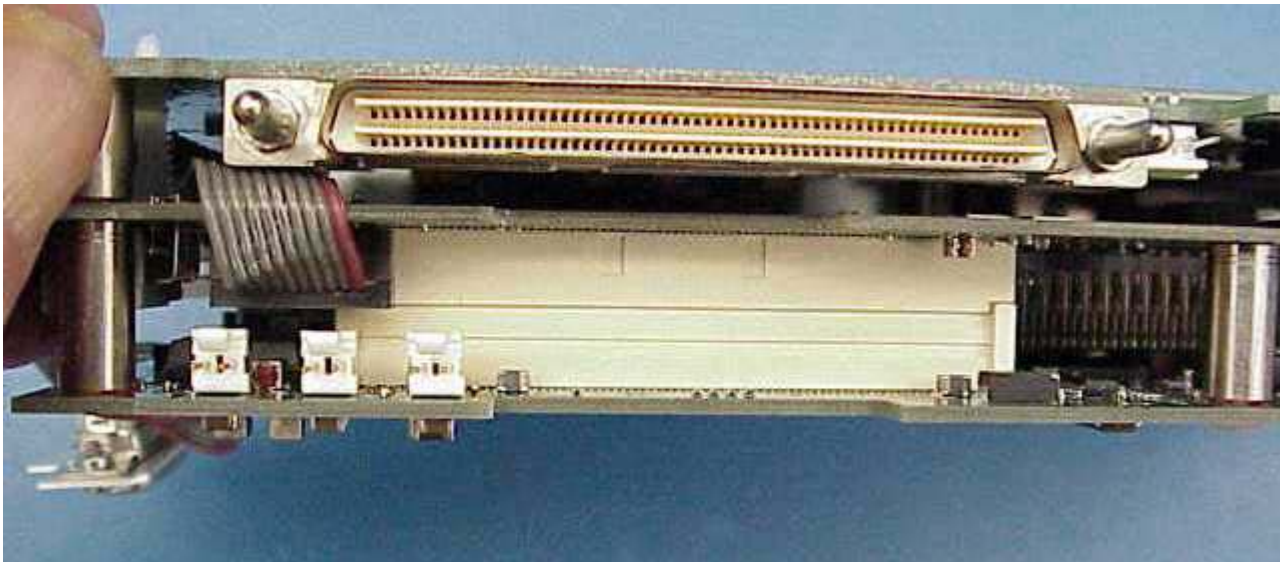
#2 Separate the board-stack at this connector.

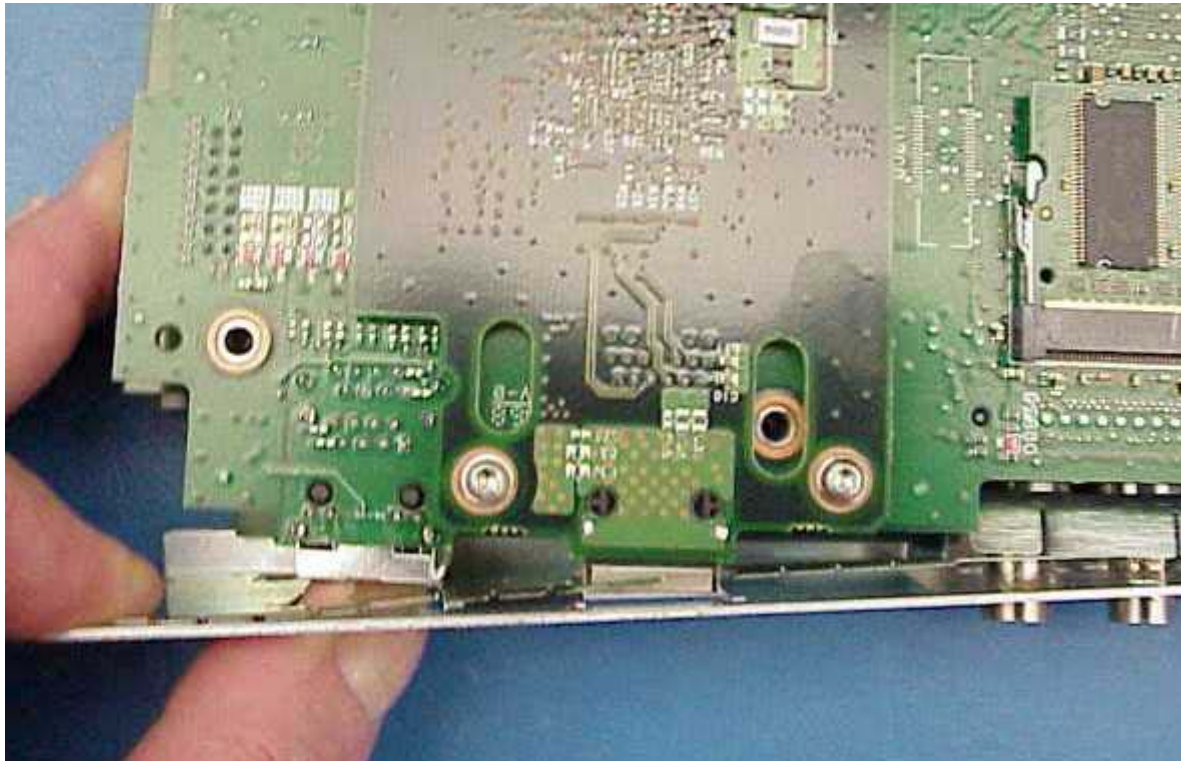
#3 Carefully pry the sheet-metal away from the RJ connectors on the board-stack until they completely clear the RFI gasket.

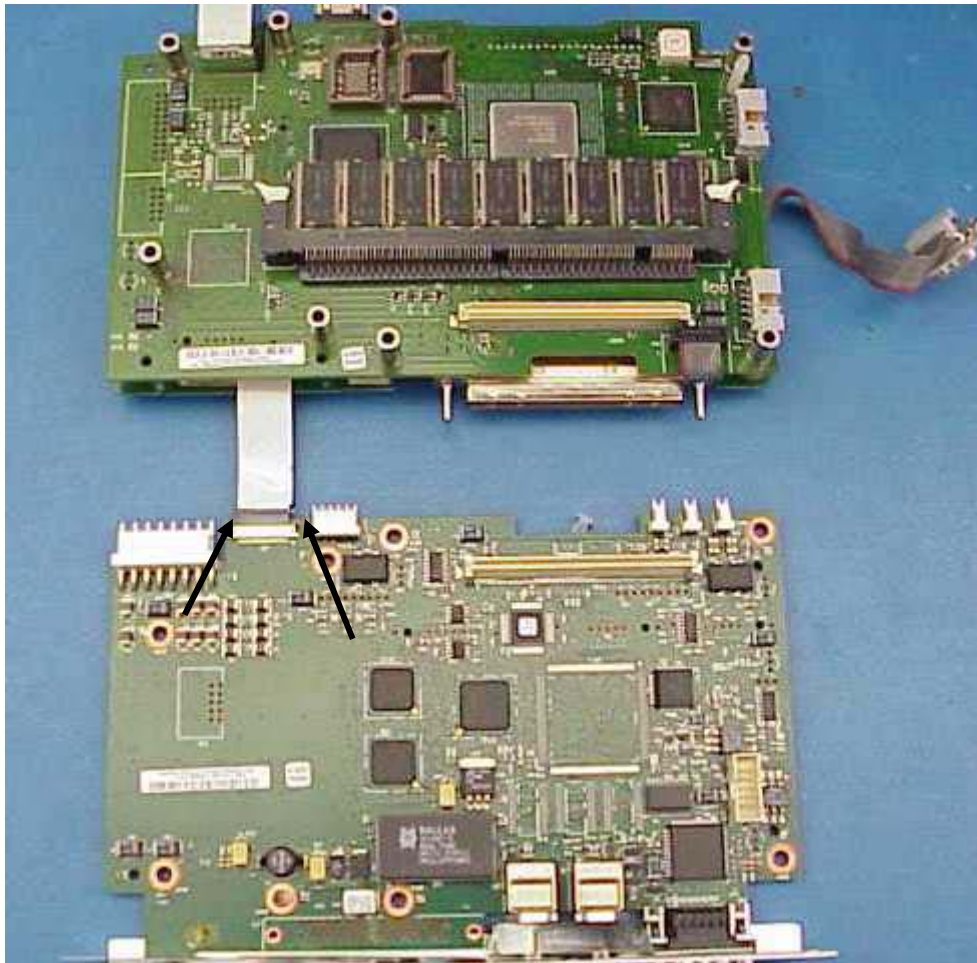
#4 Once the RJ connectors are clear of the sheet-metal rotate this top board away from you and place on the work surface. You should be presented with the view on the next page.

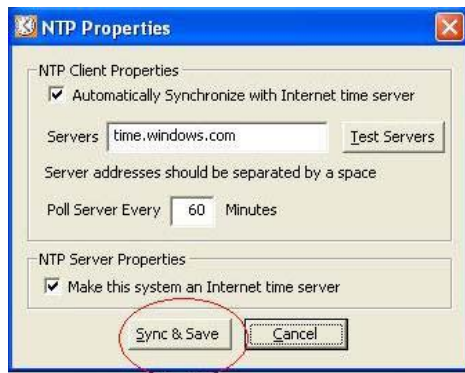
2. Set the NTP Server values as shown

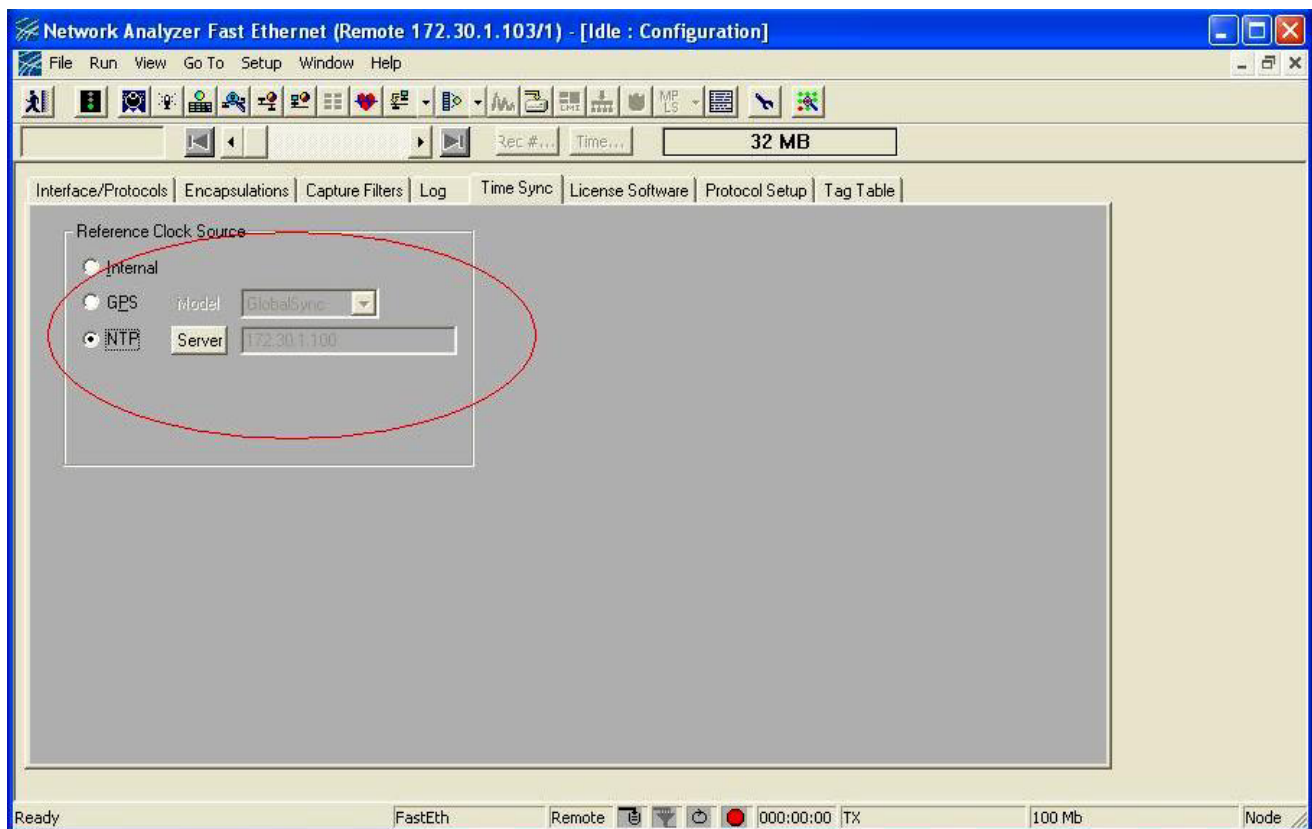
3. Open NA and connect to the Master DNA(first unit in chain) and set the Reference Clock Source to NTP. Set the IP address = to the second NIC card address (172.30.1.100 for compatibility). Leave the NA window open. Open another instance of NA Hardware Select LIM.
