Modification Recommended Service Note

Supersedes:
J7201A-01

J7201A Attenuation Control Unit, DC to 6 GHz, 0 to 121 dB, 1-dB Steps

Serial Numbers: MY59400001 to MY61410090

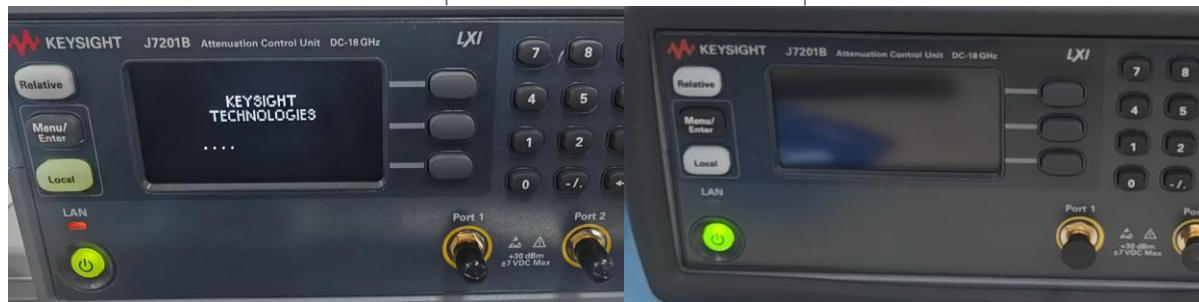
The instrument is unable to boot up and is stuck on the boot-up screen as follows. It is not functioning.

Replace PPMC board P0600-63004 with Programmed PPMC board serial number P06006300423**2413**000007 onwards where 13 is the work week and 24 is the year.

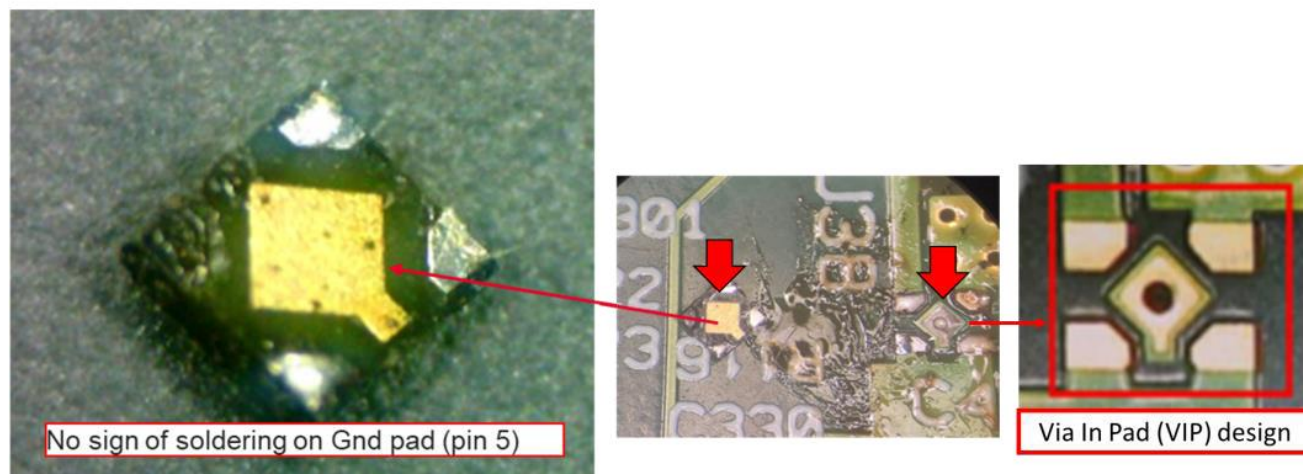
Failure analysis had indicated defective on P0600-63004 board where insufficient solder was observed at 2 locations. The insufficient solder was due to Via in Pad (VIP) where the melted solder had flown to the secondary side of the PCB.

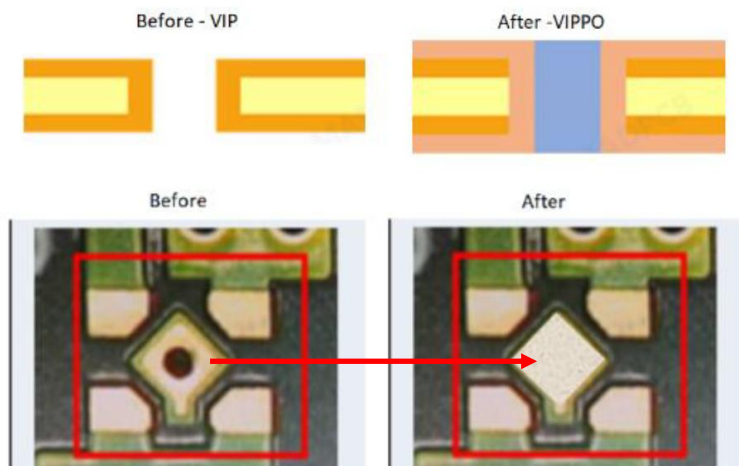
The improvements were made from Via in Pad (VIP) to Via in Pad Plated Over (VIPPO) as per below.
