L4490A-04

Modification Recommended Service Note

L4490A 2U RF/Microwave Switch Platform

Serial Numbers: MY56460538 - MY56460741

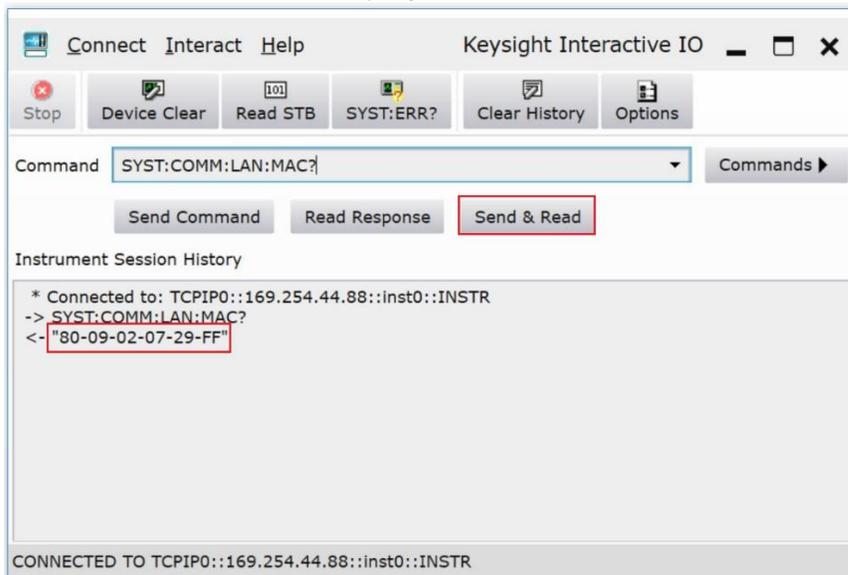
4. Launch Keysight Interactive IO tool within Connection Expert and verify the MAC address of the instrument using SCPI command:
 - (a) "SYST:COMM:LAN:MAC?" : query the instrument's LAN MAC address.

5. If the MAC address is [80-09-02-07-29-FF], please proceed to step 6. Else, the instrument is not affected by the MAC address issue and no further action is required.
6. Create a new folder directory with the name "ABELANMAC" on the PC controller's C:\ drive.
7. Go to URL: <ftp://ftp.keysight.com/mpusup/L449XALANMAC>
8. Place L449XALANMAC.exe, L449XAMAC.csv and Agilent.TMFramework.InstrumentIO.dll files from step 7 inside the "C:\ABELANMAC" folder.

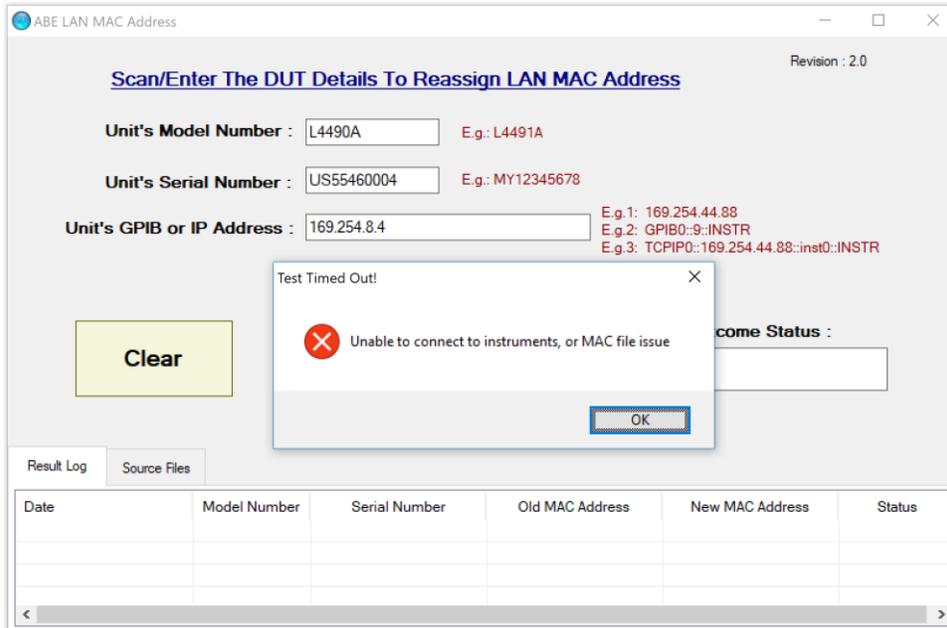
- A. Test program displays a “Test Timed Out!” prompt and closes the application.

Possible Cause 1: The connection between the PC controller and GPIB or LAN cable is not established.

Possible Cause 2: Incorrect instrument's GPIB or IP address entered at the program text box.

Possible Cause 3: Instrument is not powered on when the program is running.

Possible Cause 4: When connecting with the LAN cable, the LAN LED on the instrument's front panel is not yellow.

Possible Cause 5: Missing “L449XAMAC.csv” file according to the Source Files location. Default location for the “L449XAMAC.csv” file is C:\ABELANMAC\.

Possible Cause 6: The “L449XAMAC.csv” file is opened.

Solution 1: Ensure GPIB cable or LAN cable is connected between user's PC and instrument.

Solution 2: Enter the instrument's correct GPIB or LAN IP address, referring to the Keysight Connection Expert or Keysight Interactive IO tools.

Solution 3: Power on the instrument before running the “L449XALANMAC.exe” application.

Solution 4: Refer to Solution 1 stated above and try to reboot the instrument. Wait for the LAN LED to turn yellow. If the problem persists, contact the Keysight Technical Support team.

Solution 5: Perform step 6 until step 8 in page 3 of this document.

Solution 6: Close the “L449XAMAC.csv” file.

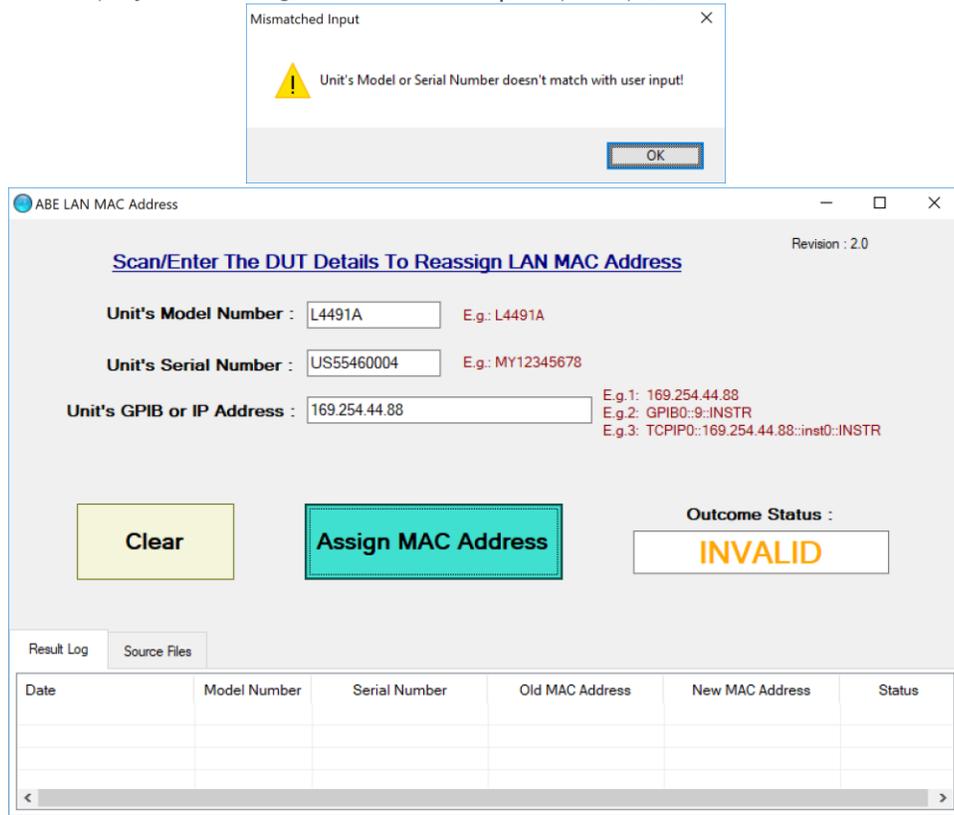
B. Test program displays a warning “Mismatched Input” prompt, and “INVALID” outcome status.

Possible Cause: The user entered the wrong model number or serial number, versus the actual instrument’s model number and serial number.

Solution: Enter the correct model number and serial number of the instrument.
