Modification Recommended Service Note

L4491A 4U RF/Microwave Switch Platform

Serial Numbers: MY56460359 - MY56460642
SG56460003 - SG56460004

The Problem – Devices found to have the same MAC address can cause an IP conflict when connected on the same local network.

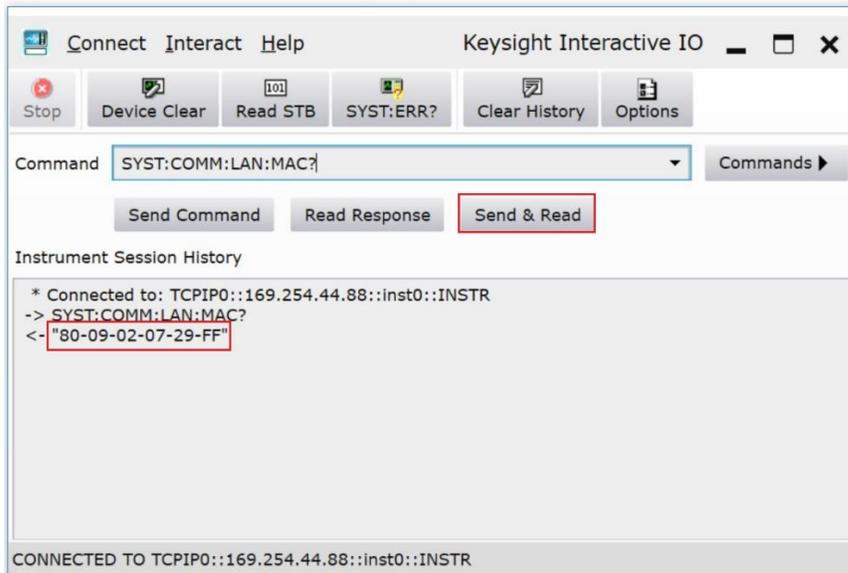
4. Launch Keysight Interactive IO tool within Connection Expert and verify the MAC address of the instrument using SCPI command:
 - (a) "SYST:COMM:LAN:MAC?" : query the instrument's LAN MAC address.

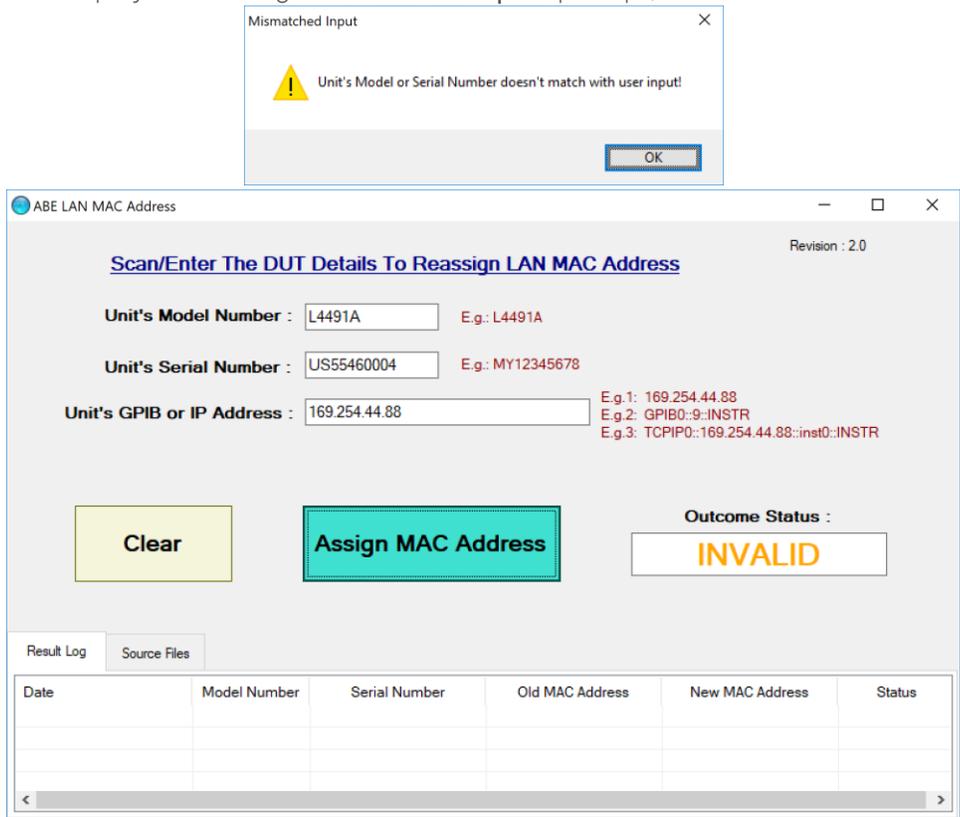
B. Test program displays a warning “Mismatched Input” prompt, and “INVALID” outcome status.

Possible Cause: The user entered the wrong model number or serial number, versus the actual instrument’s model number and serial number.

Solution: Enter the correct model number and serial number of the instrument.
