M3300A-01

Modification Recommended Service Note

M3300A PXIe AWG and Digitizer Combination

The Problem – D.C offset error on the AWG output due to:

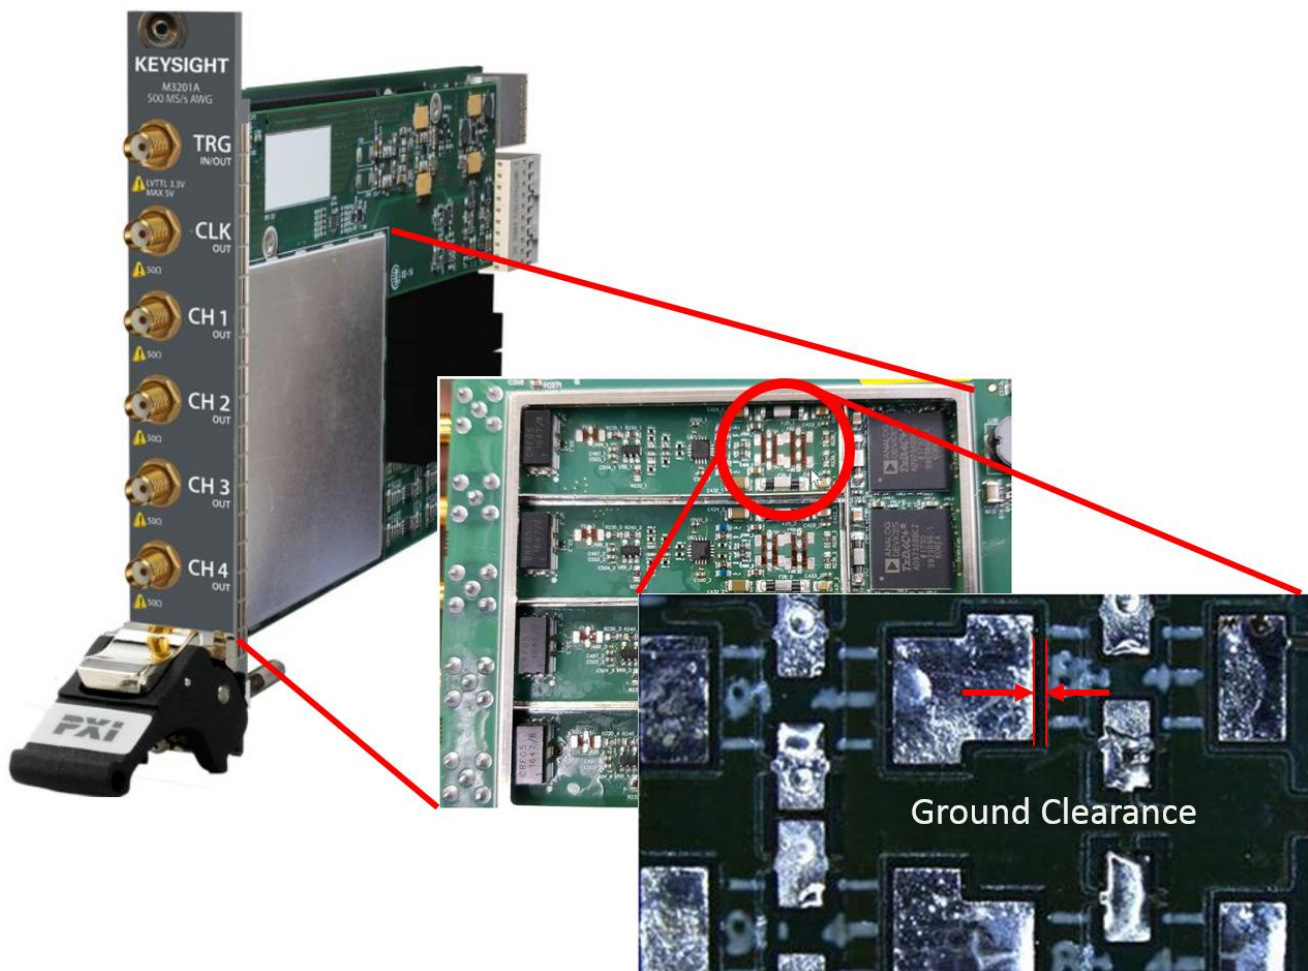
1. A possible short circuit between the filter output pad and the PCB ground plane due to insufficient ground clearance in the PCB design.
1. The performance of the filter changed sometime in 2017 which was not picked up by Keysight. This resulted in unstable DC offset performance after being in operation for some time.

The ground plane clearance problem can be seen below:

These problems have been fixed in all modules, M3201A & M3202A, M3300A & M3302A from MY57510001 onwards.

PXIe AWG M3201A & M3202A and PXIe AWG and Digitizer Combo M3300A & M3302A exhibiting excessive DC offset can be returned to keysight for repair and full calibration.
