M9018B-03

Information Only Service Note

M9018B PXIe Chassis: 18-slot, 3U, 8 GB/s

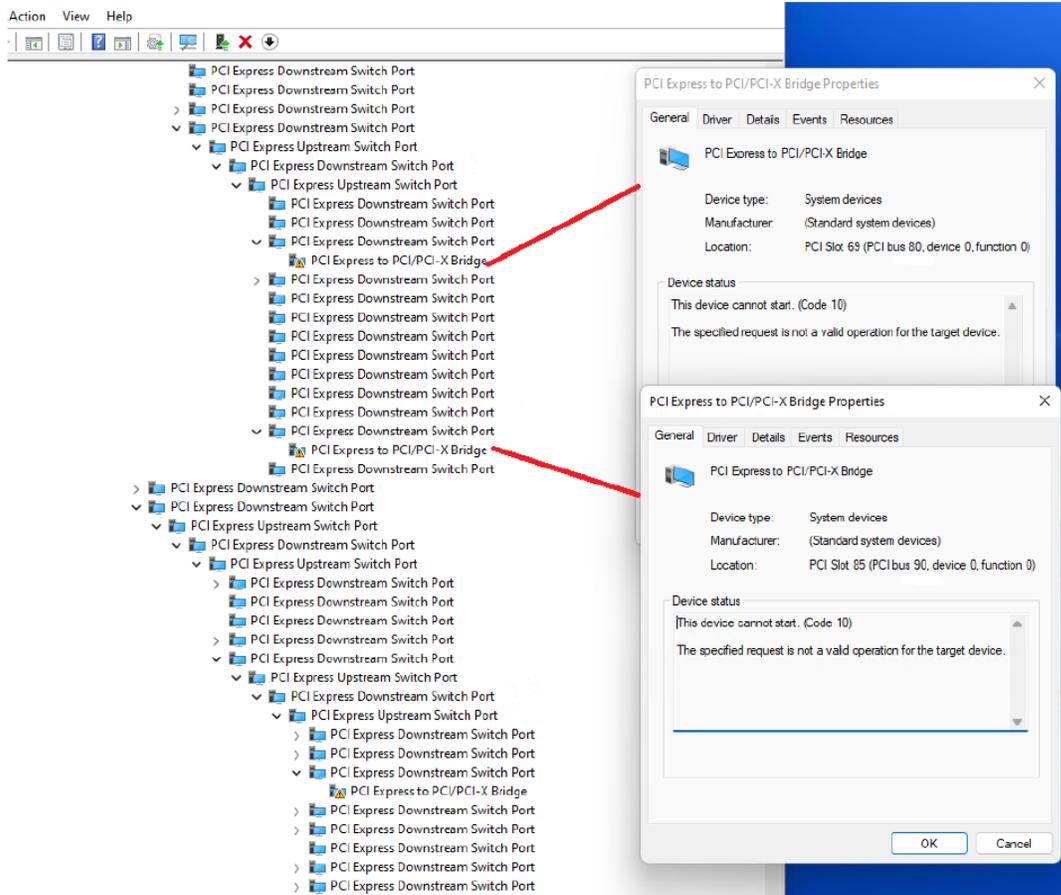
It has been found when the affected chassis are used with M9025A PXIe Thunderbolt System Module that the Device Manager would encounter code 10 errors under the PCI Express to PCI/PCI-X Bridge like picture below.

Follow the steps below to resolve the code 10 errors at the PCI Express to PCI/PCI-X Bridges.

1. Install drivers version 1.7.913.1 or later at the chassis product website <http://www.keysight.com/find/M9018B>, navigate to Technical Support > Drivers, Firmware and Software > PXIe Chassis Family Drivers.
2. After updating the drivers, run the update FW tool at the chassis product website <http://www.keysight.com/find/M9018B>, navigate to Technical Support > Drivers, Firmware and Software > Chassis Firmware.
 - a. When the *.bin file is run, it will detect the PXI-X switch Firmware needing to be updated like picture below. Press Update to update.
