M9018B-04A

# Information Only Service Note

M9018B PXIe Chassis: 18 Slot, 3U, 8 GB/s

M9018B Soft Front Panel displays Unexpected Internal Software Error (BFFA0018)

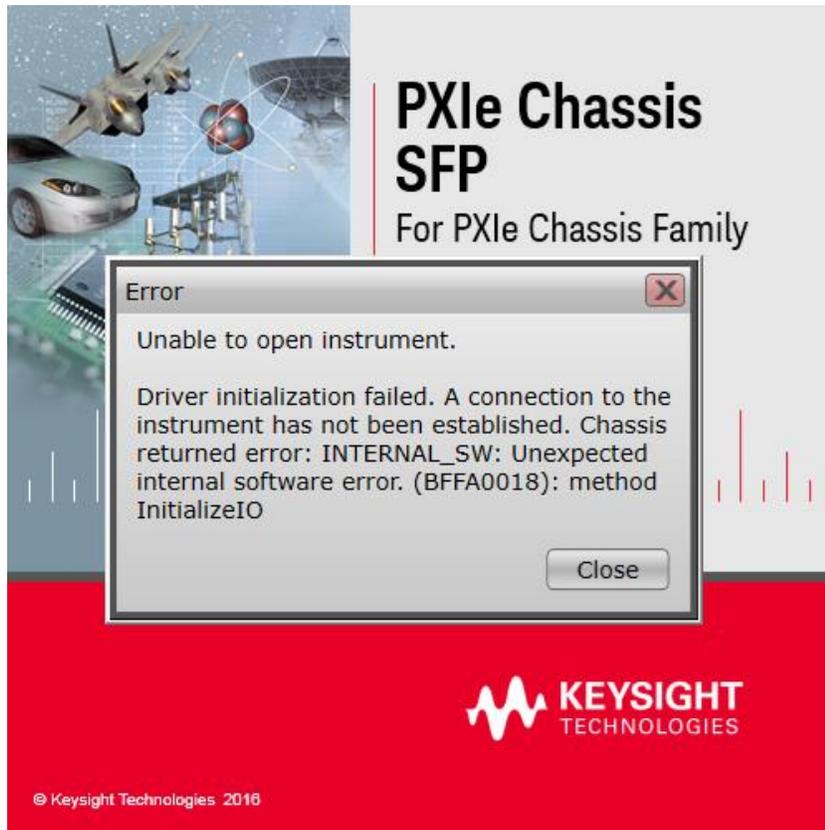
It has been found that when connected to the M9018B and the Soft Front Panel was opened, the below Soft Front Panel error is displayed:

1. Install drivers version 1.7.925.1 or later at the chassis product website <http://www.keysight.com/find/M9018B>, navigate to Technical Support > Drivers, Firmware and Software > PXIe Chassis Family Drivers.
2. Cycle power the system after the update is done.
