M9036A-04A

# Modification Recommended Service Note

## M9036A PXIe Embedded Controller

Intel Active Management Technology Escalation of Privilege

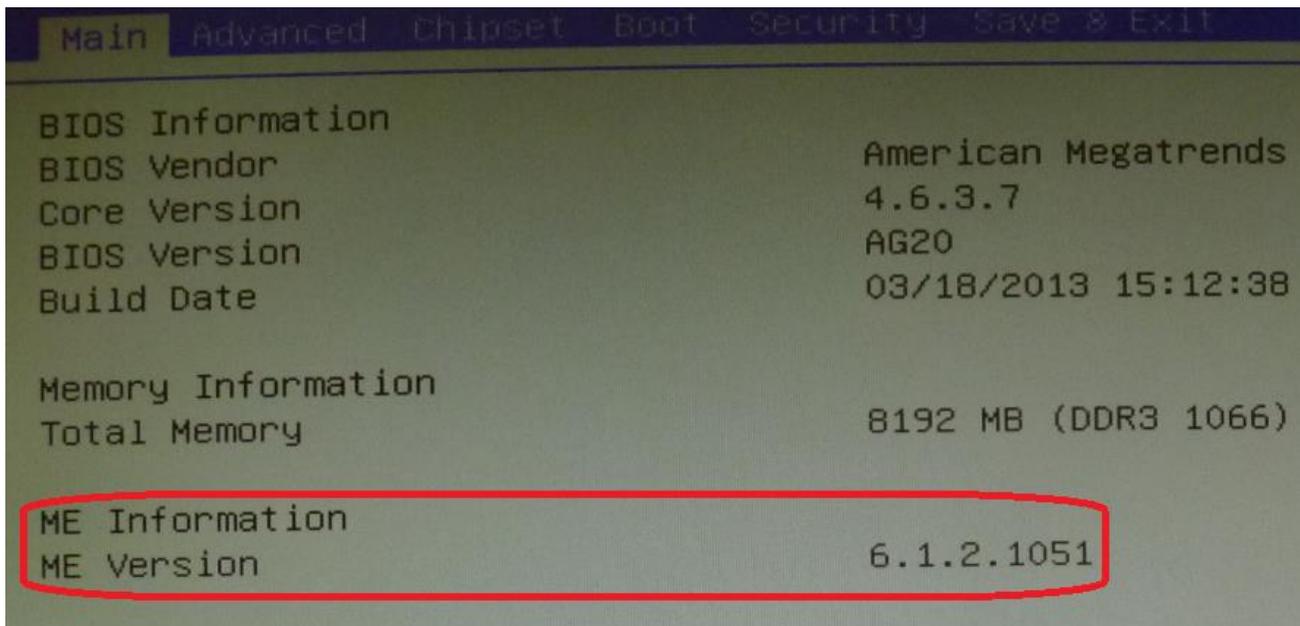
Intel disclosed a security vulnerability in the Intel® Active Management Technology (AMT) firmware that ships in Keysight embedded controllers with affected serial numbers listed above. The vulnerability can allow an unprivileged attacker to gain control of the manageability features provided by this technology. For more information, refer to [INTEL-SA-00075](https://www.intel.com/content/www/us/en/security-center/advisory-intel-SA-00075.html).

Verify that your M9036A is not vulnerable with steps below.

**Option 1:** Update the ME FW to version 6.2.61.3535 using Keysight ME update tool below.

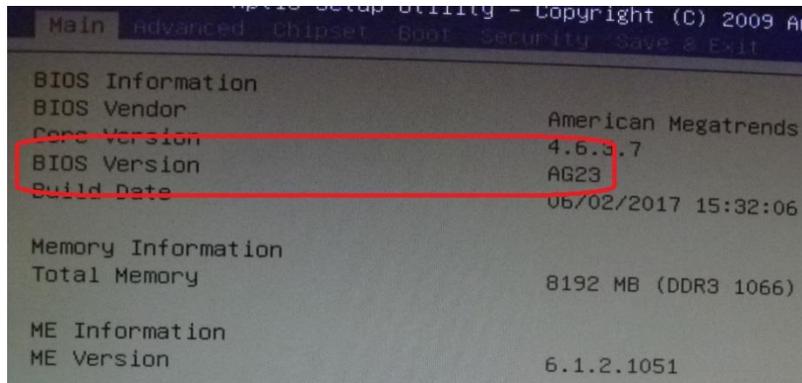
1. Make sure you have BIOS version AG23 or later loaded. You can see the BIOS version from the BIOS Main Setup screen as pictured below. If you need to update the BIOS, follow the instructions at [M9036A BIOS Downloads](#) to update.
