M9037A-05

Modification Recommended Service Note

M9037A PXIe High Performance Embedded Controller

Intel Active Management Technology Escalation of Privilege

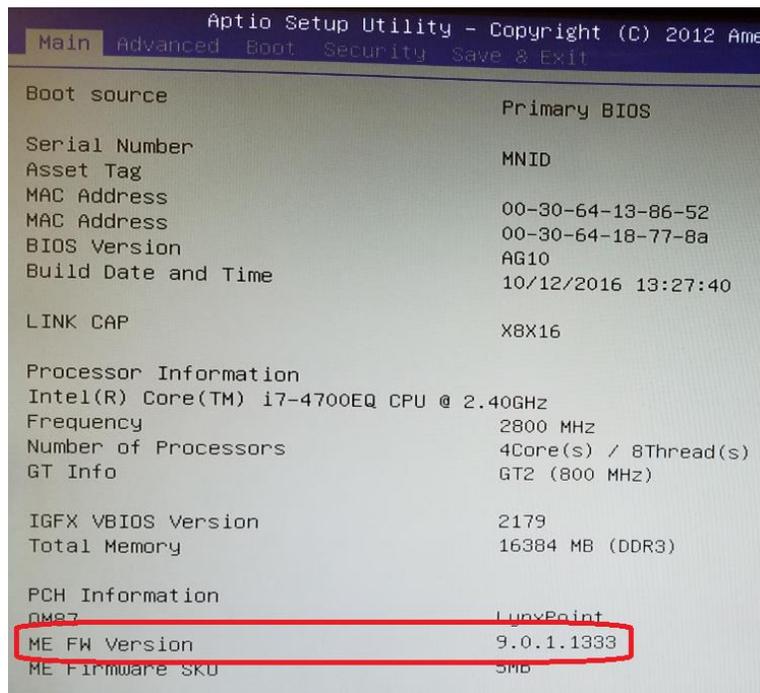
Intel disclosed a security vulnerability in the Intel® Active Management Technology (AMT) firmware that ships in Keysight embedded controllers with affected serial numbers listed above. The vulnerability can allow an unprivileged attacker to gain control of the manageability features provided by this technology. For more information, refer to [INTEL-SA-00075](#).

Option 1: Update the ME FW to version 9.1.41.3024 using Keysight ME update tool below.

1. Save and close all your application programs.
2. Download and unzip the [ME_update.zip](#) file to your embedded controller hard drive.
3. As Administrator, navigate to where you unzipped the file and run the ME_update/ME_Update.bat file.
4. At the Command Prompt window, do not interrupt the run. The controller will automatically restart after it's done with the FW update.
5. Verify your embedded controller is not vulnerable with the steps above in the Situation section.

Option 2: Refer to the [INTEL-SA-00075 Mitigation Guide](#) for the steps to mitigate.
