# Modification Recommended Service Note

## M9038A PXIe High Performance Embedded Controller: 6-Core

Serial Numbers: TW62500543 to TW62500664  
 Manufacturing ID Number: 1C62500547 to 1C62500665

Cannot boot into Microsoft Windows when rebooted in an M9010A chassis

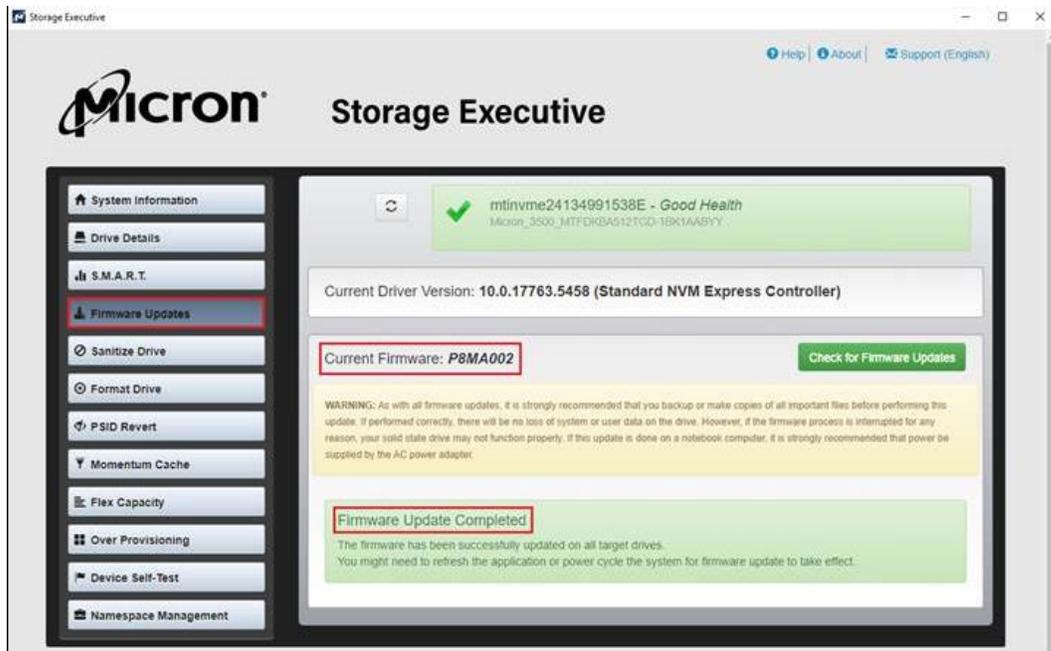
It has been found that the affected M9038A embedded controllers listed above cannot boot into Microsoft Windows after reboot when used with the M9010A Keysight PXIe chassis.

The solid-state drive (SSD) firmware (FW) needs to be updated to version P8MA002 to resolve the issue. Follow the steps below to update the SSD FW to version P8MA002.

1. If you do not have another type of Keysight PXIe chassis (e.g. M9019A or M9046A) to use, power down the system, detach the power cable from the chassis, and wait 6 hours before booting up again.
2. Download file **3500-NonSED-P8MA002.zip** from <https://www.keysight.com/my/en/assets/9925-01023/miscellaneous/3500-NonSED-P8MA002.zip> and place it at the **Desktop**.
3. Download and install **Storage Executive Software** at <https://my.micron.com/content/dam/micron/global/public/products/software/storage-executive-software/storageexecutive-windows.exe>.
4. As Administrator, run the **storageexecutive-windows.exe** file.
5. Navigate to **Firmware Updates** tab at the left of the screen.
6. Click the **Choose File** option and locate the **3500-NonSED-P8MA002.zip** FW package file at the **Desktop**.
7. Click **Update Firmware Now**. Image below shows a successful update of the FW.

8. After it is done, do a full cycle power of the system.
