Modification Recommended Service Note

M9155C PXI Hybrid Dual SPDT Coaxial Switch, DC to 26.5 GHz, Unterminated

Serial Numbers: TH60450001 - TH61350508

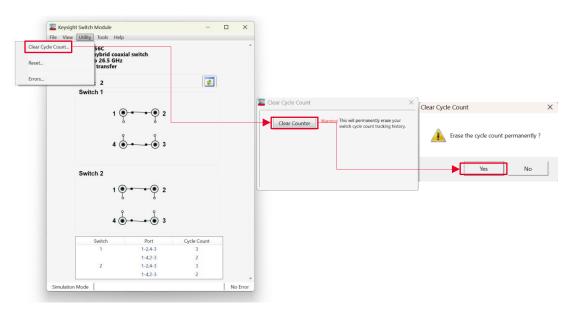
The cycle count of the unit is abnormally high. Fresh units from the factory have a cycle count of 16777215 cycles. This number is the default value for the EEPROM that stores the cycle count information. Due to a factory process issue, the cycle count was not reset. When users start using the switch, the cycle count starts from 16777215 onwards.

Clear the Cycle count using the Soft Front Panel (Keysight Switch Module) Utility -> Clear Cycle Count -> Clear Counter -> Yes
