# Modification Recommended Service Note

## M9156C PXI Hybrid Dual Transfer Switch

Serial Numbers: TH60450001 - TH61350152

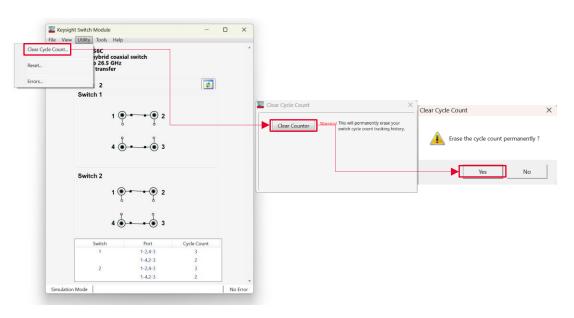
The cycle count of the unit is abnormally high. Fresh units from the factory have a cycle count of 16777215 cycles. This number is the default value for the EEPROM that stores the cycle count information. Due to a factory process issue, the cycle count was not reset. When users start using the switch, the cycle count starts from 16777215 onwards.

Clear the Cycle count using the Soft Front Panel (Keysight Switch Module) Utility -> Clear Cycle Count -> Clear Counter -> Yes
