Modification Recommended Service Note

M9157C PXI Hybrid Single SP6T Switch, DC to 26.5 GHz, Terminated

Serial Numbers: TH60450001 - TH61350204

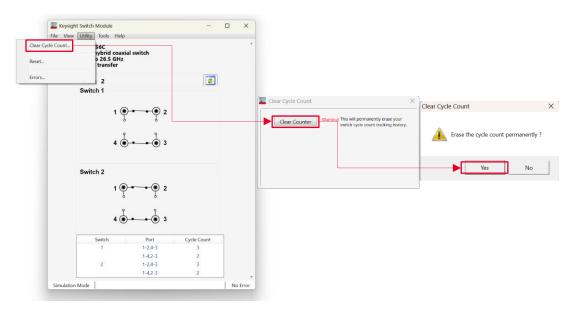
The cycle count of the unit is abnormally high. Fresh units from the factory have a cycle count of 16777215 cycles. This number is the default value for the EEPROM that stores the cycle count information. Due to a factory process issue, the cycle count was not reset. When users start using the switch, the cycle count starts from 16777215 onwards.

Clear the Cycle count using the Soft Front Panel (Keysight Switch Module) Utility -> Clear Cycle Count -> Clear Counter -> Yes
