M9505A-04

S E R V I C E N O T E

M9505A AXIe 5 slot Chassis

Replace power supply module to avoid system reset due to line voltage dropout issue

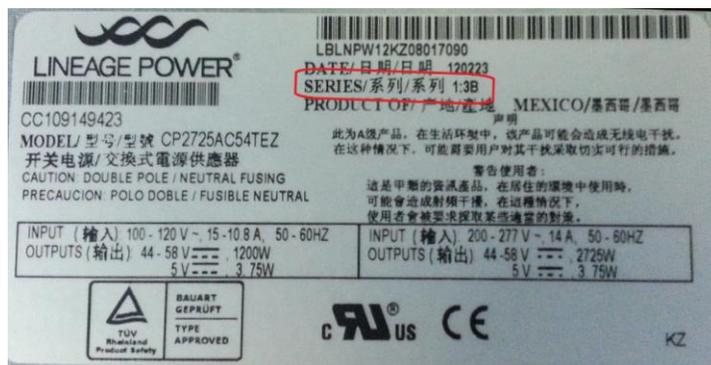
Affected Serial Numbers: TW00000000-TW51440221 and with Power Supply Assembly Revisions: 1:2B and below (revision is viewable on the power supply label-see sample picture). Power supply needs to be removed to view the label. Refer to the Troubleshoot section in the User's manual for instructions to remove the power supply.

Affected M9505A described above configured with modules that consume more than 850W (200-240V) or 400W (100-120V) total power across all 5 slots may experience occasional system reset if installed in environments prone to line voltage dropouts in excess of 20ms.

The power supply has been improved to support up to 1000W across 5 slots without any line voltage dropout issue. To avoid system resets due to this issue, upgrade to the new power supply with revision 1:3B or greater. Refer to the Troubleshoot section in the User's manual for instructions on how to replace the power supply.
