M9537A-04

Modification Recommended Service Note

M9537A AXIe High Performance Embedded Controller

Intel Active Management Technology Escalation of Privilege

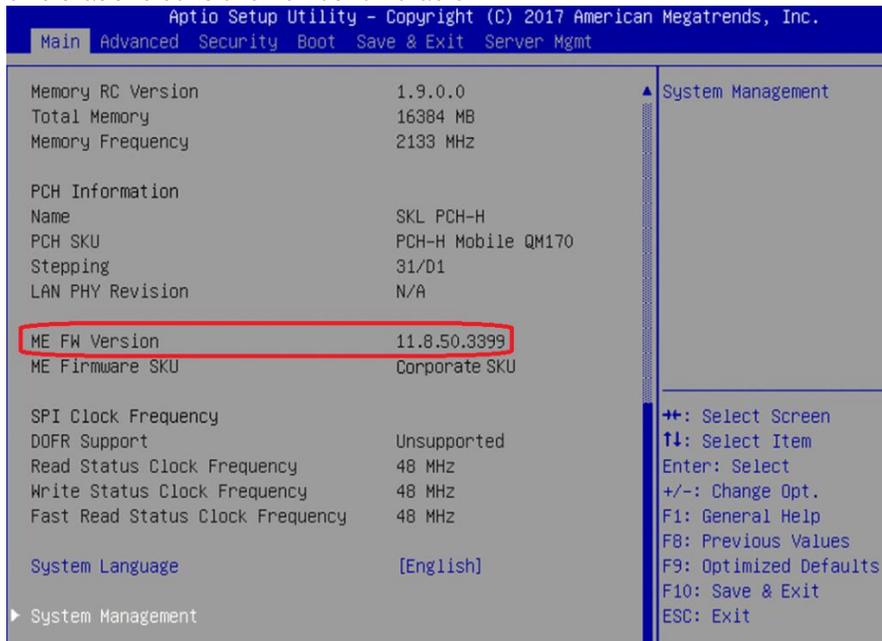
Verify that your embedded controller is not vulnerable with steps below.

1. Power on or reboot your embedded controller.
2. Press the <Delete> key when the controller beeps. This should be concurrent with the main startup screen. The BIOS setup program loads after a short delay.
3. At the BIOS Main Setup screen, verify that the “ME FW Version” is version 11.8.50.3399 or later. Below picture shows that this controller is not vulnerable.

Keysight strongly recommends taking the actions specified below for embedded controllers with affected ME firmware. There are two options you can choose from to mitigate the issue.

Option 1: Update the BIOS to version SL06 or later by following the instructions at [M9537A BIOS Downloads](#).

Option 2: Refer to the [Intel SA-00086](#) for the steps to mitigate.
