MSO8104A-01A S E R V I C E N O T E

MSO8104A – 8000 Series Oscilloscopes

Serial Numbers: MY45000105 - MY45000154

USB connectors disconnect from the motherboard in 8000 and 80000B Series oscilloscopes.

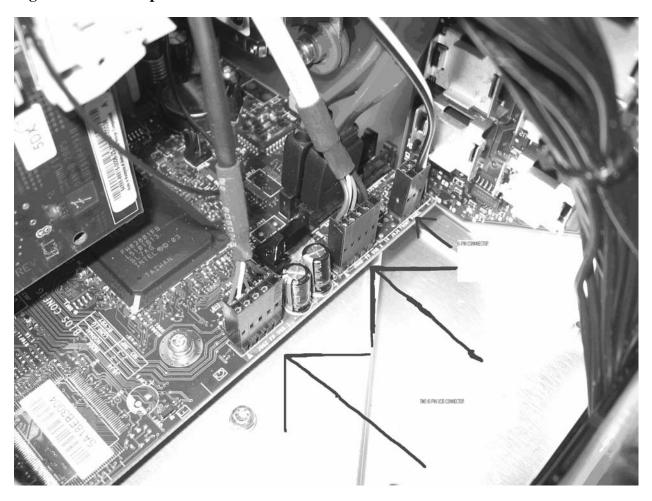
Figure 1: Standard picture of Front Panel

This picture shows the (2) 10-pin USB connector for the front panel USB port cable (labeled as J962FPUSB1 and J9H2PFUSB2 on the motherboard) and touch screen cable and the (1) 6-pin connector for the motherboard switch cable plugged (labeled as J9J4 Front Panel on the motherboard) into the 915 motherboard.

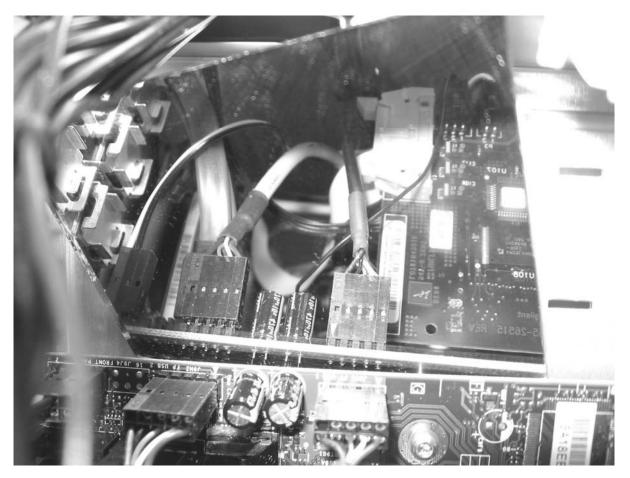
Following a single 3.2" drop in the top to bottom axis it was determined that these three cable connections will begin to separate from the motherboard. The following picture shows the results of a single 3.2" drop.

A mirror was used to aid in showing how the connectors begin to disconnect. Notice the gold pins visible under the connector on the left; the connector on the right was re-seated to show the contrast following the single drop. There are two known instances where one or more of these three cable connections have disconnected completely during transit

- 10. Following the assembly of the 915 motherboard into the chassis and connecting the touch screen cable (D8104-61604), USB cable (D8104-61602) and motherboard switch cable (54855-61624) to the 915 MB; be sure that the connectors are seated down against the MB completely. 6.

- 11. With the connectors seated properly; room temperature vulcanization (RTV) silicone will be applied to the USB connectors to secure the connectors to the MB. Use the following RTV: Loctite 5145; Agilent part number 0470-2123. Loctite 5145 is an electronic grade RTV silicone that is non-corrosive and translucent.
