MSO8104A-01B

S E R V I C E N O T E

MSO8104A-8000 Series Oscilloscopes

USB connectors disconnect from the motherboard in 8000 and 80000.

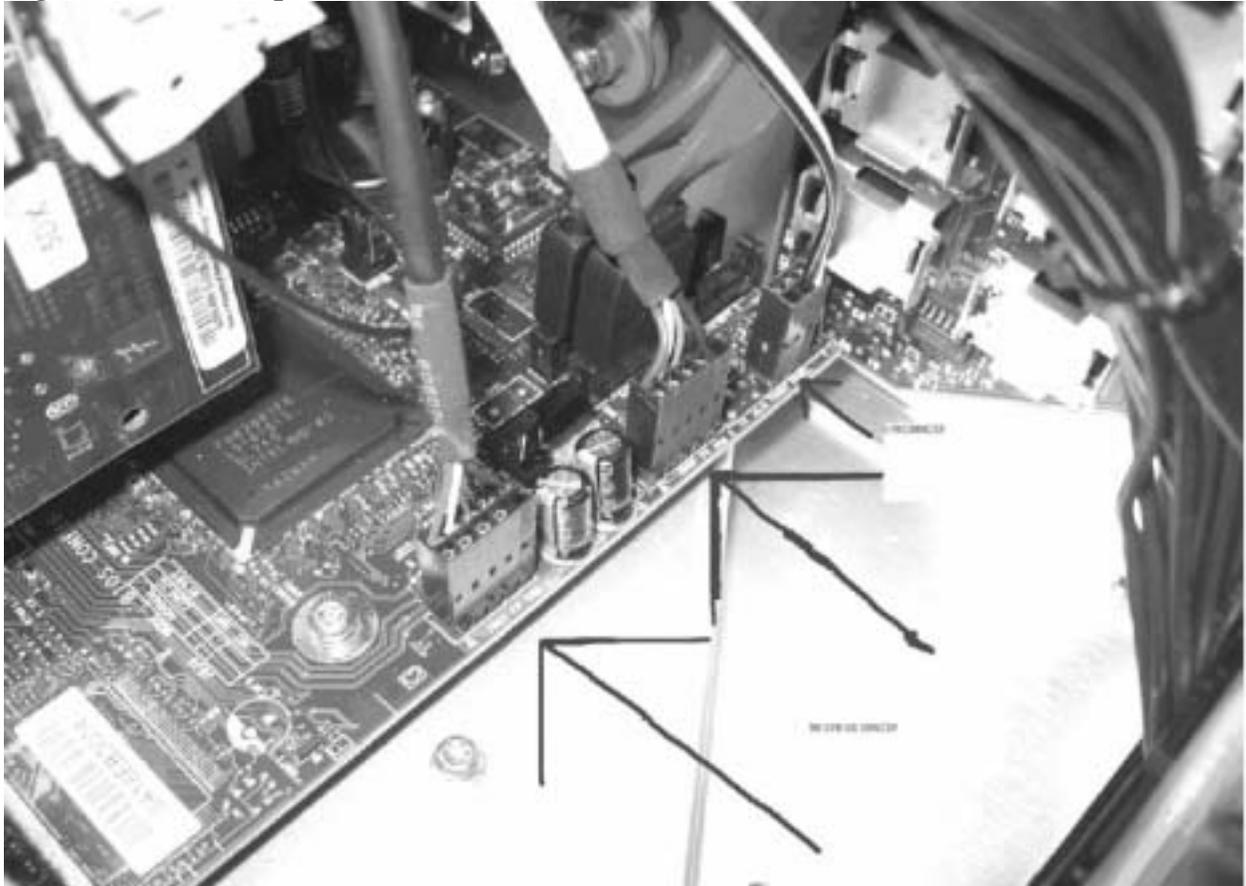
Figure 1: Standard picture of Front Panel

This picture shows the (2) 10-pin USB connector for the front panel USB port cable (labeled as J962FPUSB1 and J9H2PFUSB2 on the motherboard) and touch screen cable and the (1) 6-pin connector for the motherboard switch cable plugged (labeled as J9J4 Front Panel on the motherboard) into the 915 motherboard.

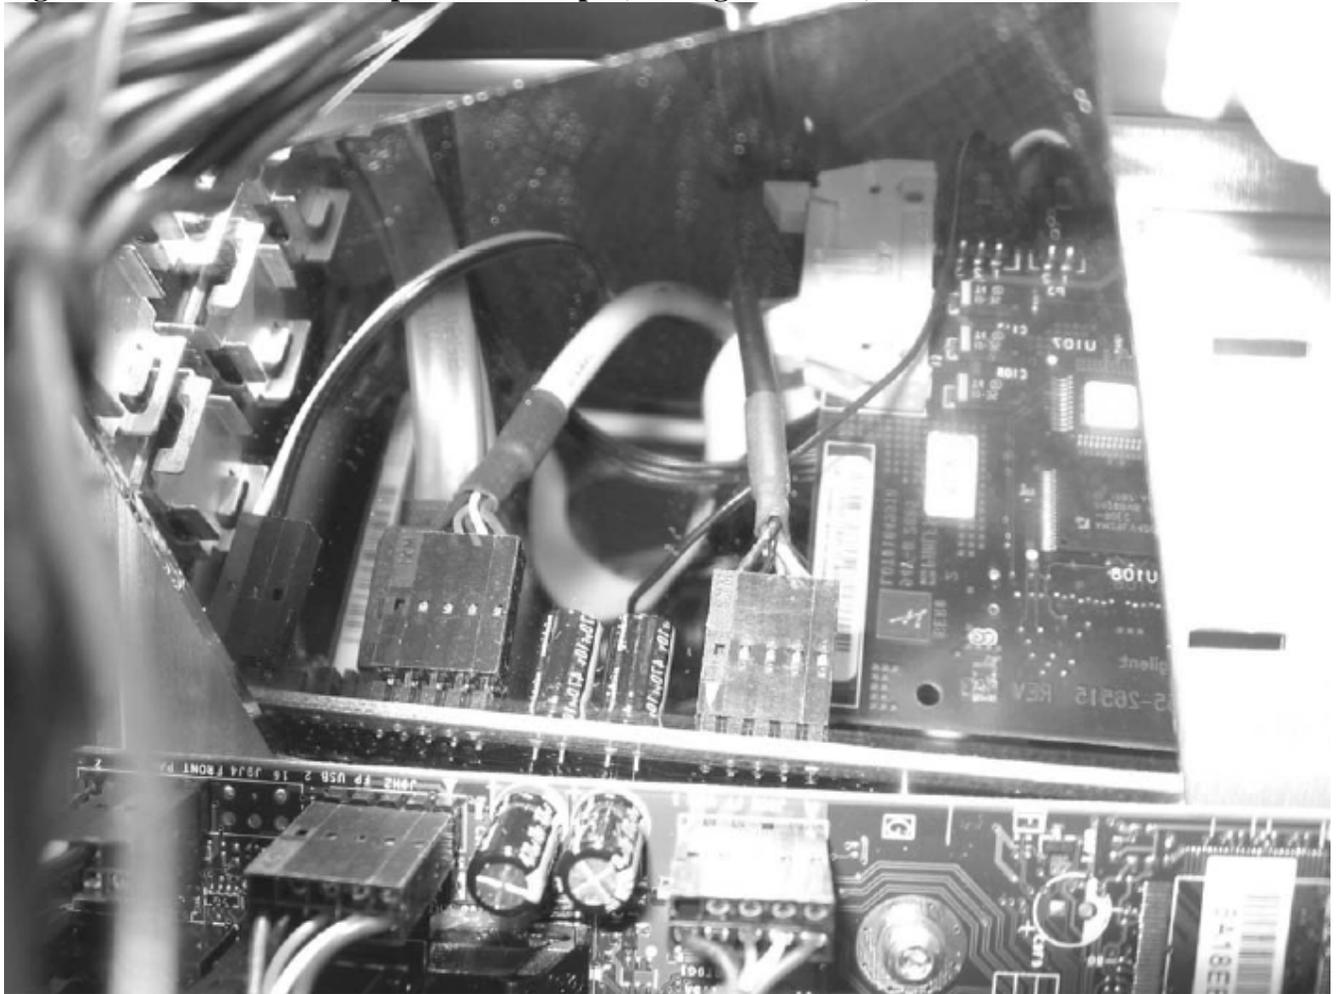
Figure 2: Results of 3.2” drop of oscilloscope (looking at mirror).

Following a single 3.2” drop in the top to bottom axis it was determined that these three cable connections will begin to separate from the motherboard. The following picture shows the results of a single 3.2” drop.

A mirror was used to aid in showing how the connectors begin to disconnect. Notice the gold pins visible under the connector on the left; the connector on the right was re-seated to show the contrast following the single drop. There are two known instances where one or more of these three cable connections have disconnected completely during transit

11. With the connectors seated properly; room temperature vulcanization (RTV) silicone will be applied to the USB connectors to secure the connectors to the MB. Use the following RTV: Loctite 5145; Agilent part number 0470-2123. Loctite 5145 is an electronic grade RTV silicone that is non-corrosive and translucent.
