MSO9254A-02

# S E R V I C E N O T E

## MSO9254A – 2.5 GHz Mixed Signal Oscilloscope

**Intermittent power failure on some 9000 series units.**

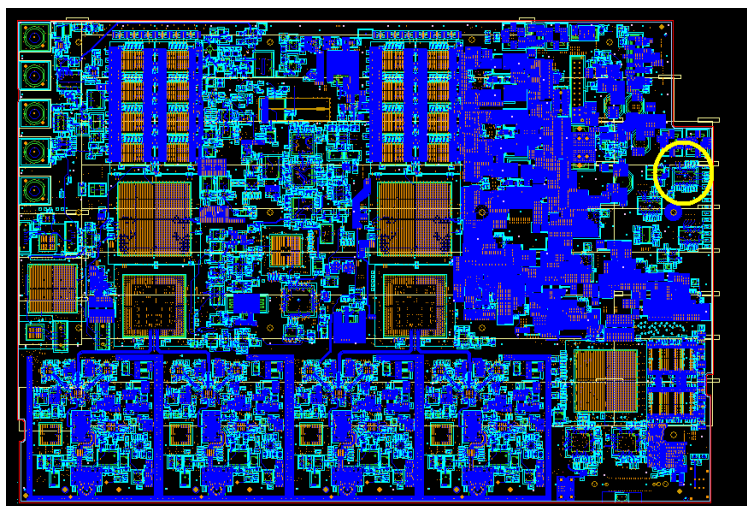
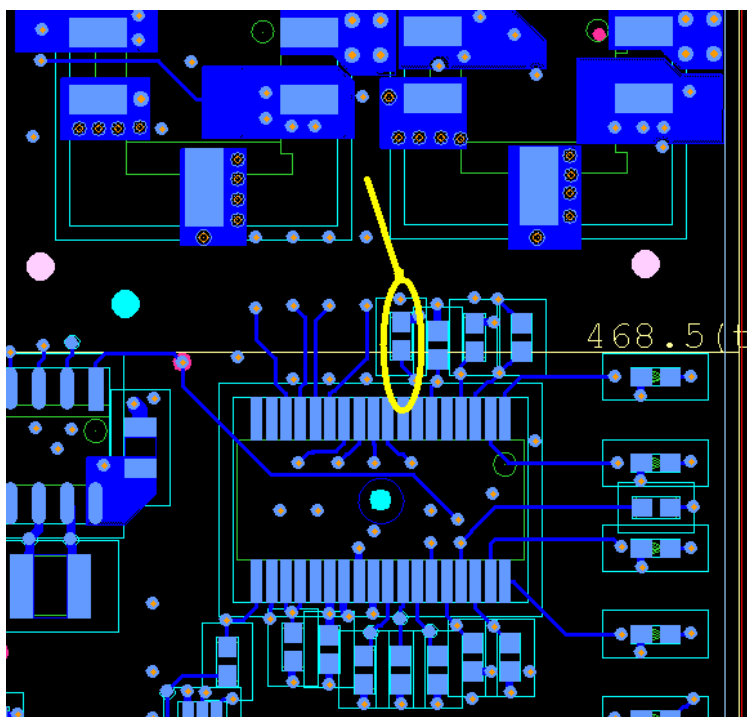
1. Use the disassembly instructions in the service manual to remove the acquisition board.
2. Refer to the below drawings to identify R2830. The area of interest is marked with a yellow circle

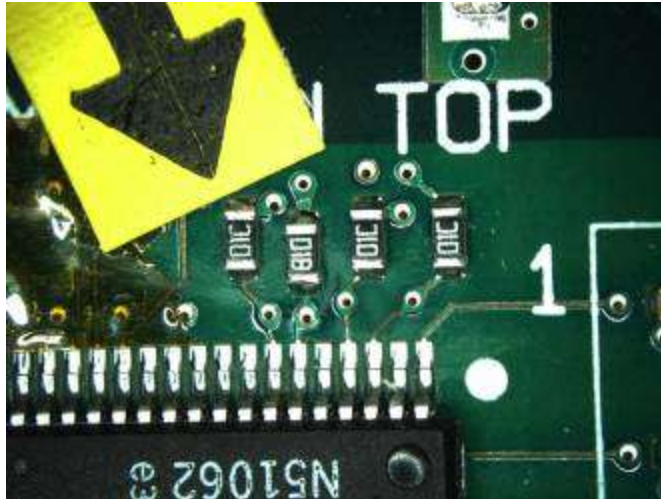
Before modification

A few of the 9000 series scopes randomly turn off. The fix is modifying the power distribution circuit on the acquisition board and dressing the wires that attach to the power supply. Make sure you use RoHS soldering station because the acquisition board components are RoHS compliant

3. Remove existing 10K resistor R2830.
4. Clean the solder pad and install the 10.5K SMD resistor on the pad.
5. Solder the 220nF SMD capacitor on top of the 10.5K resistor as shown in the below picture. Make sure the solder overflows down to the resistor pad entirely. A poorly soldered capacitor won't work as a capacitor.
6. Check the quality of your work by using a multimeter probe tip. Gently touch the lower pad of the capacitor several times. The probe tip introduces enough noise to turn the scope off if the capacitor is not soldered correctly. The capacitor forms a low pass filter to reduce noise. If the capacitor is soldered correctly, noise will not cause the scope to turn off.
