MSOS204A-02B

Modification Recommended Service Note

MSOS204A – MSO Infiniium S Series 2GHz 4 channel

Serial Numbers: MY00000001 - MY58060101

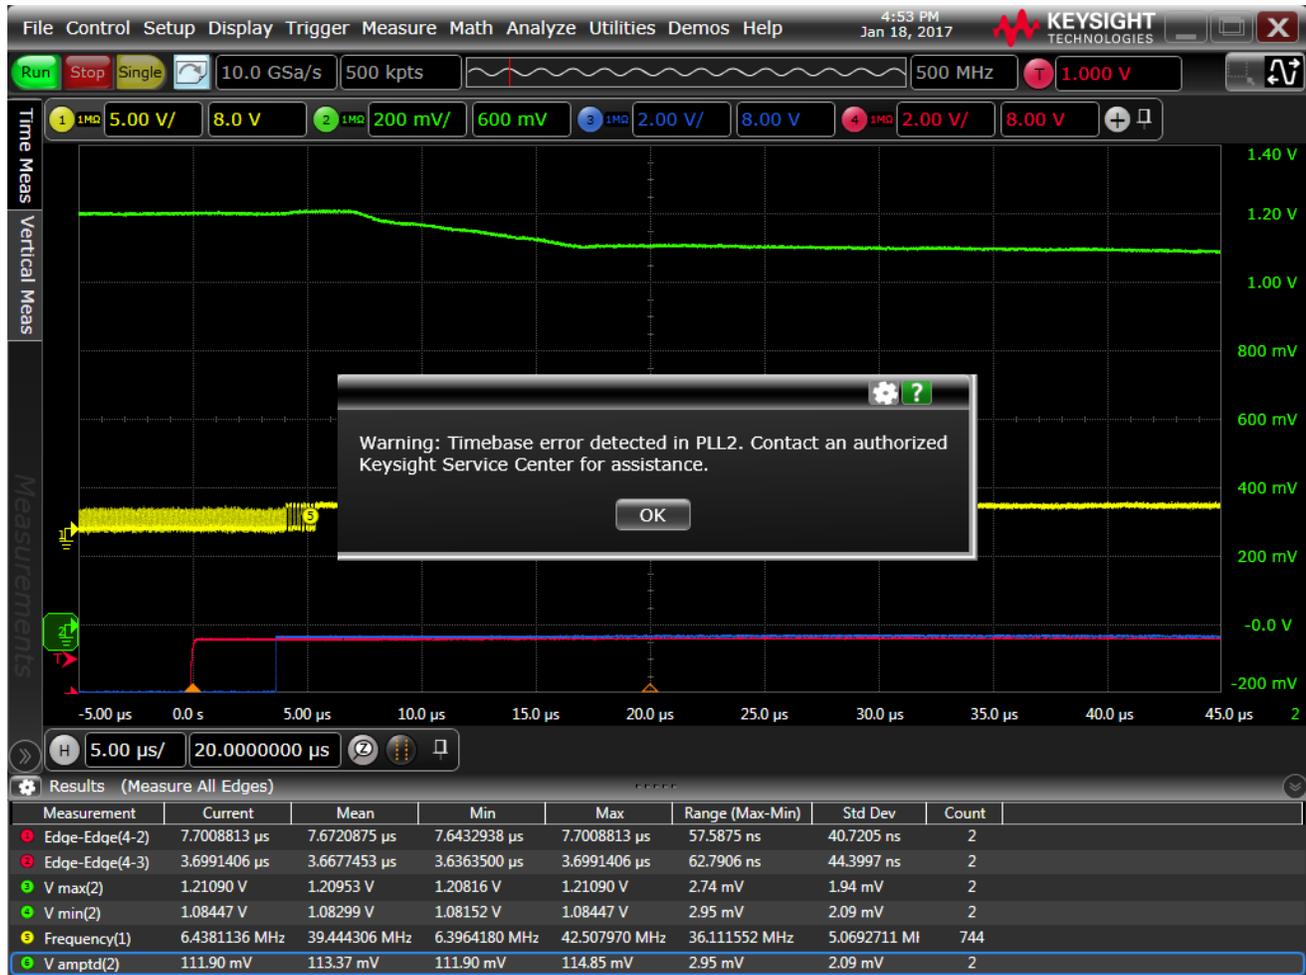
The Problem – Under certain circumstances a PLL2 error may occur on the S-series products.

On older acquisition boards a PLL2 error message sometimes occurs. The error message appears on the screen as below:

There are new acquisition boards that fix this issue for the S-series scopes.

1. If the customer needs to have software revision < 6.10, then replace the acquisition board with the 54911-69532 board.
2. If the customer can have software revision > 6.10, then it can be replaced by any of these three boards: 54911-69521, 54911-69531, or 54911-69532.
3. Save the Serial Numbers of the replaced and the new Acquisition Boards in Siebel. Please, follow this procedure:
 - a. For each Service Order in Siebel, there is a tab labeled Activities:
