MX0020A-01

# Modification Recommended Service Note

## InfiniiMax Ultra 10 GHz Probe Amp with AutoProbe 2 Interface

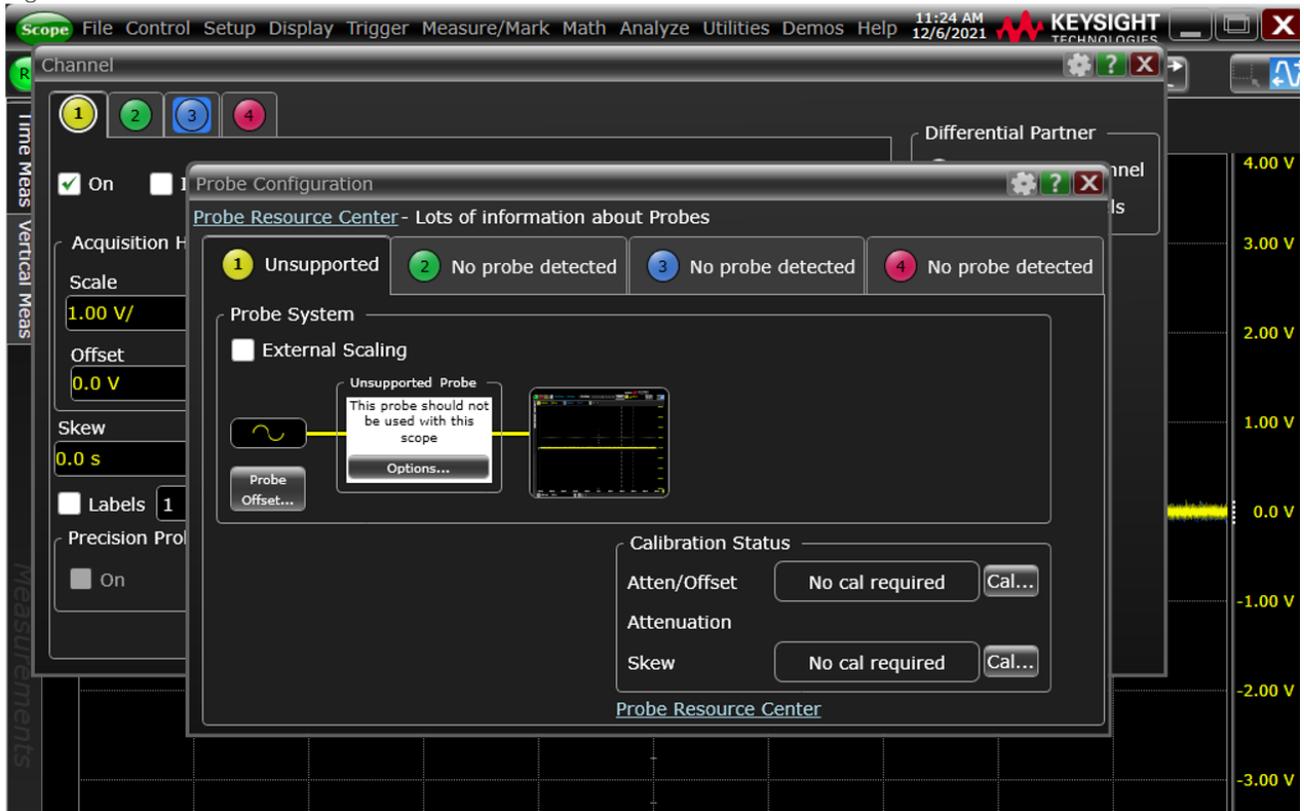
The early shipments of MX0020A probes have a quality concern that can cause probes to not be recognized when attached to the scope channel. Please see Figure 1.

- 1. Capacitor failure

Please return defective probe amplifier to service center for repair.
