MX0023A-01

# Modification Recommended Service Note

## InfiniiMax 25 GHz RC Probe Amp with AutoProbe 2 Interface

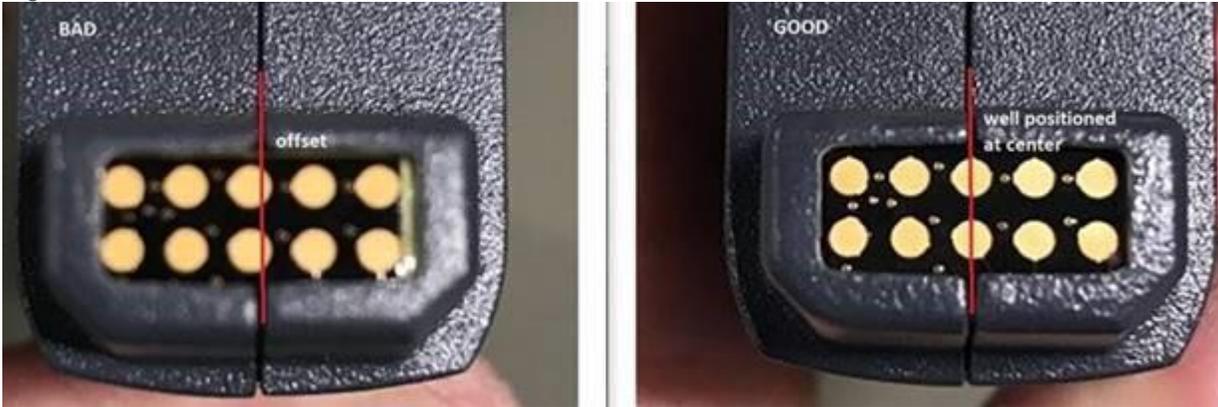
The early shipments of MX0023A probes have been found to have an assembly issue with the AutoProbe Interface 2 Flex Circuit alignment.

Visual inspection of the probe amp AutoProbe interface is to compare returned probe to the below pictures to identify Good from Bad flex circuit assembly. Refer to Figure 1 below.

Please return defective probe amplifier to service center for repair.
